**Town of Carmel
60 McAlpin Avenue
Mahopac, NY 10541
RE: 99 Everett Road; Mahopac, NY
300,000 Gallon GST
March 25, 2019
Mr. Rich Franzetti
Engineer
(845) 628-1500 x181
Job No. 319099-C**

GROUND STORAGE INSPECTION REPORT

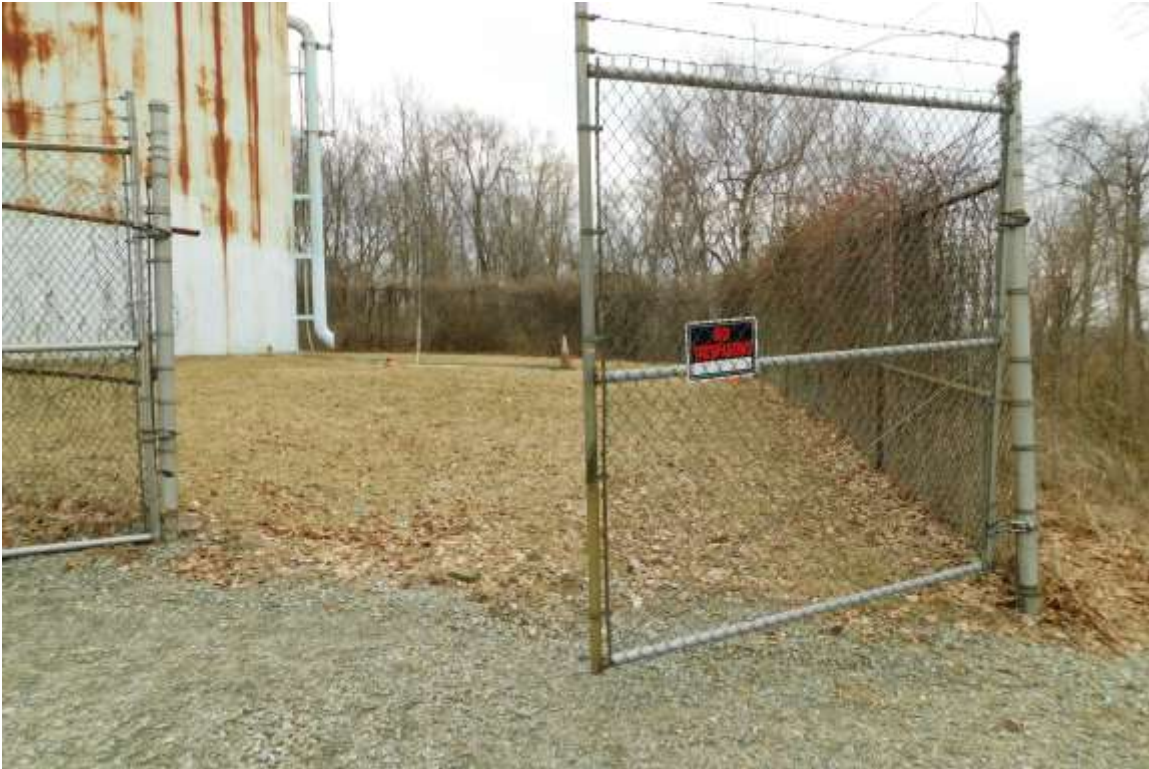
Photo shows the tank is secured with fencing. We recommend posting a **Warning, Tampering With This Facility is a Federal Offense** (US code title 42, section 300i-1) sign.

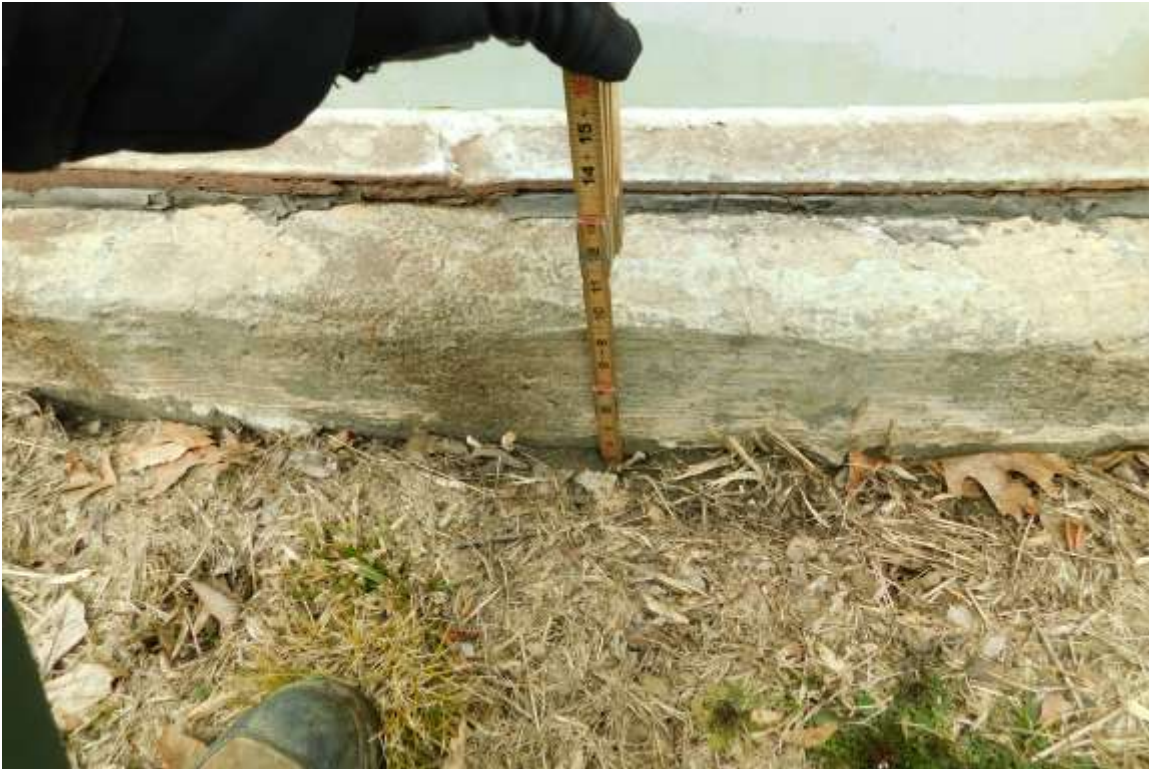
Photo shows the area around the tank foundation is properly graded and in compliance with **AWWA D100-11; 12.7.1 Height aboveground.**

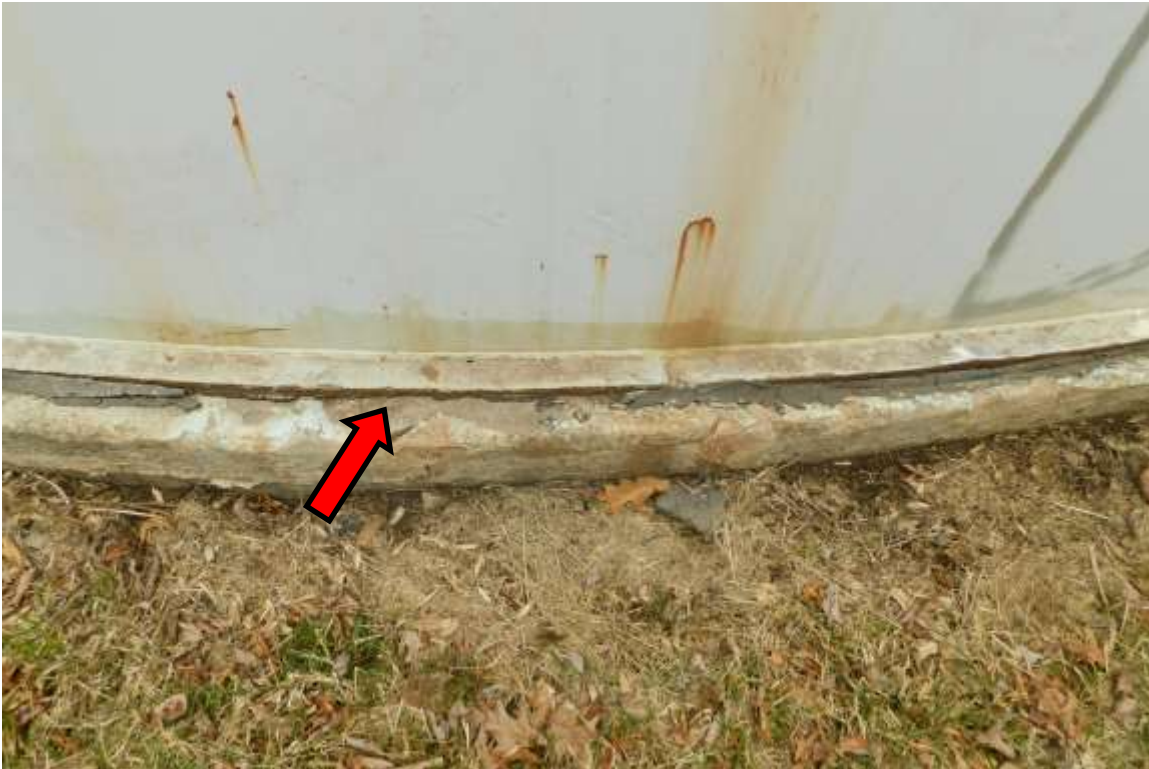
Photo shows the condition of the foundation. We recommend repairing any cracks and spalling in the concrete with a commercial non-shrinking grout, caulking/grouting around the base of the tank to foundation connection to prevent water from entering under the tank, then sealing the foundation with a sealant.

We further recommend inserting sacrificial cathodic protection rods radially every 15' beneath the floor of the tank.

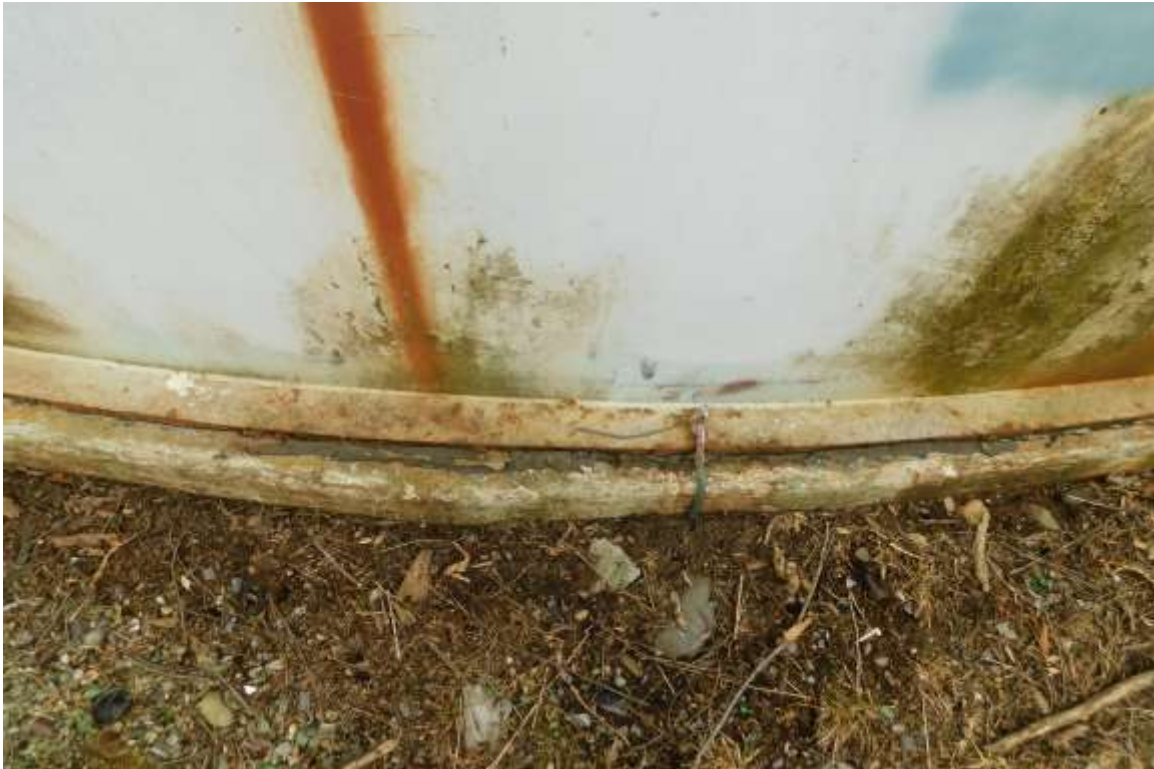
Photo shows the tank is electrically grounded for lightning protection as required by **OSH Act of 1970 Section 5** and appears to be in good condition.

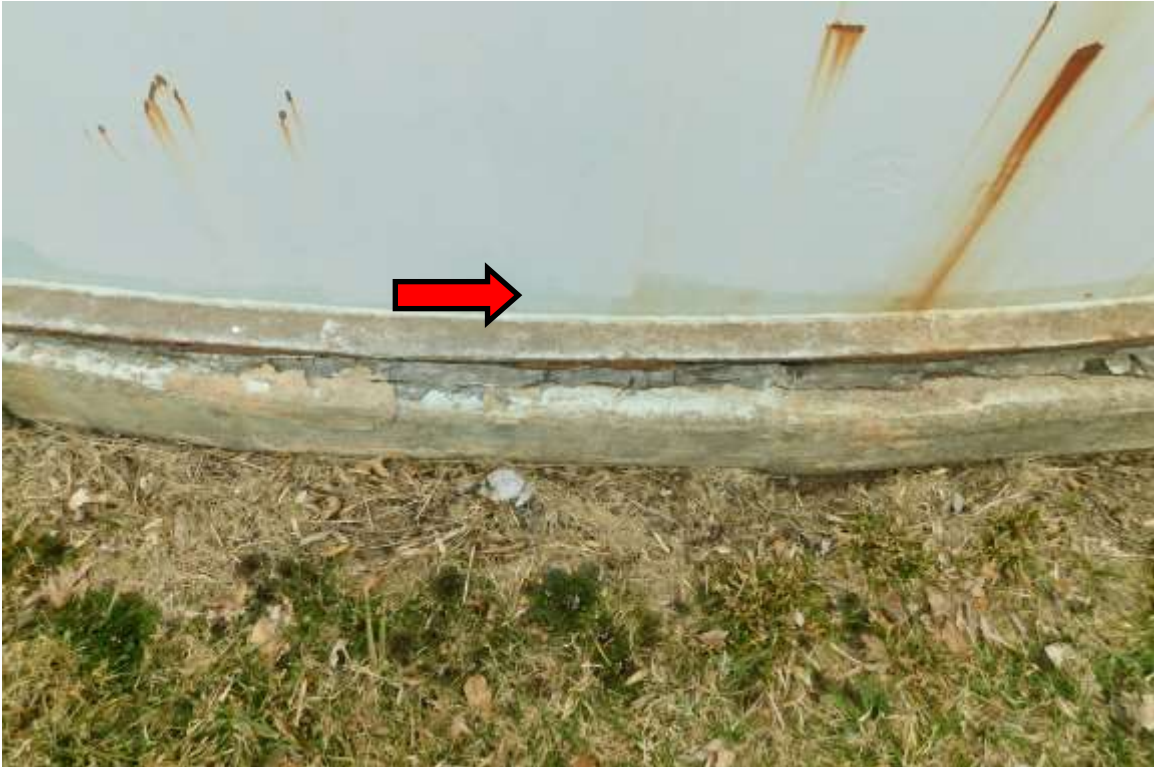
Photo shows the condition of the shell. Currently there is no drain valve. We recommend installing a frost proof drain valve near the shell-to-floor connection, complete with a locking device to prevent unauthorized draining of the tank and a splash pad to direct water away from the foundation.

**Splash pad to be installed by owner.*

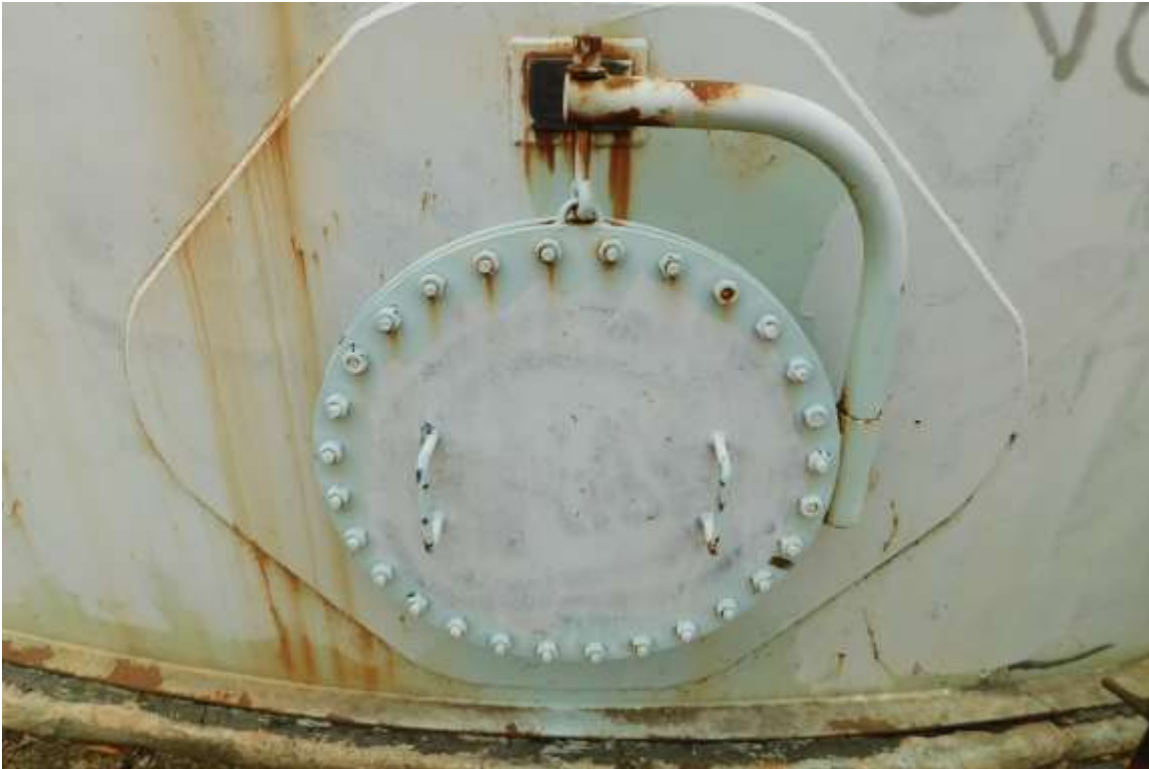
Photo shows the condition of the 24" primary shell manway. The following is required for the tank to be in compliance with **AWWA D100-11; 7.4.4 Shell man-holes** and **OSHA 1910.146(c)(2) Confined spaces**.

We recommend:

Install 30" secondary shell manway 180° from primary manway
Post **Confined Space Entry** signs
Install maintenance free galvanized steel bolts

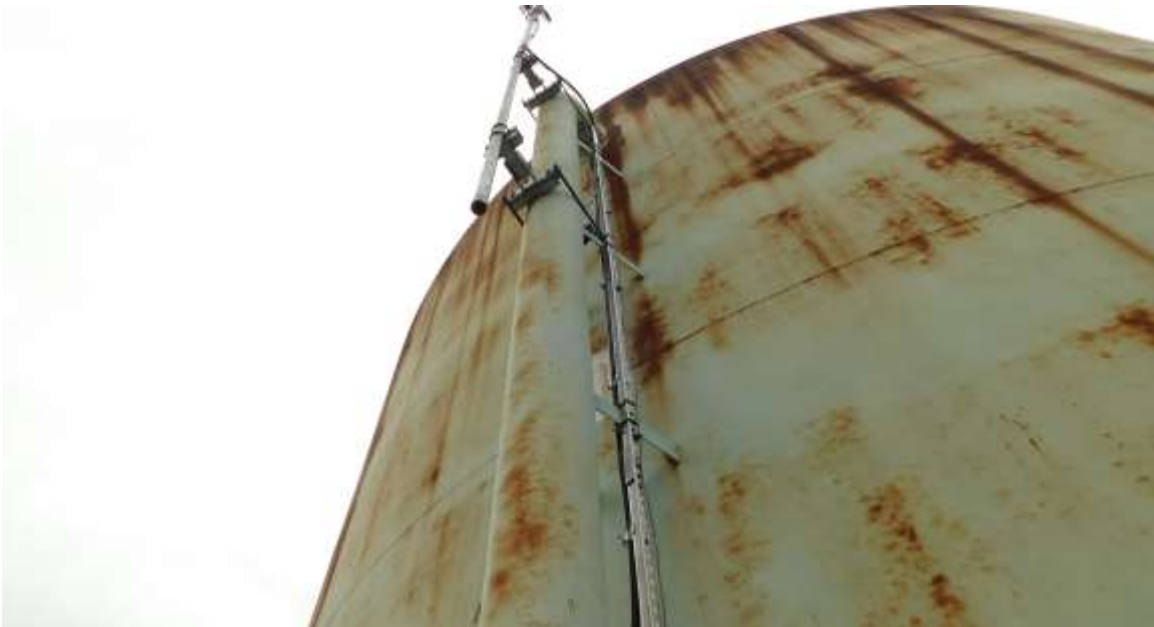
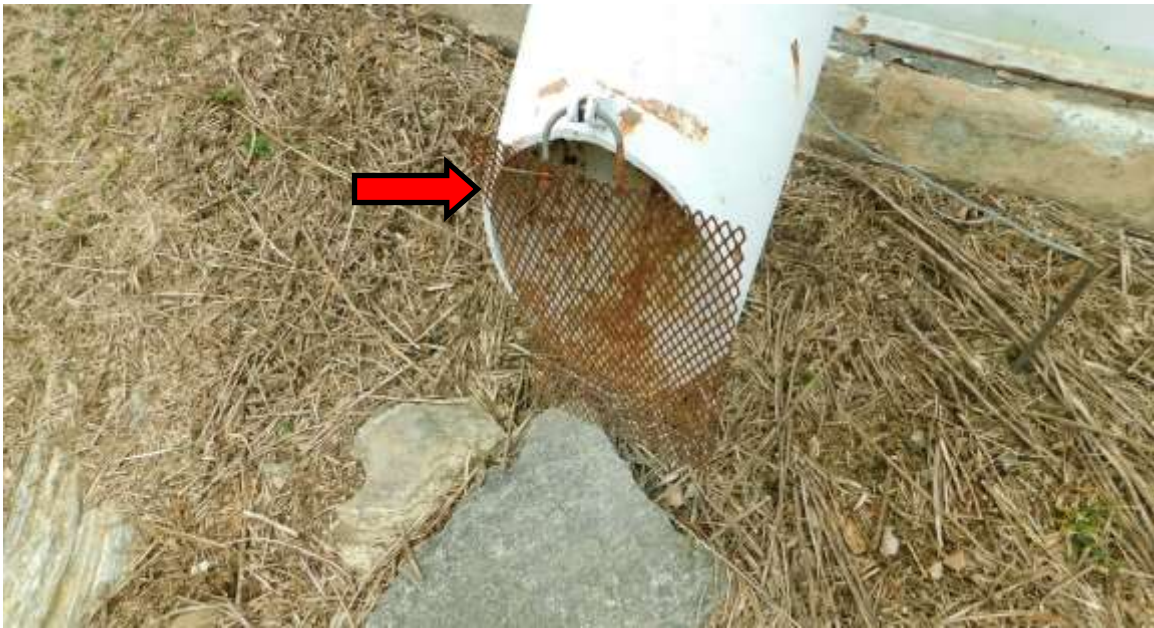
Photos show the 12" overflow pipe system, which is not equipped with a flapper valve as required by **AWWA D100-11; 7.3 Overflow**. We recommend installing a flapper valve and new screen on the existing overflow pipe elbow, and a splash pad to direct the water away from the tank foundation.

**Splash pad to be installed by owner.*

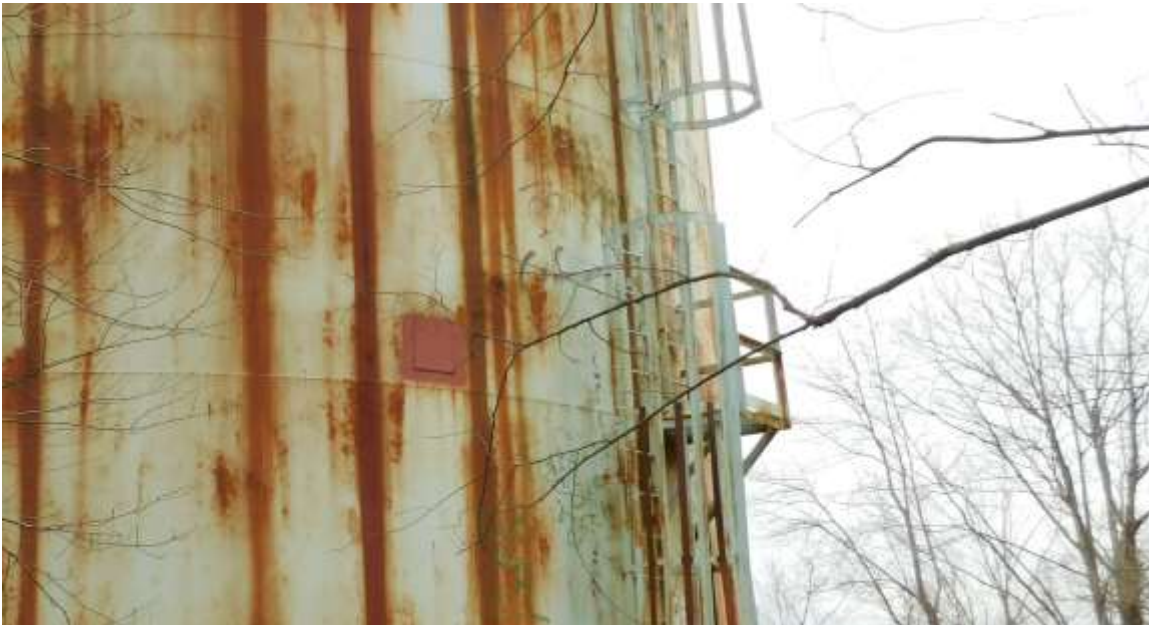
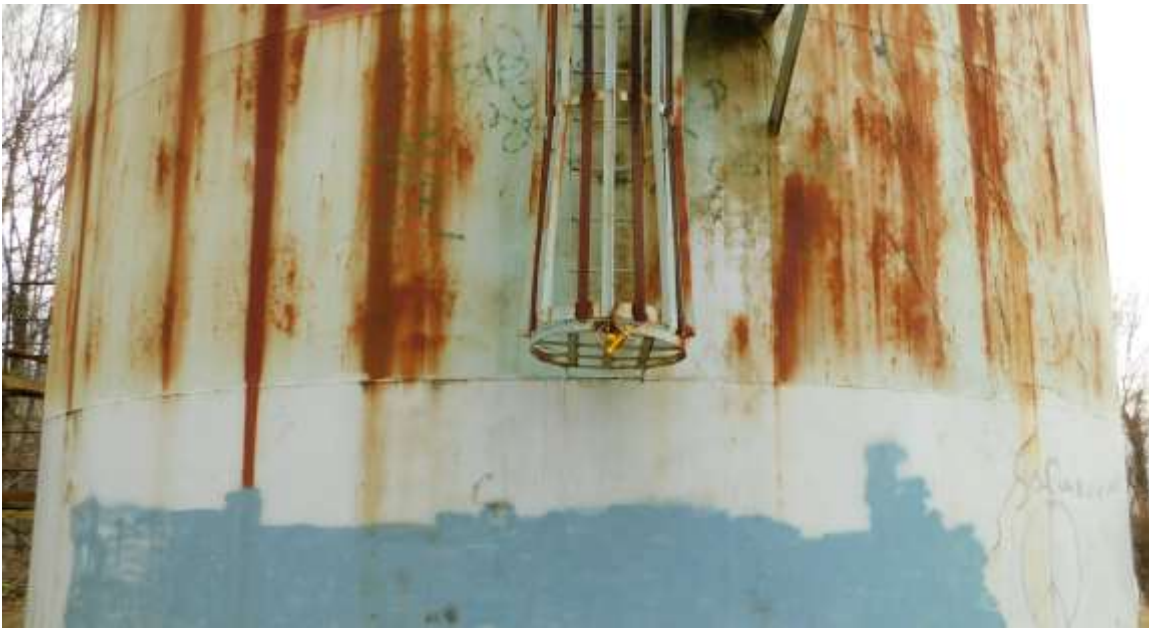
Shell access ladders in above photos are 16" wide, but are not equipped with anti-skid rungs. We recommend installing anti-skid rung covers, cable type ladder safety devices and posting a **Fall Protection Required** sign at the base of the ladder.

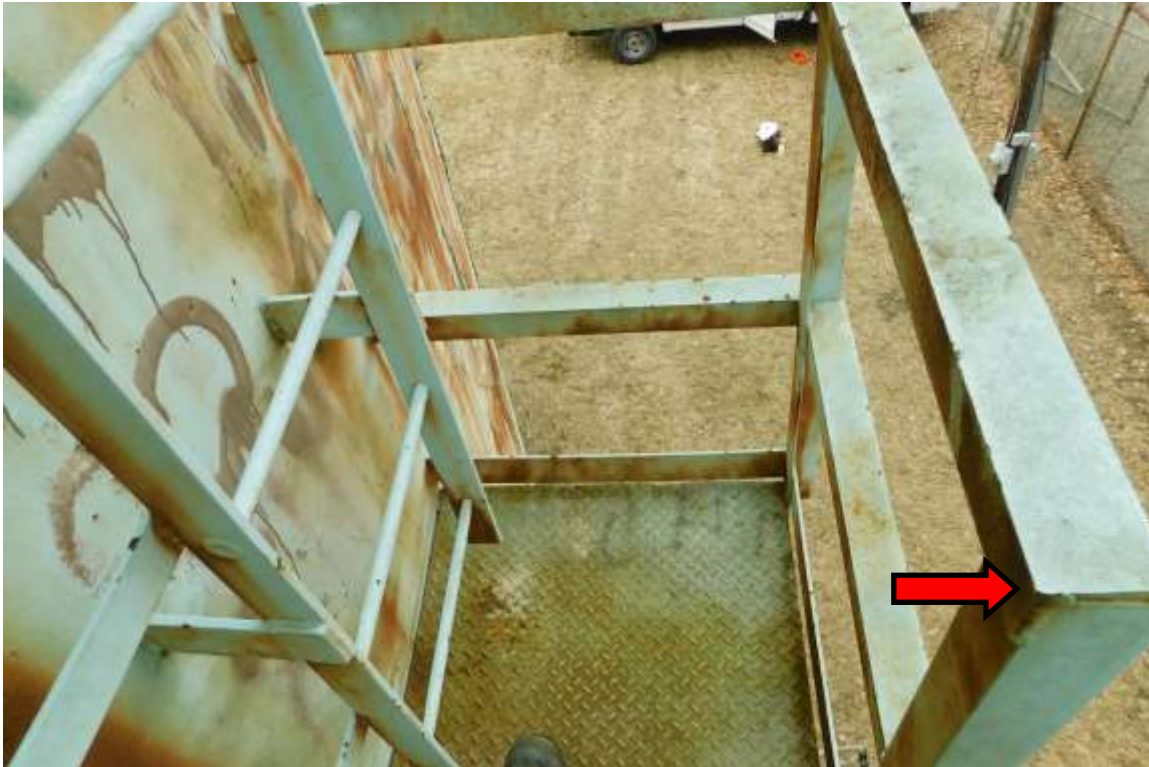
Photo shows the condition of the shell access standoff platform, which is equipped with an anti-skid floor and a 42" high **OSHA** compliant handrail system, complete with an intermediate rail and toeboard. We recommend installing a swing gate at the access standoff platform.

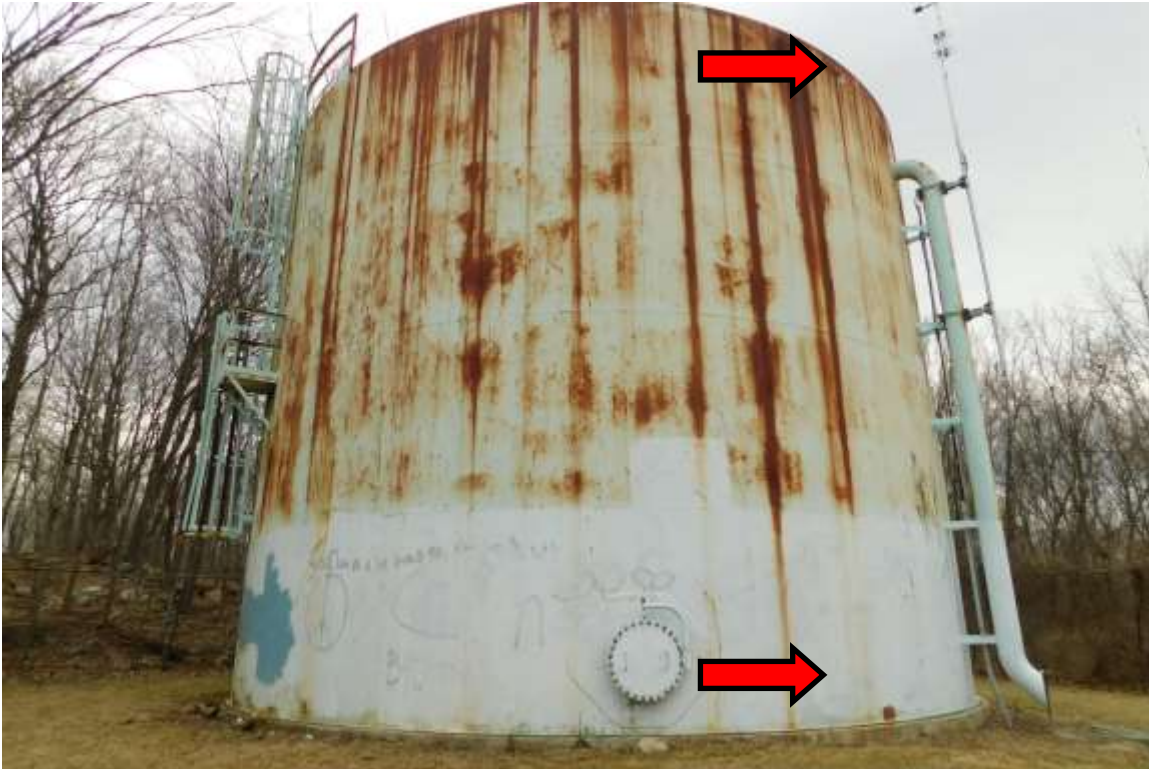
Photo shows the tank is not equipped with a liquid level indicator. We recommend installing a float-type liquid level indicator.

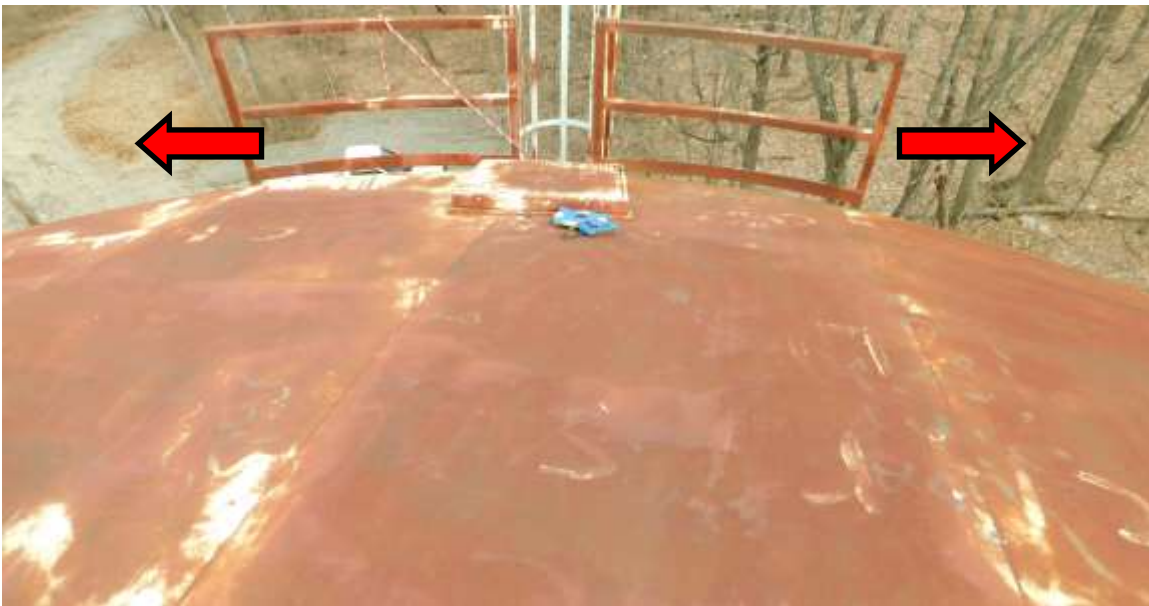
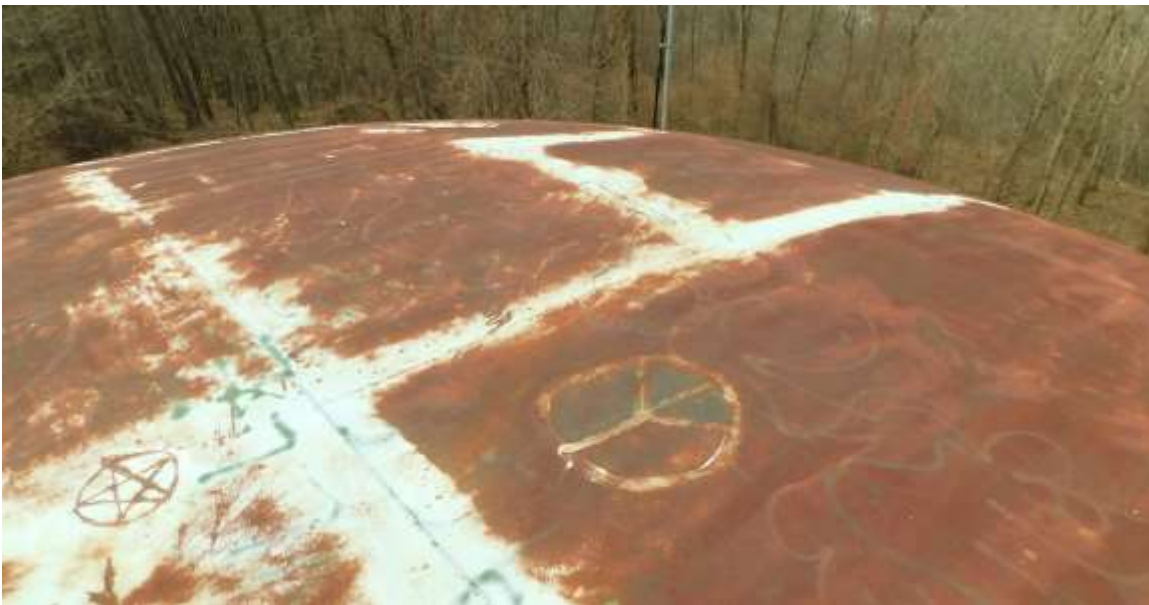
Photos show the tank roof edge is not equipped with a required handrail system for fall protection. **OSHA 1910.28(b)(1)(i)** states, "...the employer must ensure that each employee on a walking-working surface with an unprotected side or edge that is 4 feet (1.2 m) or more above a lower level is protected from falling by one or more of the following: **1910.28(b)(1)(i)(A) Guardrail systems.**" The tank is equipped with 42" high handrails to the left and right of the access ladder. We recommend extending the handrails around the circumference of the tank roof, complete with an intermediate rail, a toeboard, and a swing gate at the junction of the shell-to-roof access ladder and tank roof.

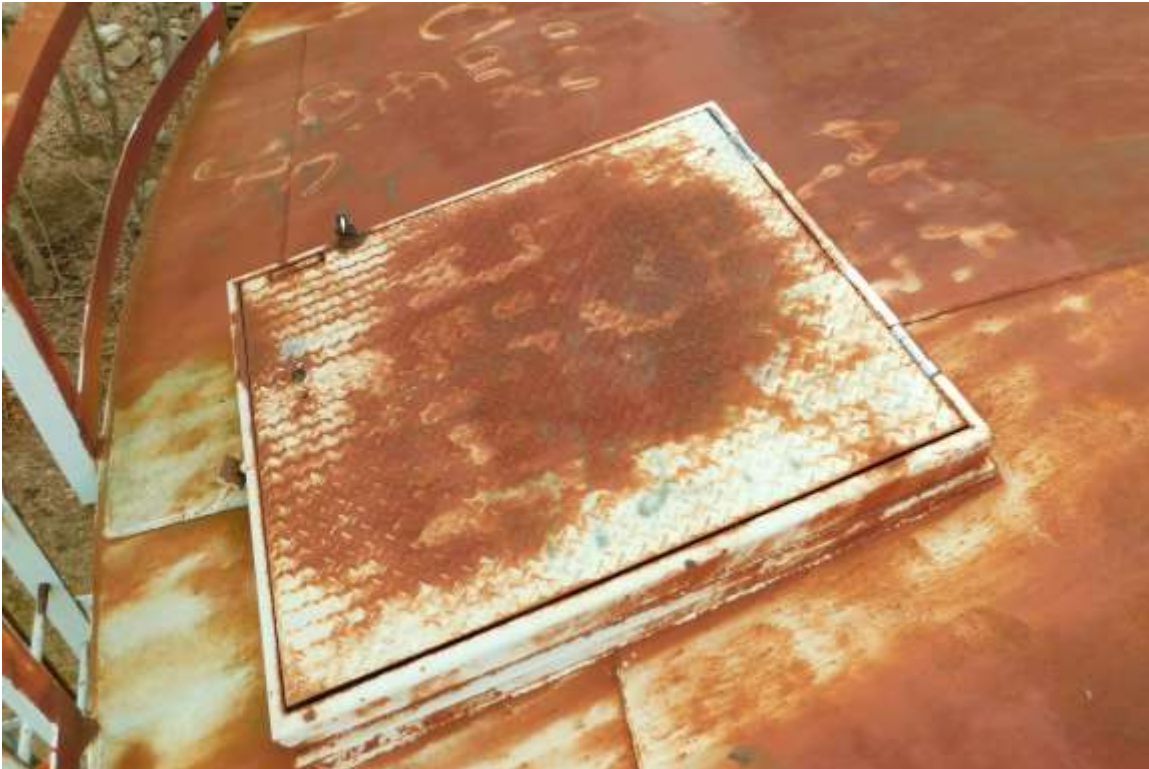
Photo shows the condition of the 30" primary roof hatch. Roof openings on this tank require the following to be in compliance with **AWWA D100-11; 7.4.3 Roof openings** and **OSHA 1910.146(c)(2) Confined spaces**.

We recommend:

Replace 30" primary hatch cover with a 2" overlapping cover
Post **Confined Space Entry** sign

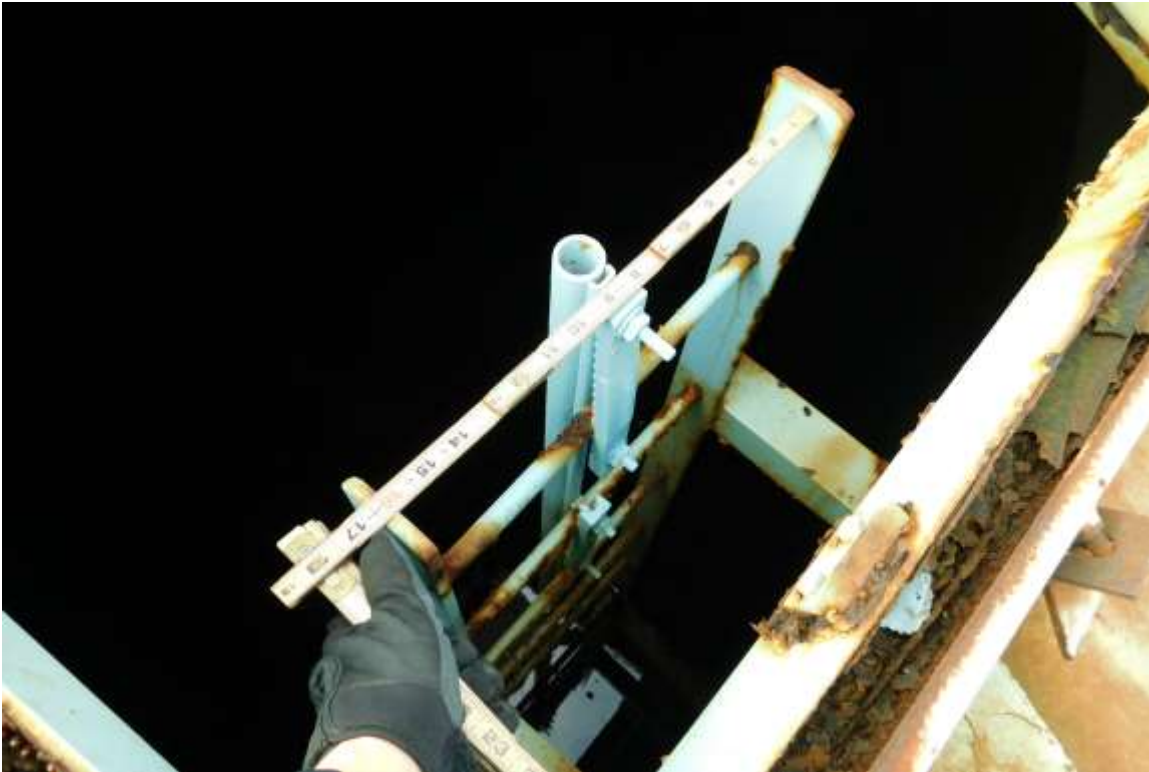
Primary interior access ladder in above photo is 16" wide, but is not equipped with anti-skid rungs. We recommend installing anti-skid rung covers and replace existing safety device with a cable type ladder safety device on the primary interior access ladder.

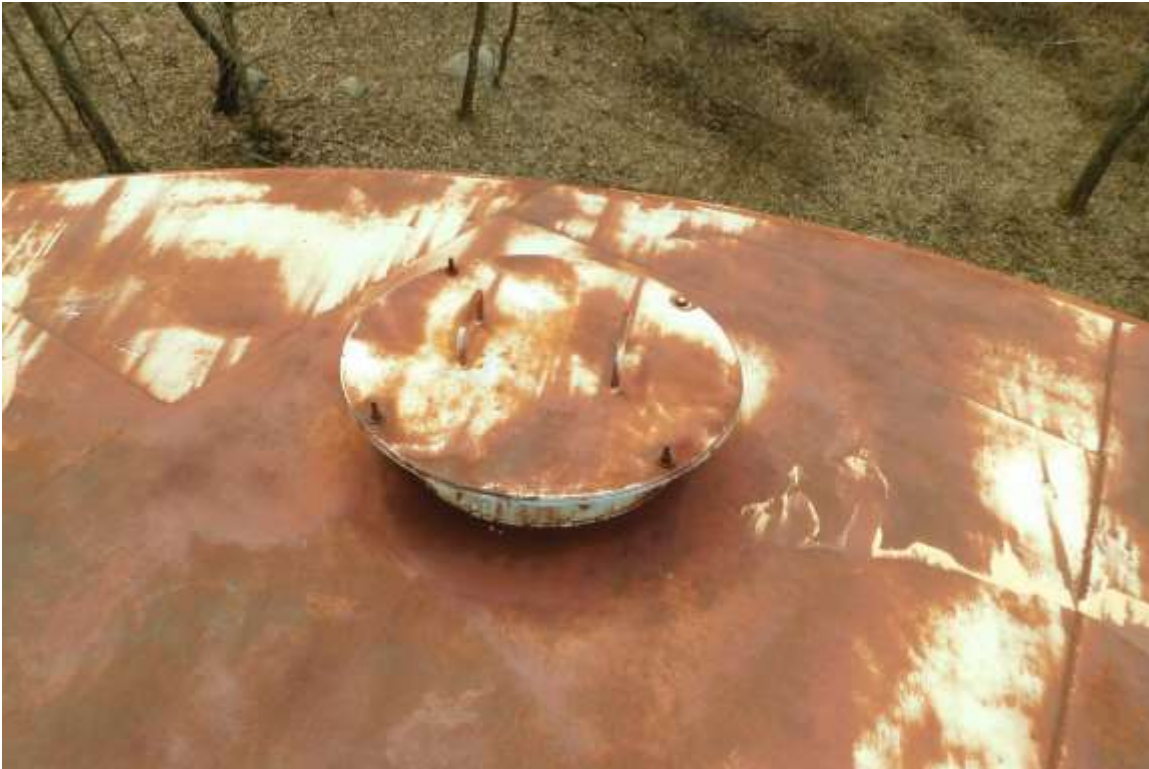
Photo shows the condition of the 24" secondary access point / fan mount. Roof openings on this tank require the following to be in compliance with **AWWA D100-11; 7.4.3 Roof openings** and **OSHA 1910.146(c)(2) Confined spaces**.

We recommend:

Post **Confined Space Entry** sign

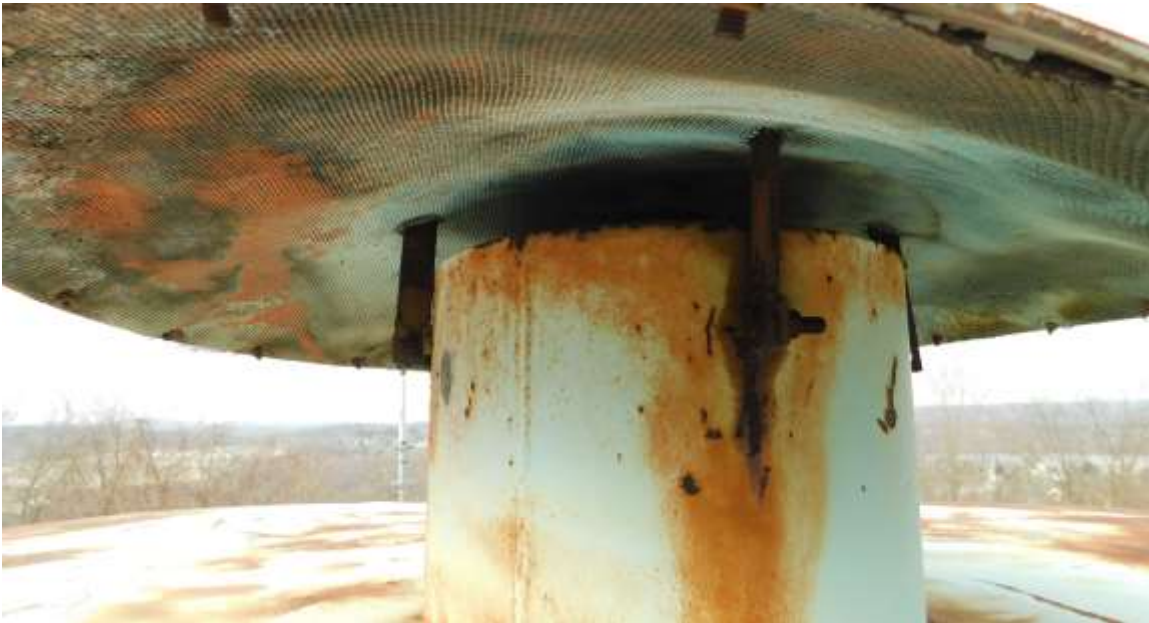
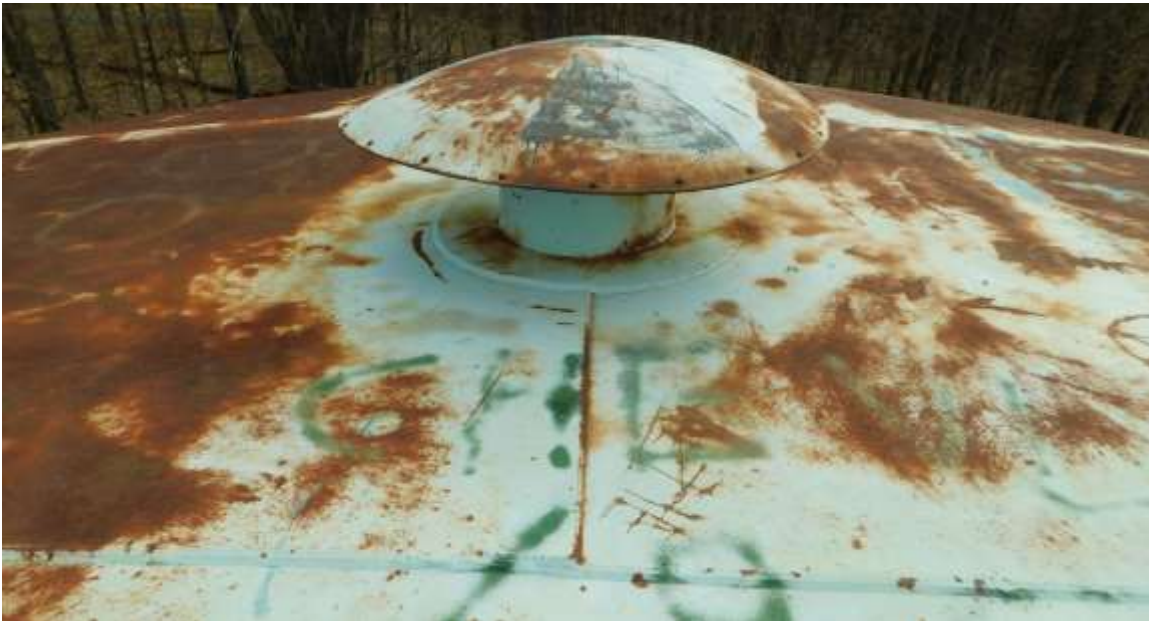
Photos show the condition of the existing 14" roof vent. **This vent is allowing the ingress of rain and wind-borne contaminants into the water system. An improperly vented tank may cause external pressure to act on the tank which can cause buckling even at low pressure differential.** We recommend replacing the existing roof vent with a vacuum-pressure, frost proof vent and screen.

This work should be performed on an emergency basis.

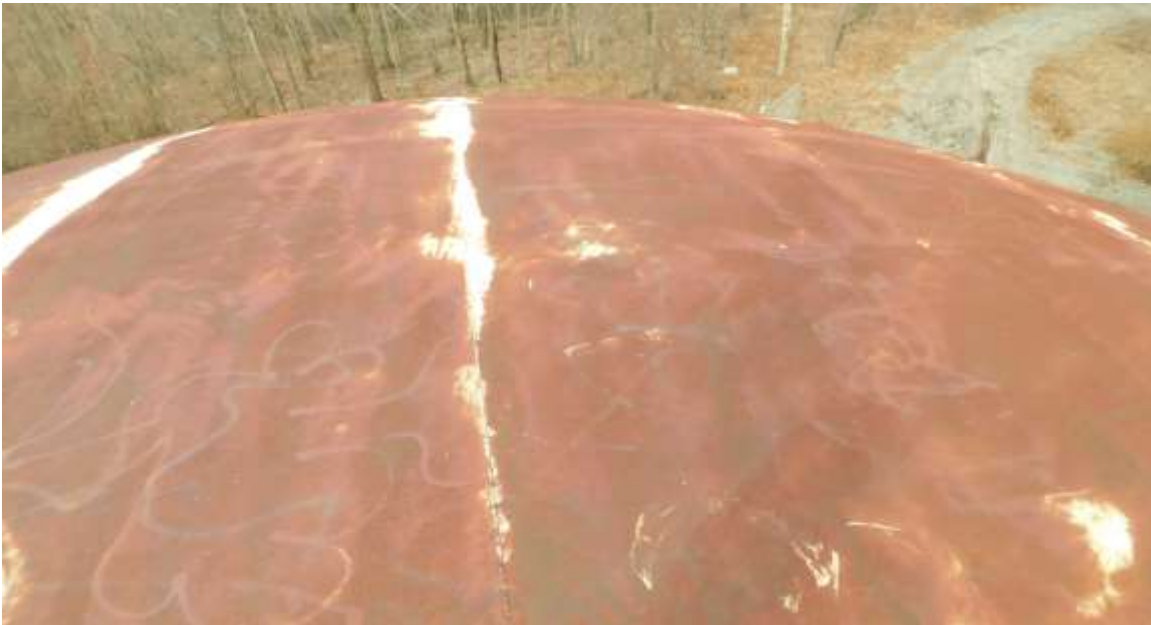
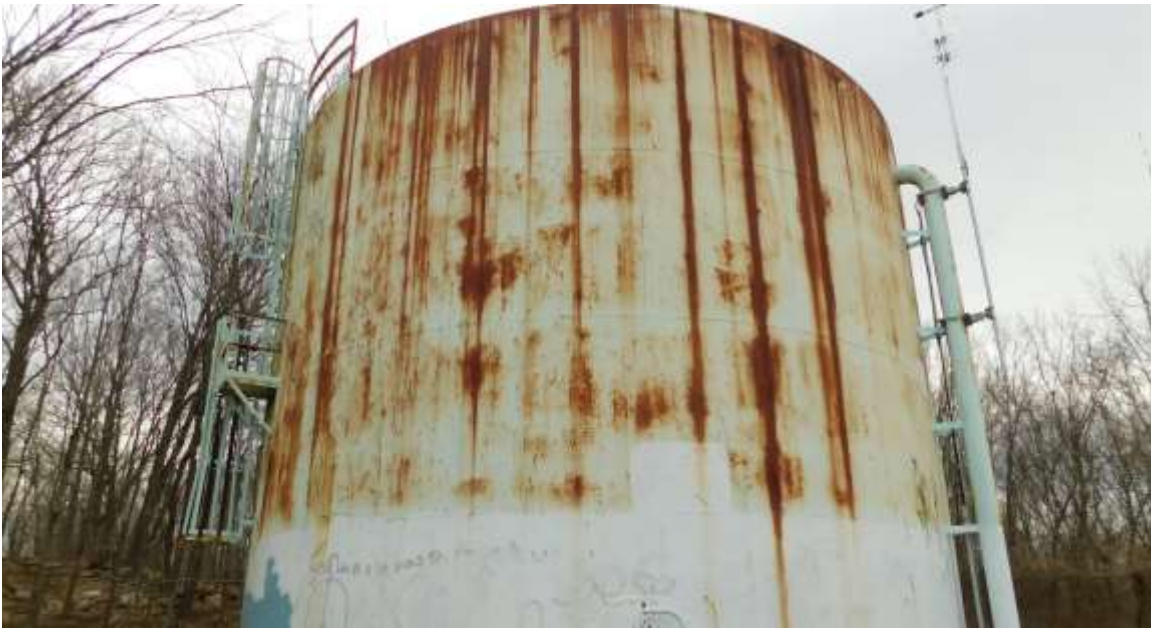
Photos show the tank exterior coating system. We recommend pressure washing the tank exterior and support structure using an anti-fungal biodegradable solution, hand tool cleaning as necessary, then applying a full prime coat of Macropoxy 5000, followed by an intermediate coat of Sherwin Williams Dura-Plate 235, and one (1) full finish coat of Sherwin Williams Acrolon 218 HS.

This work should be performed on an emergency basis.

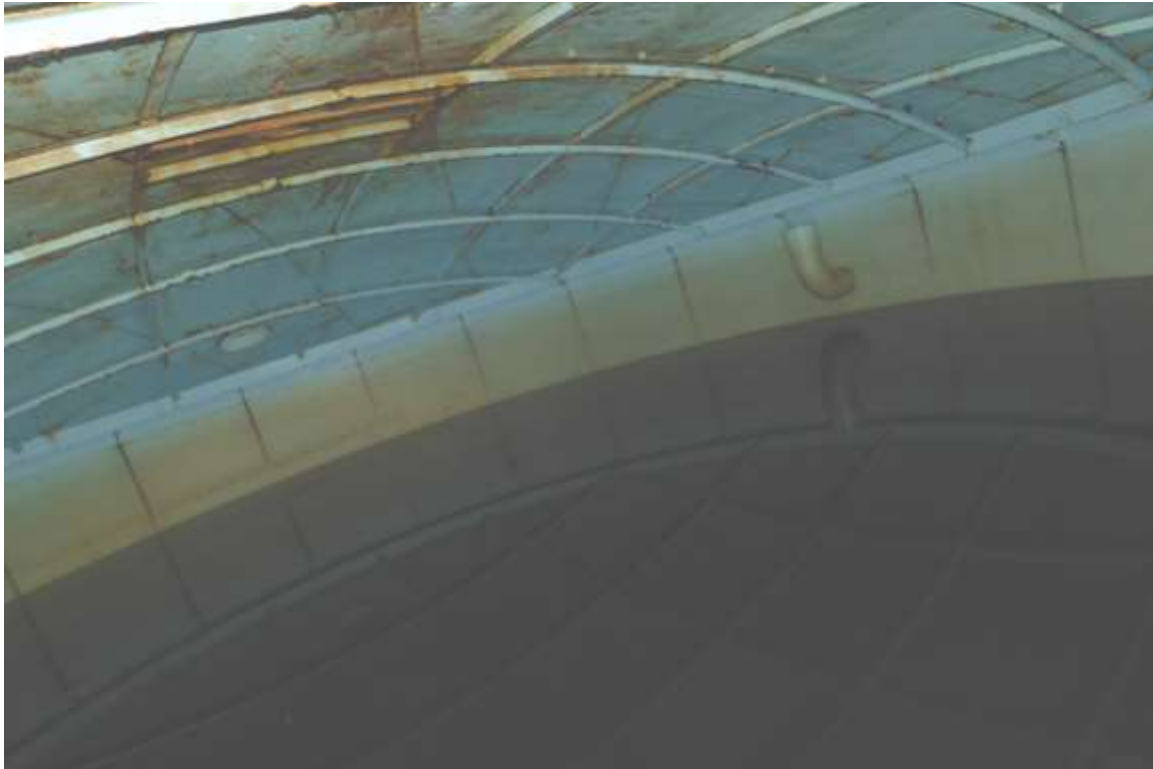
Photo shows the condition of the interior roof. Notice the rust forming at the roof lap seams. We recommend seam sealing using Sikaflex® 1a on all un-welded interior roof lap seams to prevent failure of a new interior liner. This work is to be performed in conjunction with application of new interior liner.

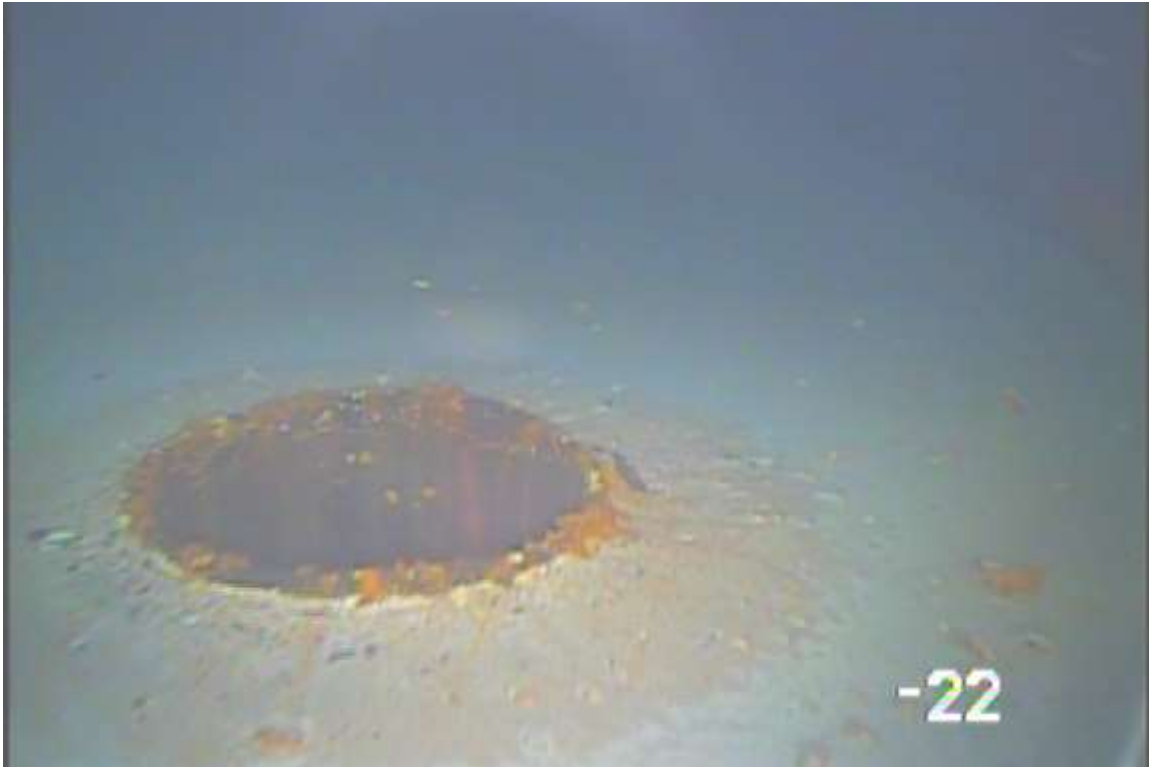
Photo shows a fill pipe on the tank interior. A temperature difference between the water in the top and bottom of a tank, even as little as 1-2 degrees Fahrenheit, is an indication of thermal stratification and the tank water not being completely mixed. Incomplete mixing would result in short-circuiting, and localized increase in water age would develop inside the tank. This typically leads to water quality problems, such as loss of residual, DBP spikes, HPC spikes, bacteria regrowth, formation of bio-film, changes in pH and dissolved oxygen. We recommend installing a mixing system. Electrical work to be done by others if required.

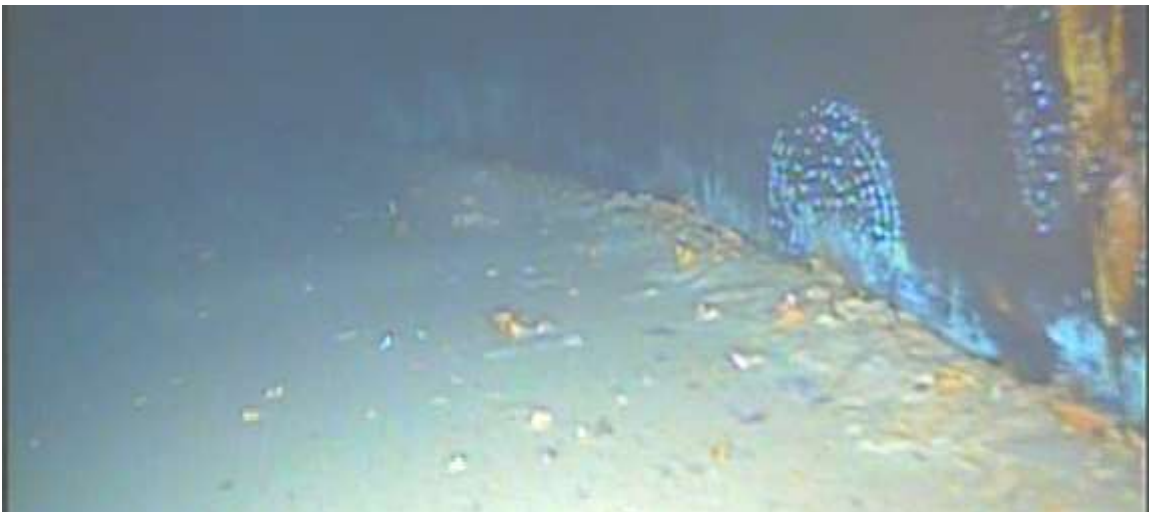
Photos show sediment in the tank. We recommend performing a dry interior cleanout in order to prevent contamination issues associated with excessive sediment buildup.

Due to amount of sediment and debris, a robotic in-service cleanout can not be performed.

This work should be performed on an emergency basis.

We further recommend installing a passive cathodic protection system.

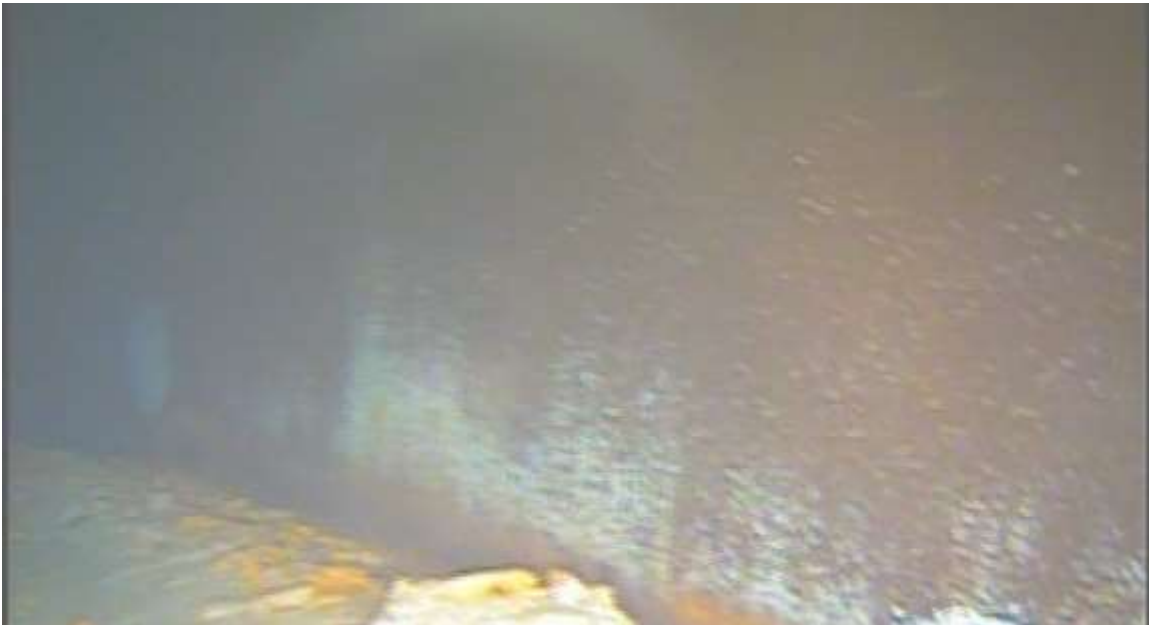
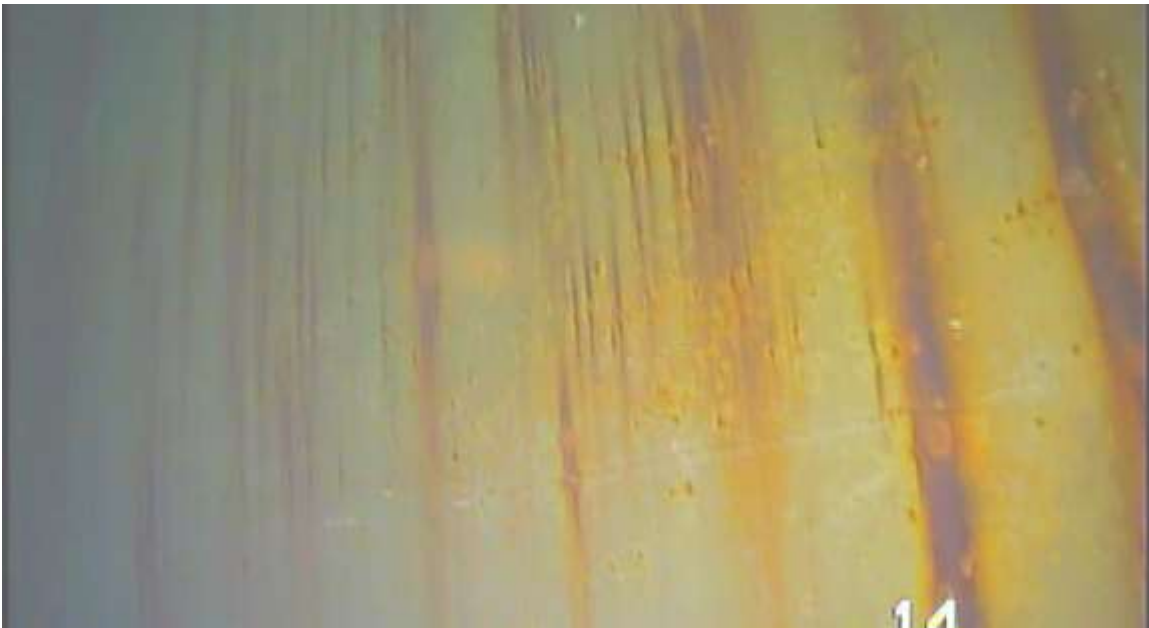
Photos show the condition of the interior coating system. We recommend sand-blasting all rusted and abraded interior areas to SSPC-SP10 (near white), and brush blasting all remaining interior areas to SSPC-SP7; then applying one (1) spot coat of epoxy primer to all areas sandblasted to #10, stripe coating all weld seams, and applying epoxy to the entire tank, to achieve 8 to 10 mils of total dry film thickness. Total mil thickness will include a combination of the existing and new coating.
