**Town of Carmel
60 McAlpin Avenue
Mahopac, NY 10541
RE: 31 Lindy Drive; Mahopac, NY
300,000 Gallon GST
March 25, 2019
Mr. Rich Franzetti
Engineer
(845) 628-1500 x181
Job No. 319099-G**

GROUND STORAGE INSPECTION REPORT

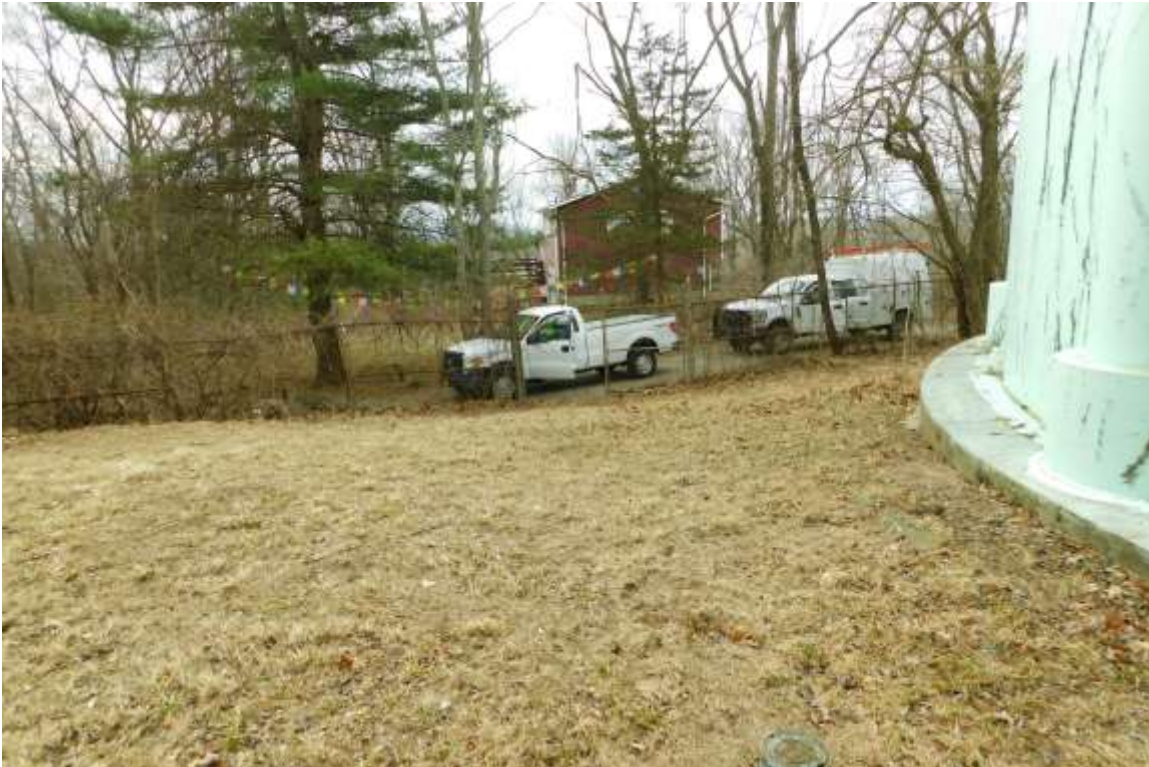
Photo shows the tank is secured with fencing. We recommend posting a **Warning, Tampering With This Facility is a Federal Offense** (US code title 42, section 300i-1) sign and a **No Trespassing** sign.

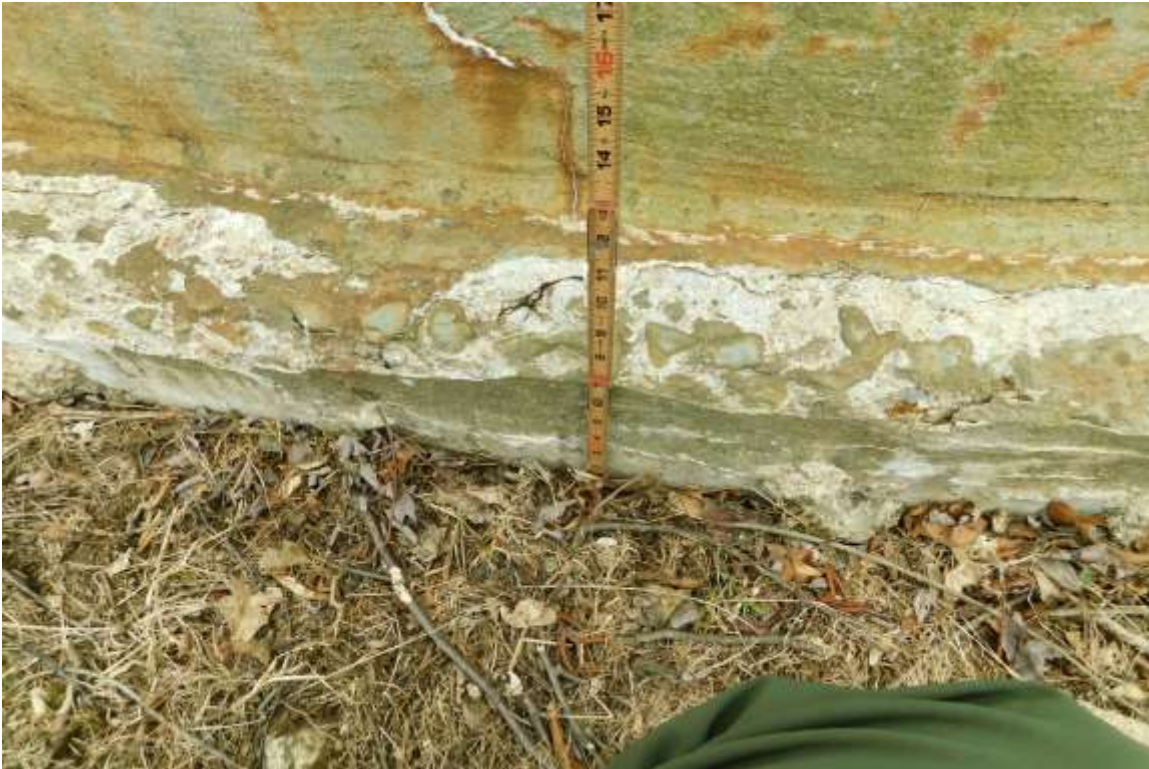
Photo shows the area around the tank foundation is properly graded and in compliance with **AWWA D100-11; 12.7.1 Height aboveground.**

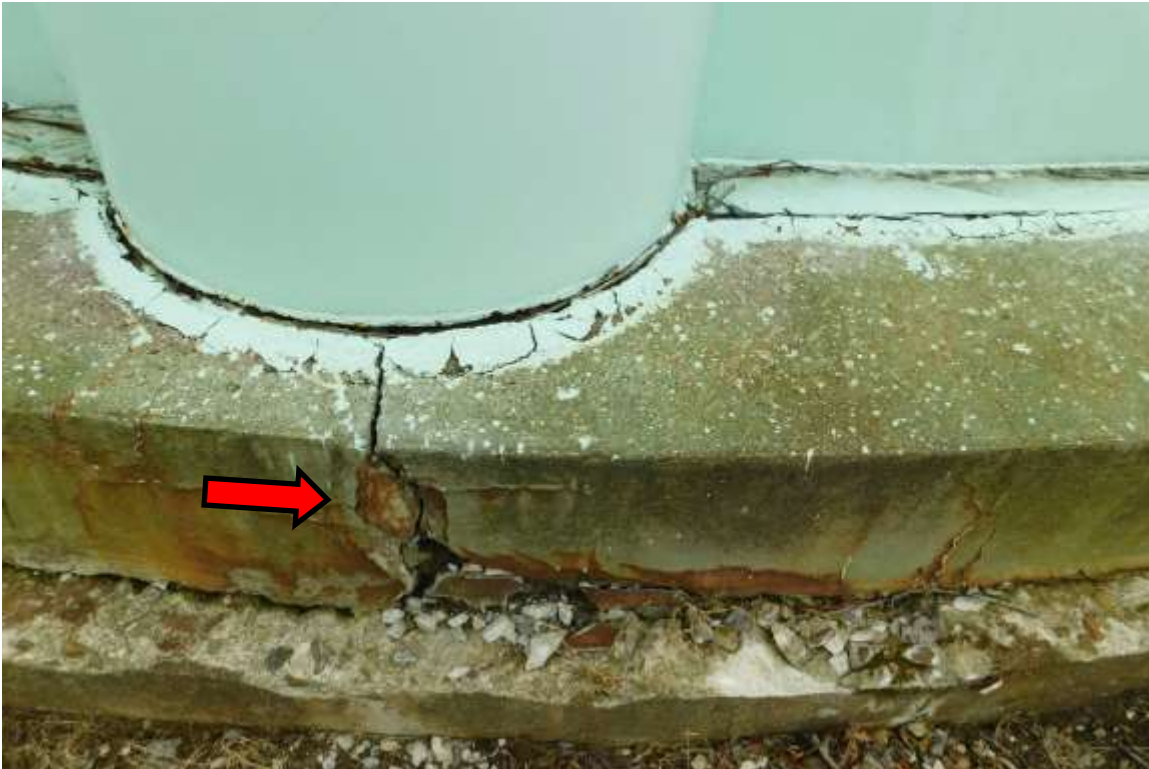
Photo shows the condition of the foundation. We recommend repairing any cracks and spalling in the concrete with a commercial non-shrinking grout, caulking/grouting around the base of the tank to foundation connection to prevent water from entering under the tank, then sealing the foundation with a sealant.

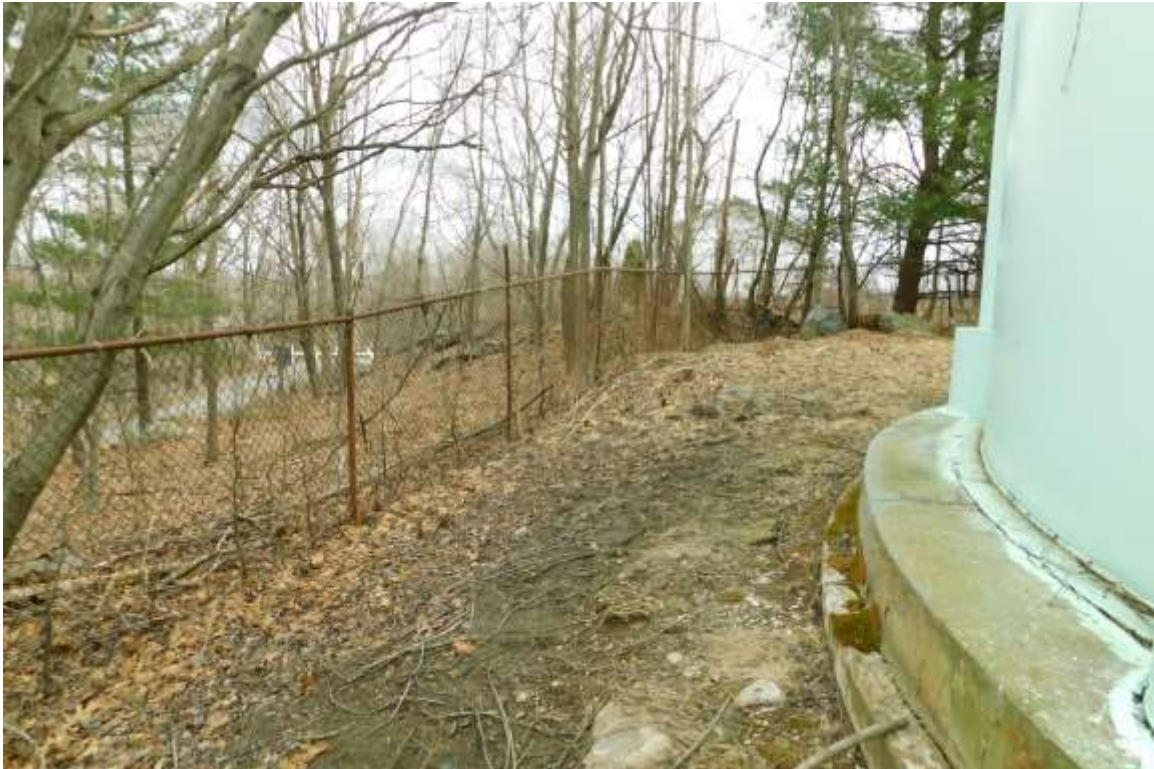
Photo shows the tank has no grounding system. We recommend electrically grounding the tank for lightning protection as required by **OSH Act of 1970 Section 5** and **NFPA 780-2017; 5.4 Metal Towers and Tanks**.

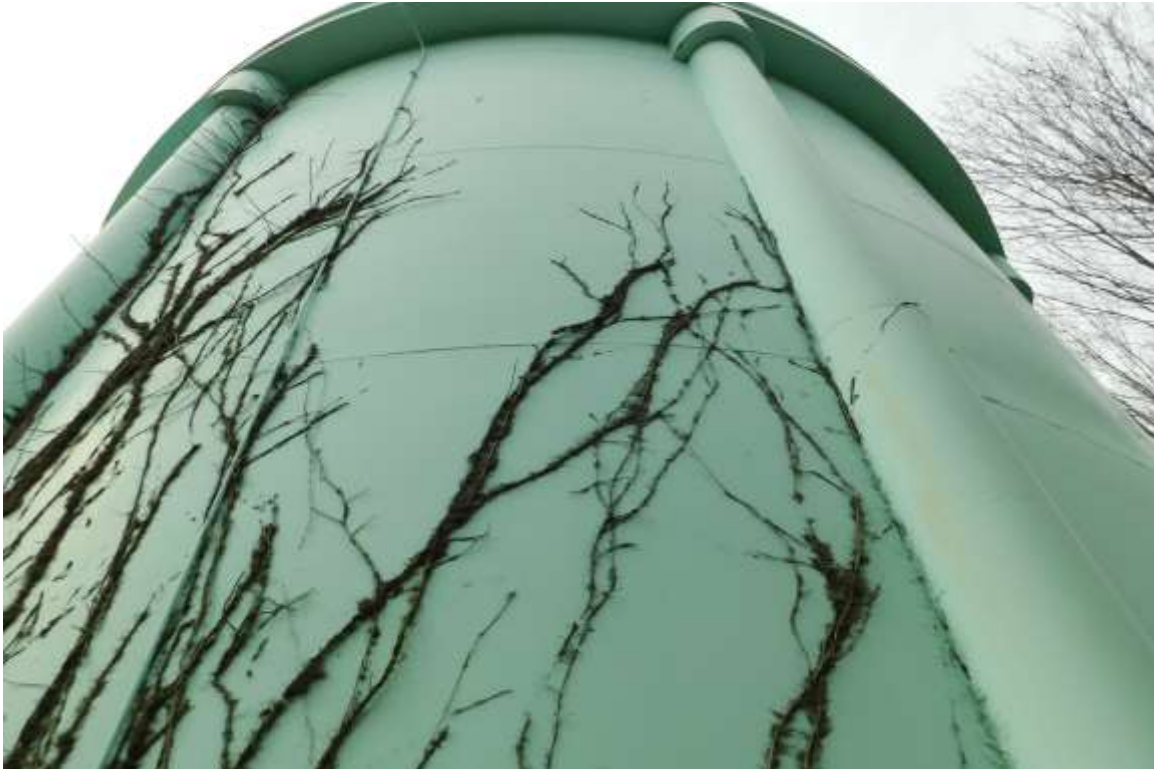
Photo shows the condition of the tank site. **Notice the vegetation growth on the tank.** This could lead to deterioration of the structural components of the tank. **OSHA 1910.176(c)** states, "Storage areas shall be kept free from accumulation of materials that constitute hazards from tripping, fire, explosion, or pest harborage. Vegetation control will be exercised when necessary." We recommend removing the vegetation from the tank. This should be done by others.

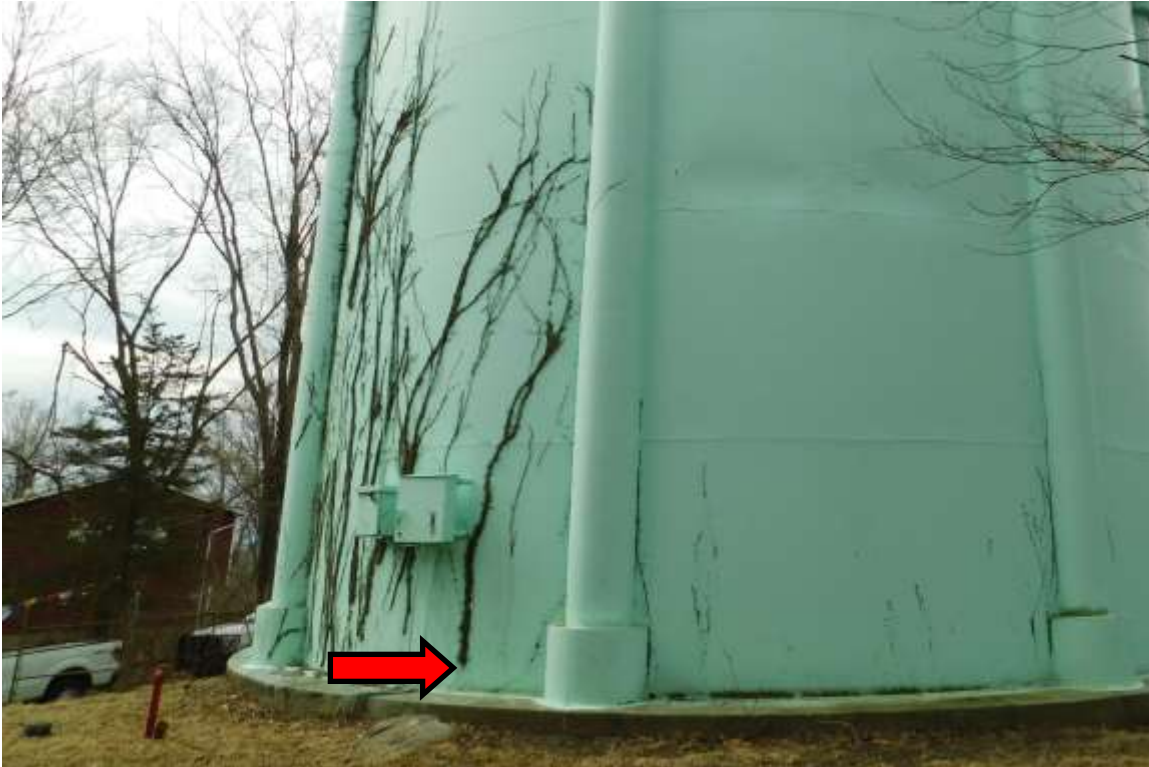
Photo shows the condition of the shell. Currently there is no drain valve. We recommend installing a frost proof drain valve near the shell-to-floor connection, complete with a locking device to prevent unauthorized draining of the tank and a splash pad to direct water away from the foundation.

**Splash pad to be installed by owner.*

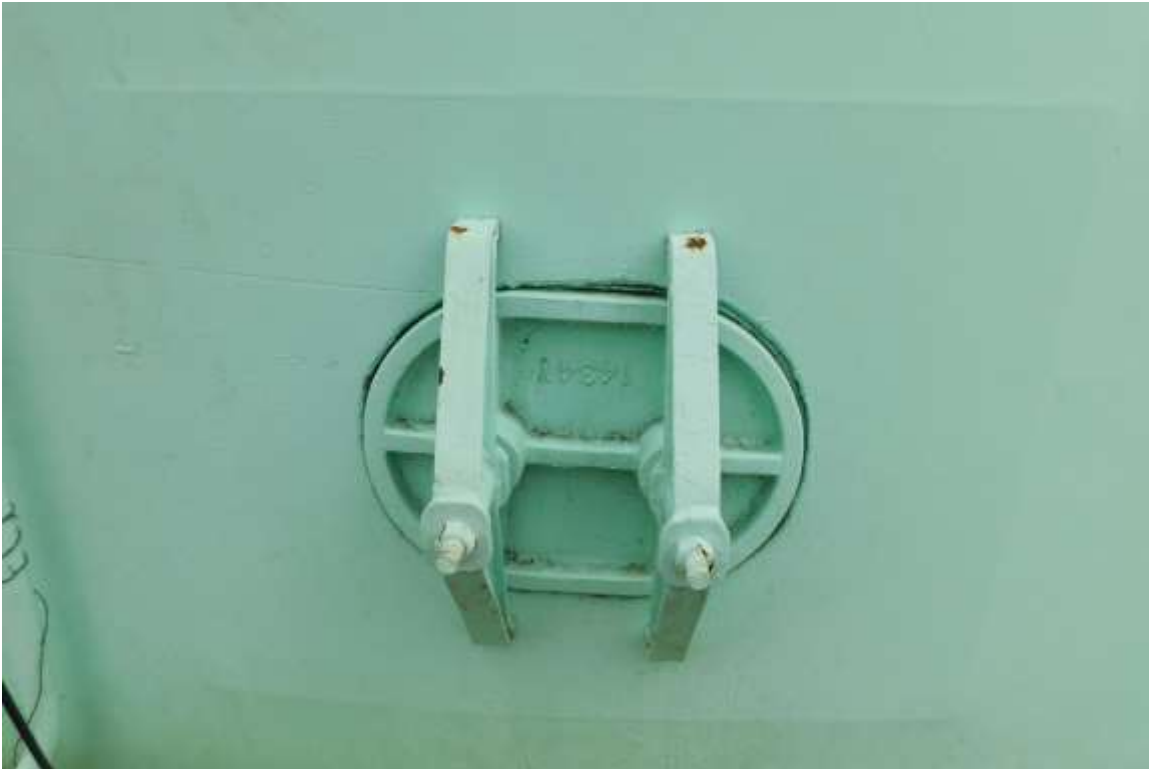
Photo shows the condition of the 18" x 22" primary shell manway. The following is required for the tank to be in compliance with **AWWA D100-11; 7.4.4 Shell manholes** and **OSHA 1910.146(c)(2) Confined spaces**.

We recommend:

Install 30" secondary shell manway 180° from primary manway
Post **Confined Space Entry** signs

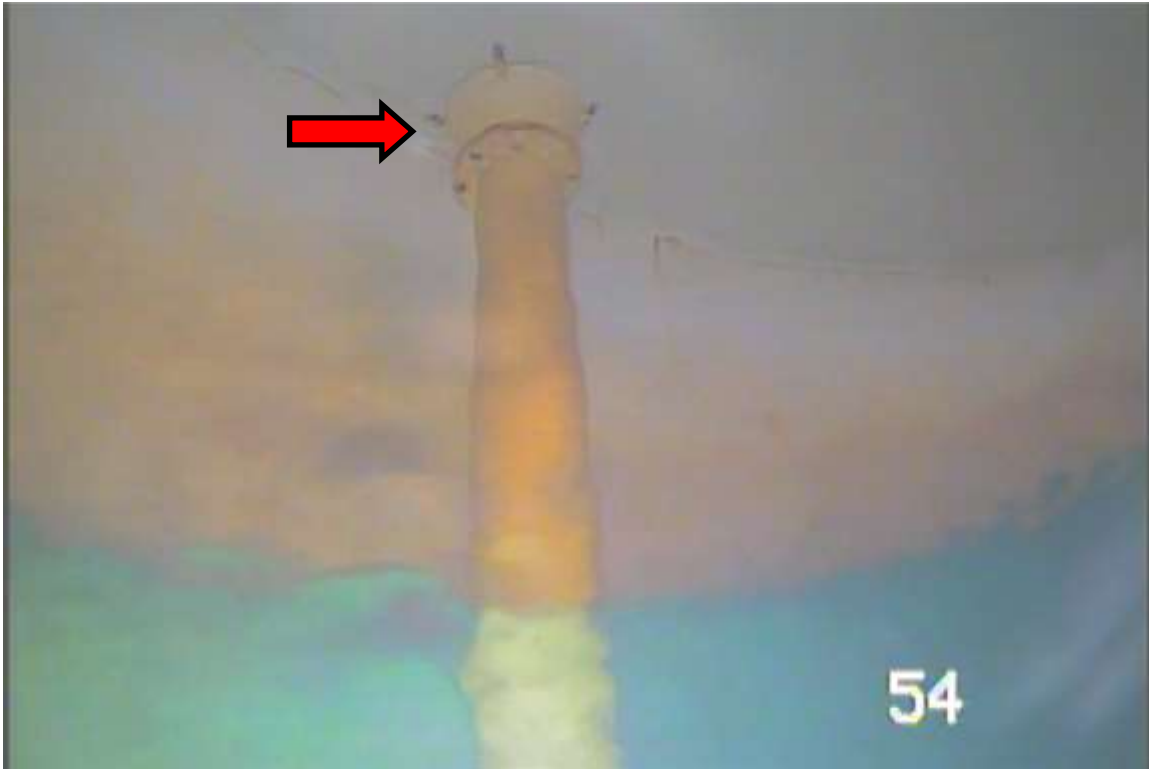
Photo shows the condition of the overflow pipe system. **AWWA D100-11; 7.3 Overflow** states, "An internal overflow is defined as an overflow with piping inside the tank container. The consequences of an overflow failure, which can empty the tank contents, shall be considered when an internal overflow is provided." We recommend replacing the internal overflow system with a properly sized exterior overflow system, which will be complete with a weir box on the interior, standoffs every 10' on center extended to grade, an elbow fitted with a flapper valve and screen to prevent the ingress of contaminants, and a splash pad to direct the water away from the tank foundation.

**Splash pad to be installed by owner.*

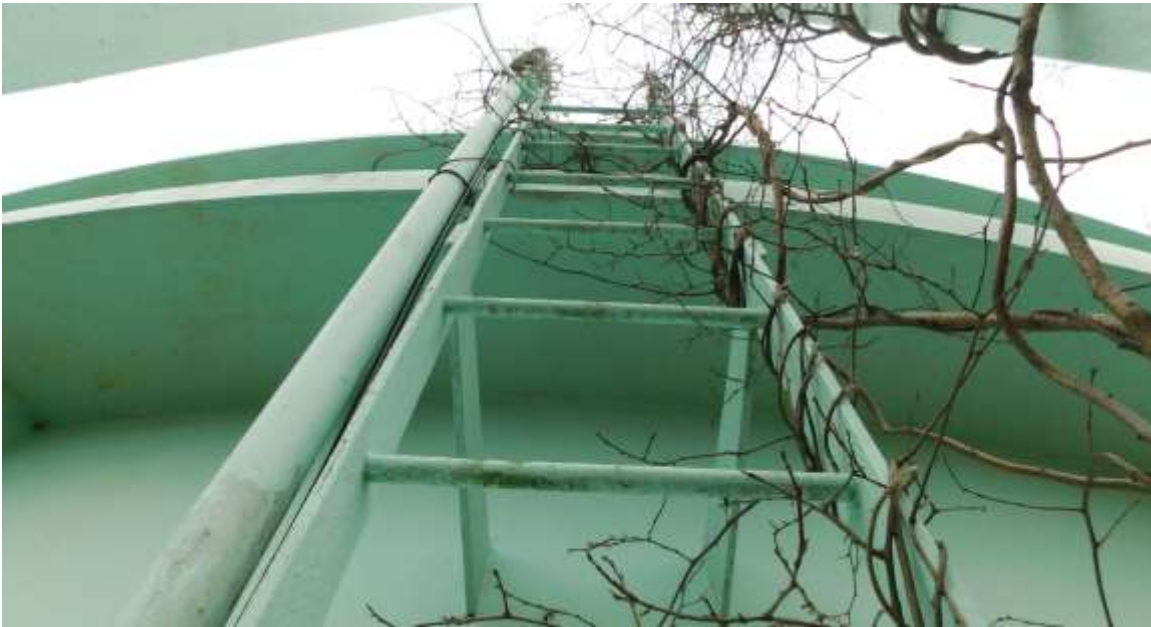
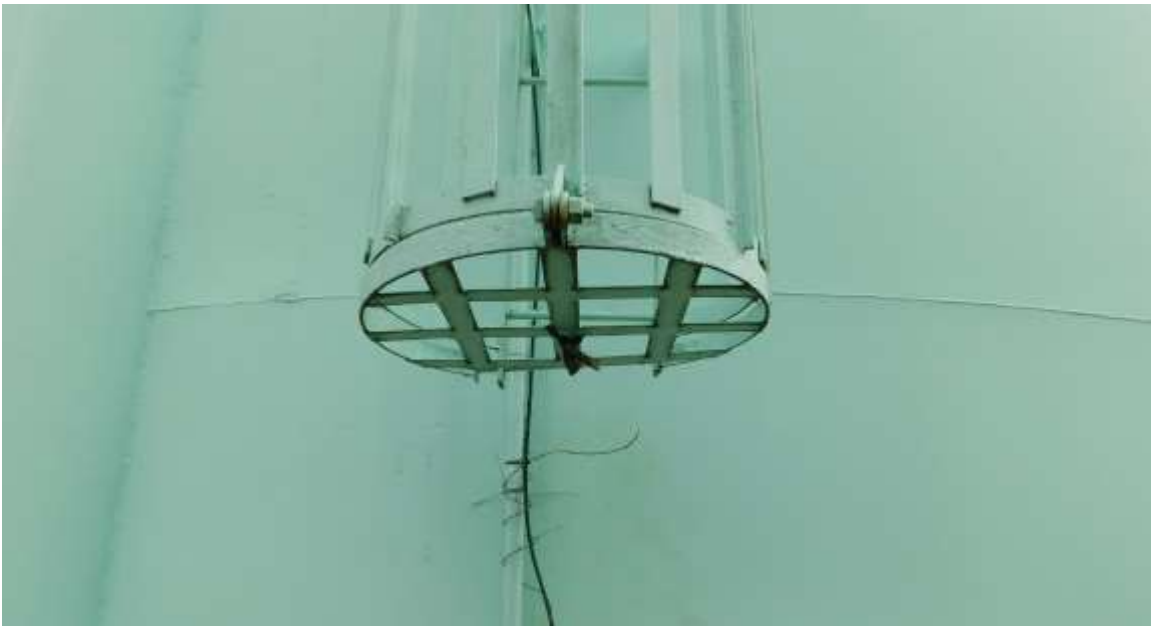
Shell access ladder in above photos is not equipped with anti-skid rungs, and is only 13" wide. **OSHA 1910.23(b)(4)** states, "Ladder rungs, steps, and cleats have a minimum clear width of... 16 inches (41 cm) (measured before installation of ladder safety systems) for fixed ladders,..." **Notice the tree vines growing on the ladder.** We recommend installing an **OSHA** compliant shell access ladder complete with standoffs every 10' on center, a cable type ladder safety device, a lockable ladder guard to prevent unauthorized access and posting a **Fall Protection Required** sign at the base of the ladder.

10	Install a compliant exterior shell access ladder complete with standoffs every 10' on center.			X		
	Install a cable type ladder safety device on exterior shell access ladder.			X		
	Install a lockable ladder guard on exterior shell access ladder.					X
	Post Fall Protection Required sign at base of exterior shell access ladder.			X		
11	Install a float-type liquid level indicator.		X			
12	Install a compliant 42" high handrail system around the circumference of the tank roof, complete with intermediate rail, toeboard and a swing gate at the junction of the shell-to-roof access ladder and tank roof.			X

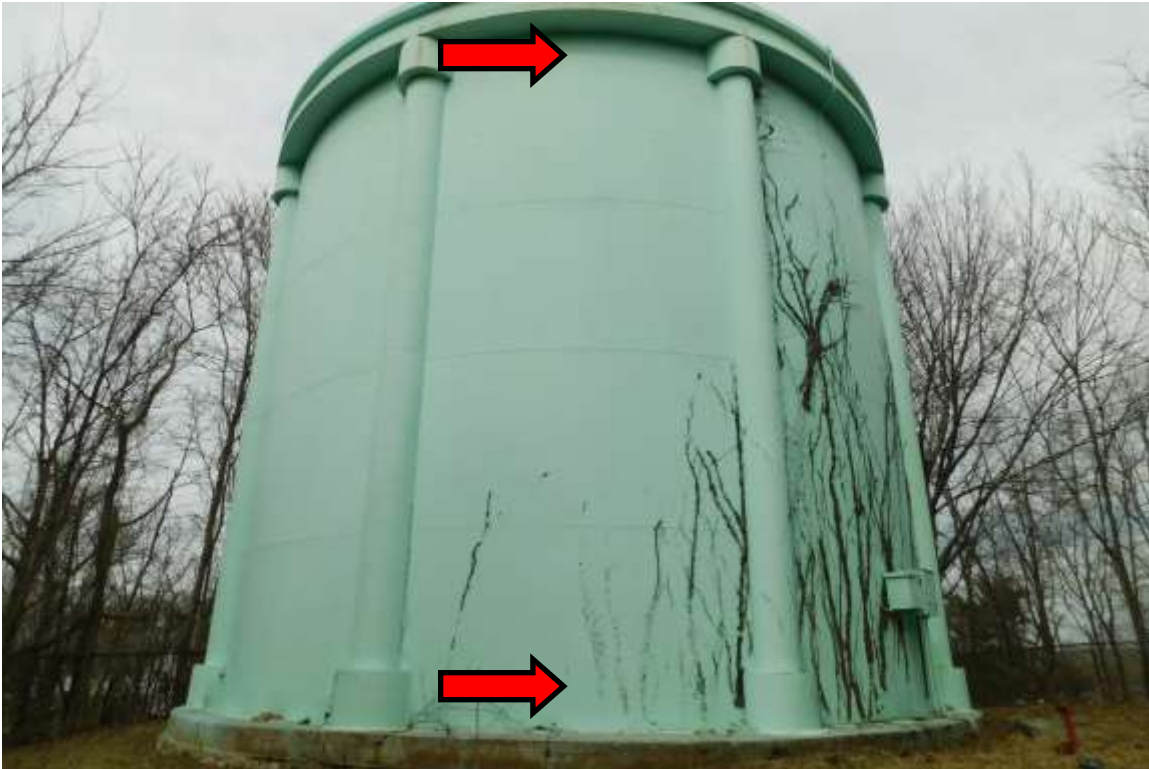
Photo shows the tank is not equipped with a liquid level indicator. We recommend installing a float-type liquid level indicator.

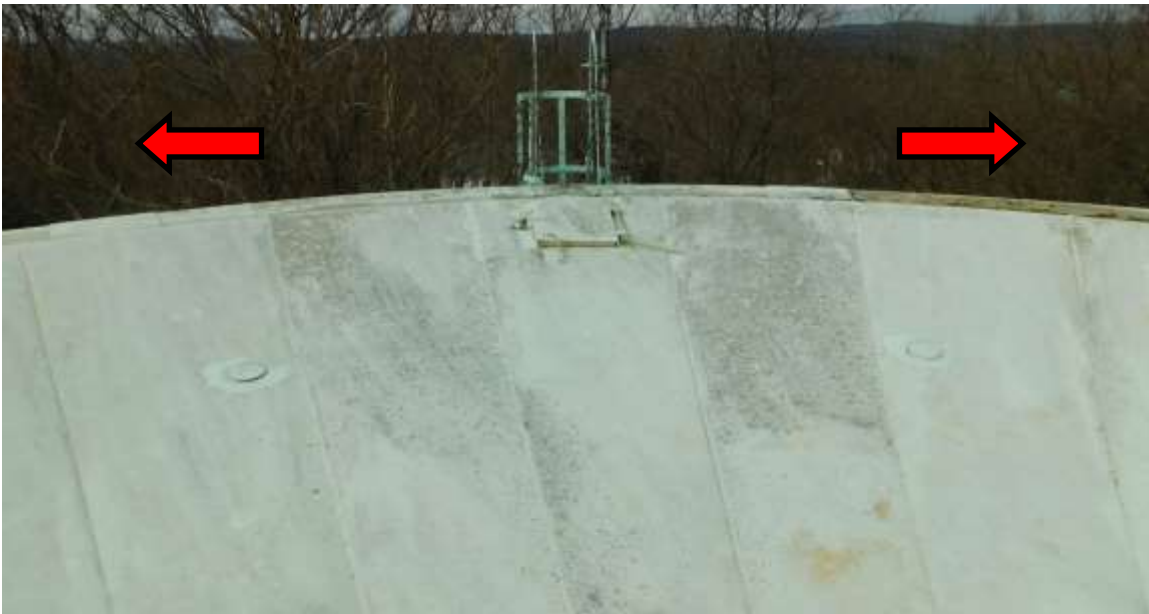
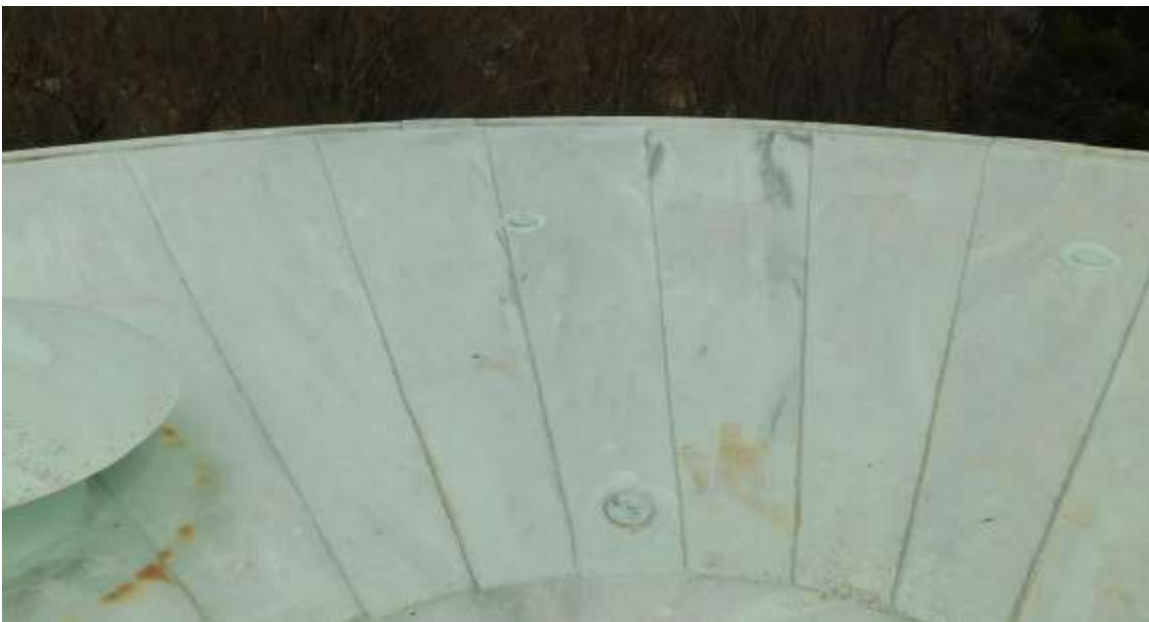
Photos show the tank roof edge is not equipped with a required handrail system for fall protection. **OSHA 1910.28(b)(1)(i)** states, "...the employer must ensure that each employee on a walking-working surface with an unprotected side or edge that is 4 feet (1.2 m) or more above a lower level is protected from falling by one or more of the following: **1910.28(b)(1)(i)(A)** Guardrail systems." We recommend installing an **OSHA** compliant 42" high handrail system around the circumference of the tank roof, complete with intermediate rail, toeboard and a swing gate at the junction of the shell-to-roof access ladder and tank roof.

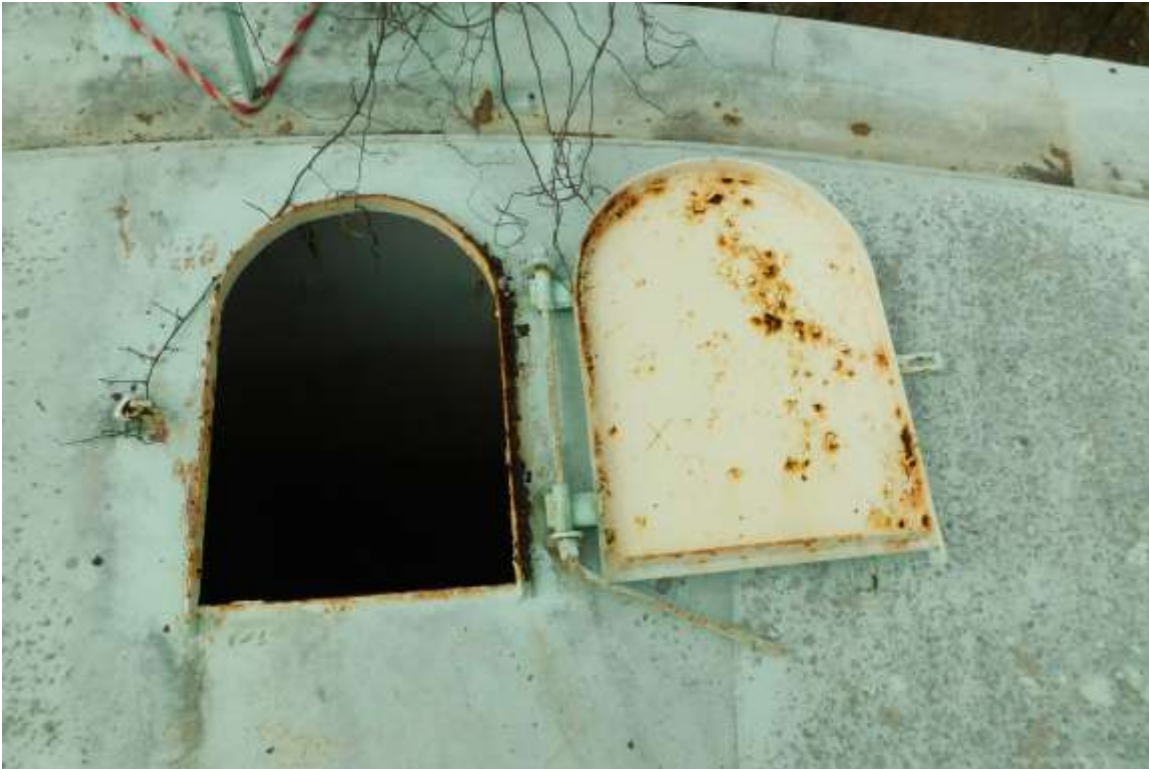
Photo shows the condition of the 18" x 27" primary roof hatch. Roof openings on this tank require the following to be in compliance with **AWWA D100-11; 7.4.3 Roof openings** and **OSHA 1910.146(c)(2) Confined spaces**.

We recommend:

- Install 30" secondary hatch 180° from primary roof hatch
- Post **Confined Space Entry** signs
- Install lock on primary hatch

We further recommend installing **OSHA** compliant interior access ladders complete with standoffs every 10' on center, and cable type ladder safety devices at the primary and suggested secondary roof hatches.

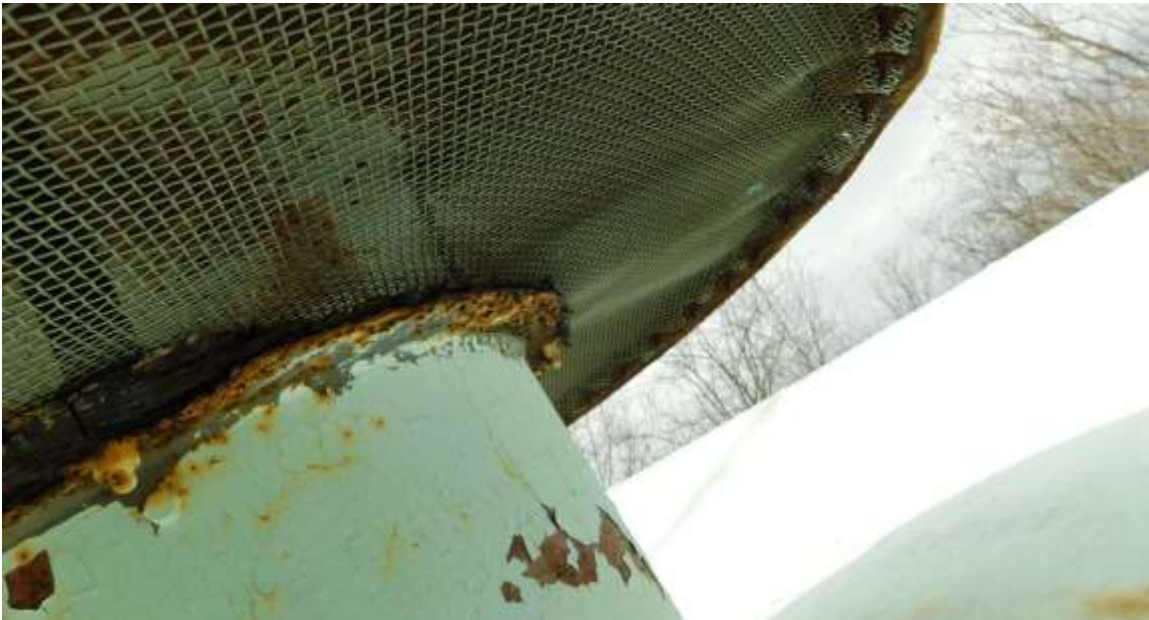
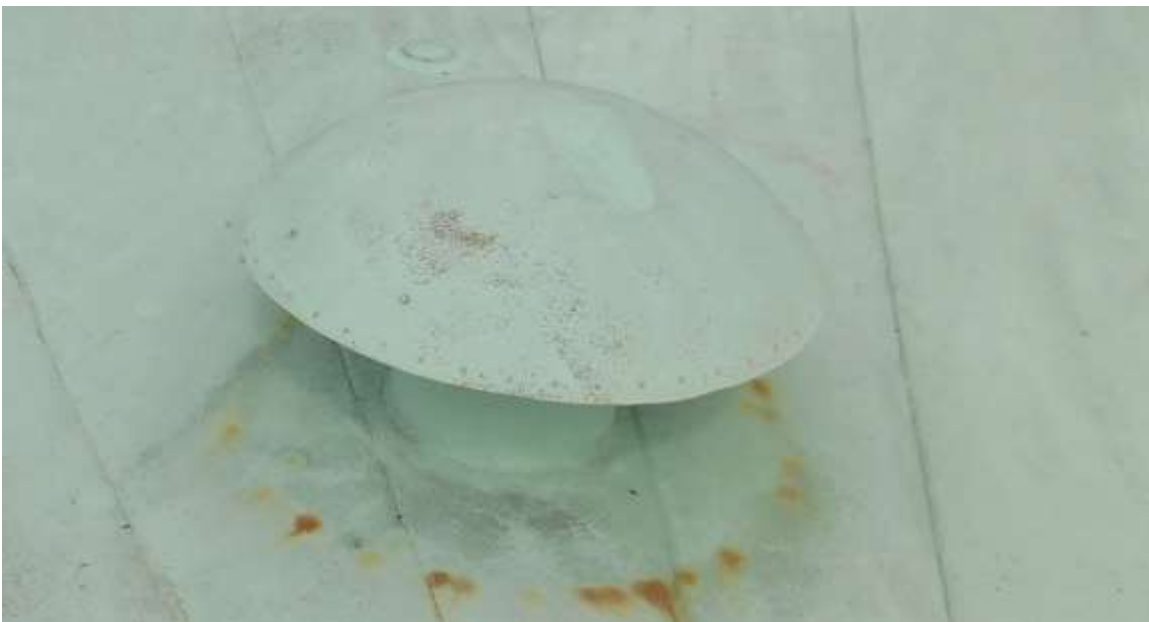
Photos show the condition of the existing 18" roof vent. **This vent is allowing the ingress of rain and wind-borne contaminants into the water system. An improperly vented tank may cause external pressure to act on the tank which can cause buckling even at low pressure differential.** We recommend replacing the existing roof vent with a vacuum-pressure, frost proof vent and screen.

This work should be performed on an emergency basis.

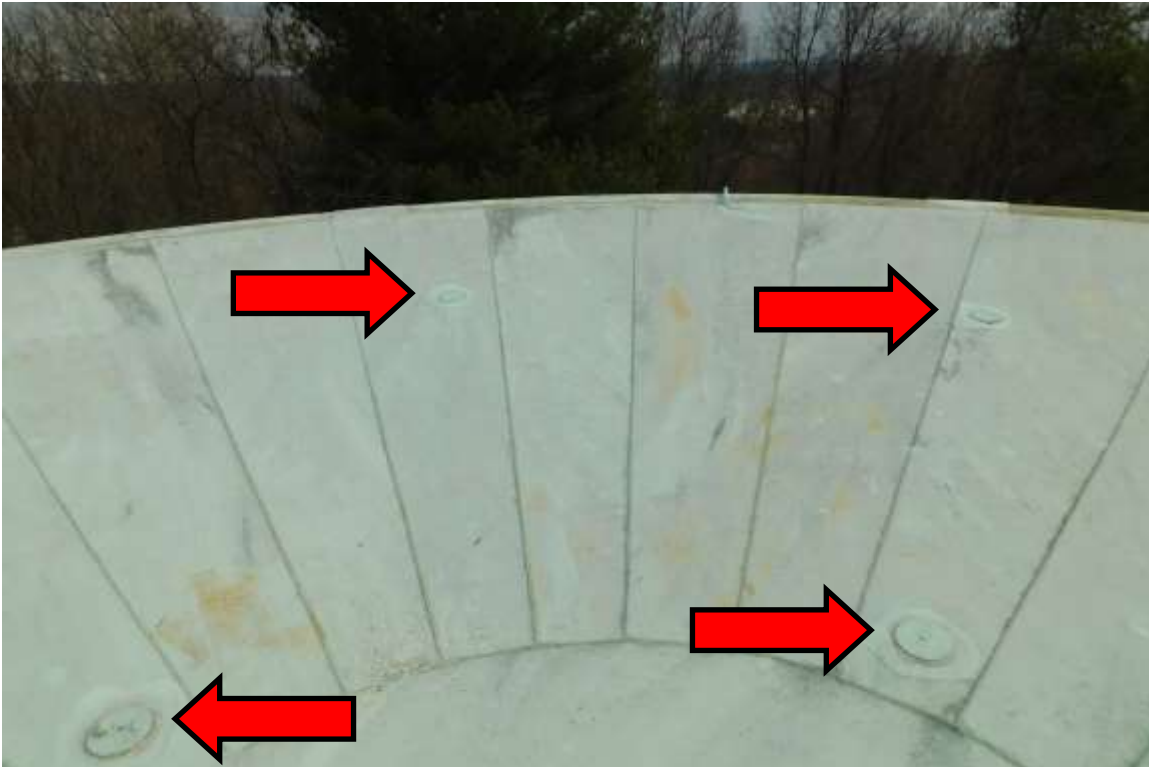
Photo shows cathodic protection system hand-hole covers. **TSS; 7.0.10 Roof and sidewall** requires the roof to be watertight. We recommend removal of the cathodic protection system and welding steel plates over the holes to prevent the ingress of contaminants into the water supply.

We further recommend installing a passive cathodic protection system.

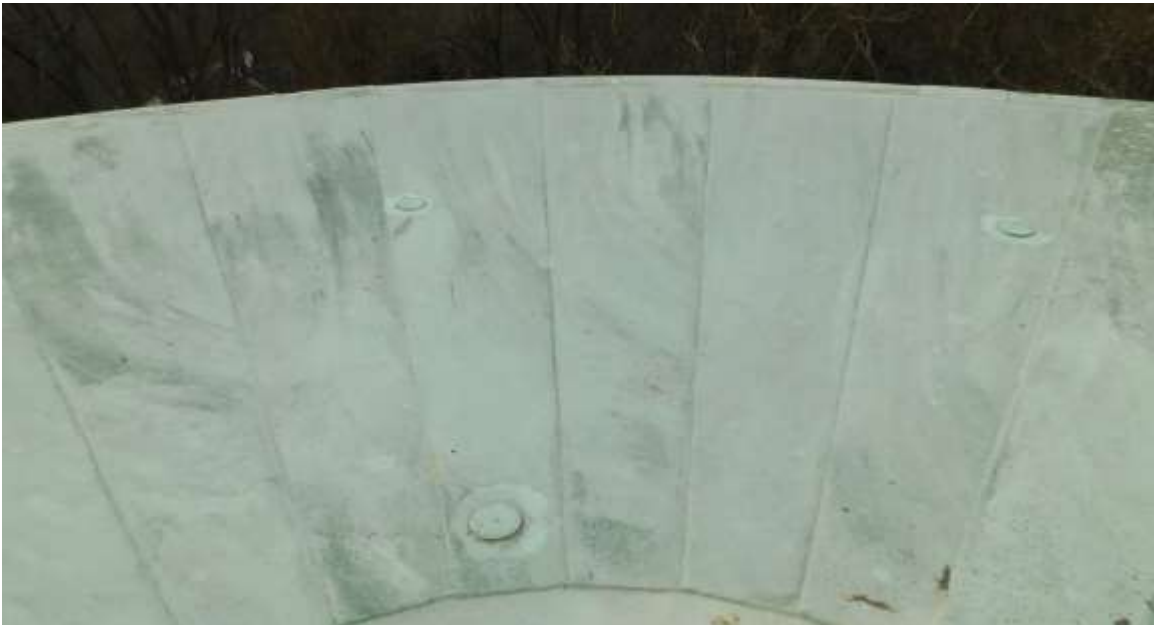
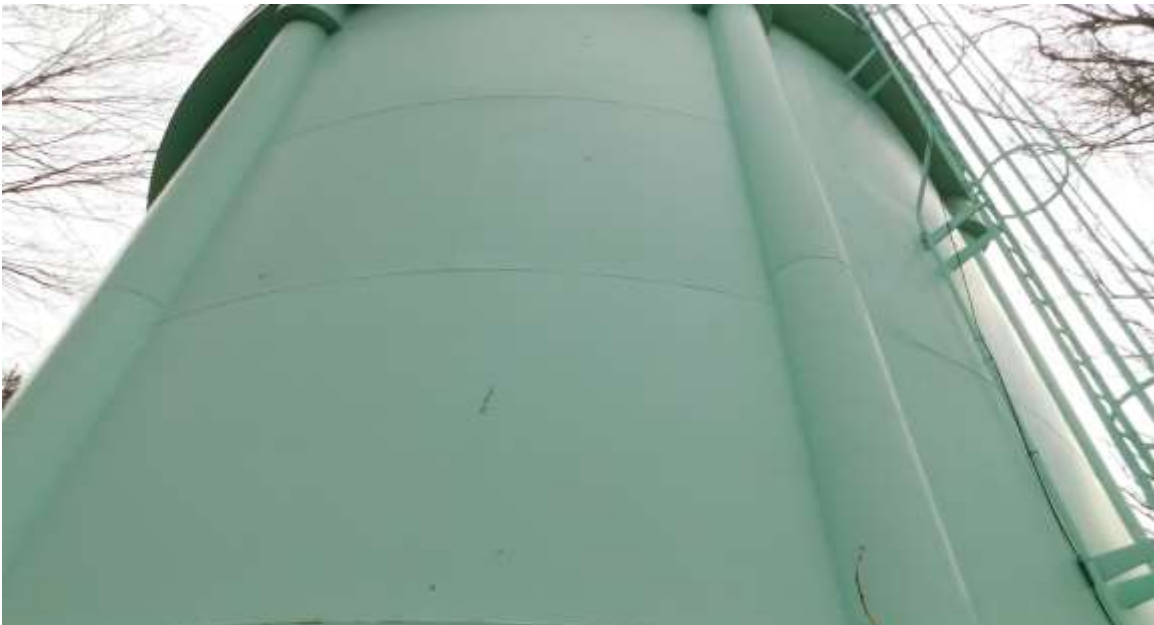
Photos show the tank exterior coating system. The overall exterior coating system appears to be in good condition. We recommend pressure washing the tank exterior with biodegradable detergent injection (minimum 3,500 psi at 3.0 gpm), then re-evaluating the tank exterior at next inspection cycle.

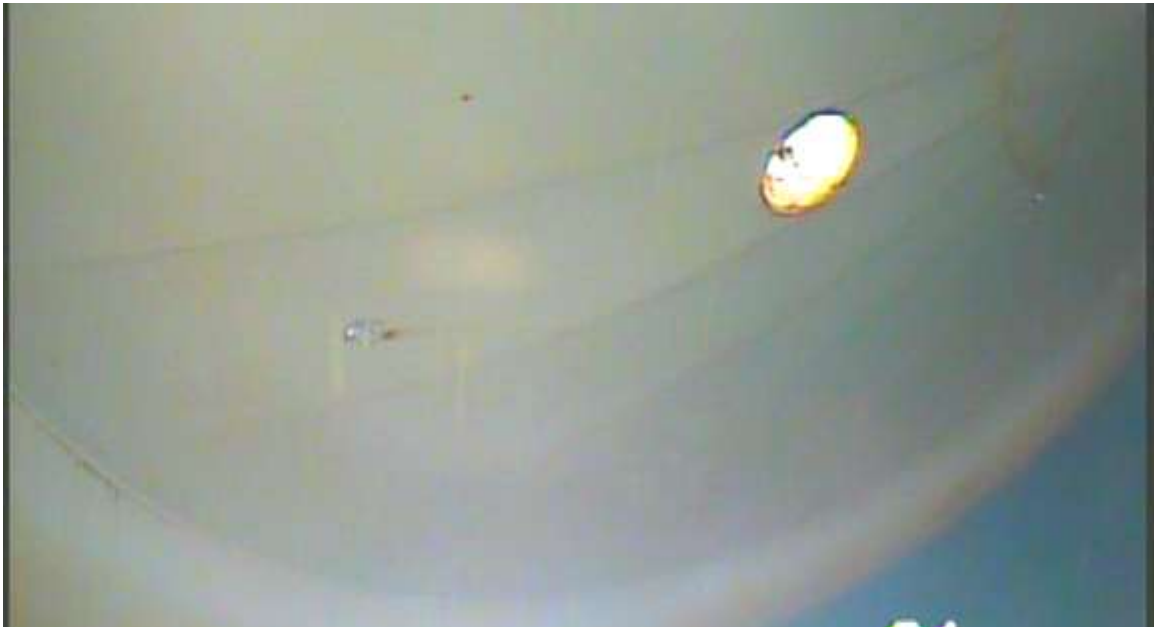
Top photo shows the interior roof lap seams, which appear to be in good condition.

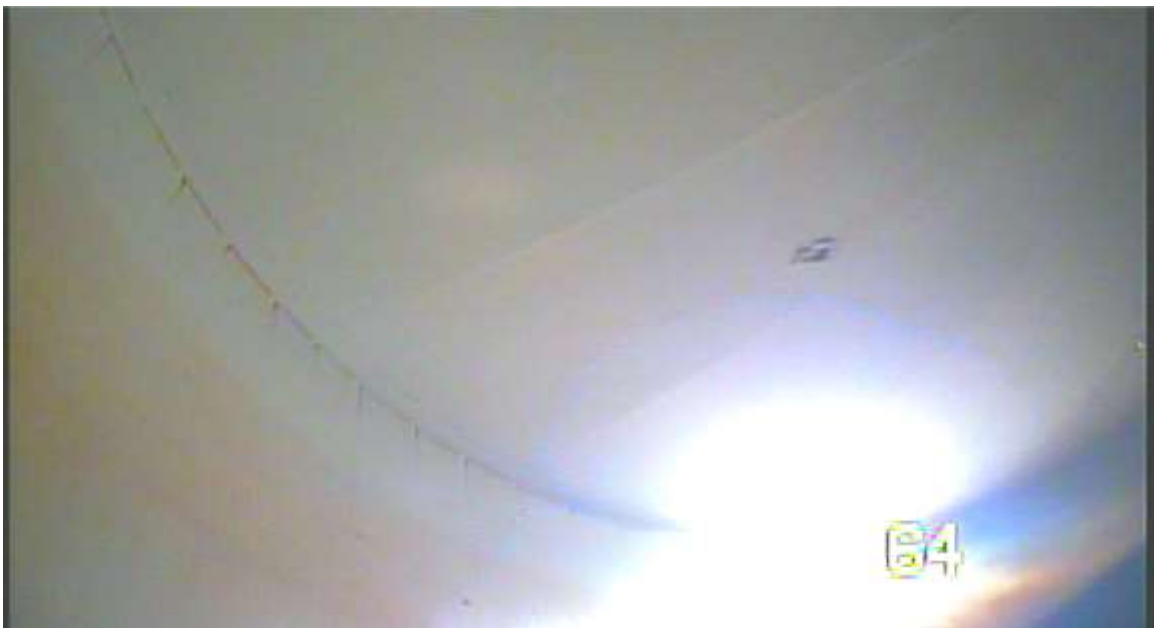
Bottom photo shows the interior roof-to-rim angle connection, which appears to be in good condition.

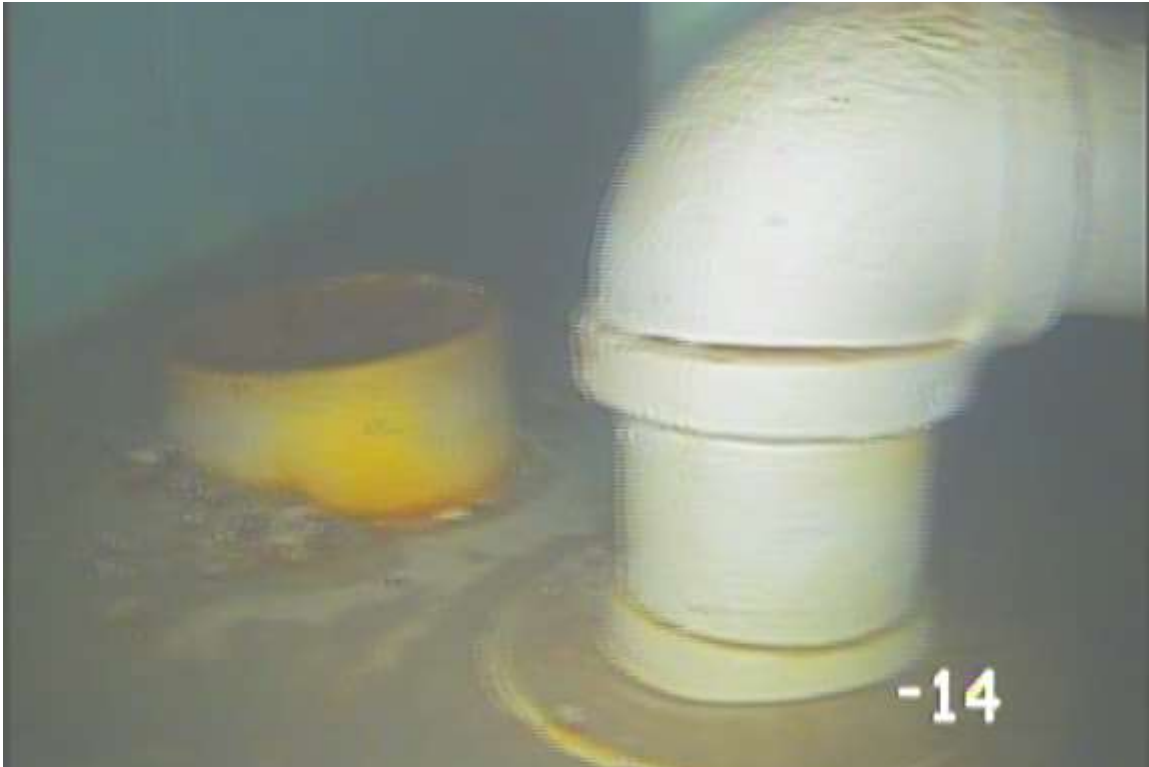
Photo shows a fill pipe on the tank interior. A temperature difference between the water in the top and bottom of a tank, even as little as 1-2 degrees Fahrenheit, is an indication of thermal stratification and the tank water not being completely mixed. Incomplete mixing would result in short-circuiting, and localized increase in water age would develop inside the tank. This typically leads to water quality problems, such as loss of residual, DBP spikes, HPC spikes, bacteria regrowth, formation of bio-film, changes in pH and dissolved oxygen. We recommend installing a mixing system. Electrical work to be done by others if required.

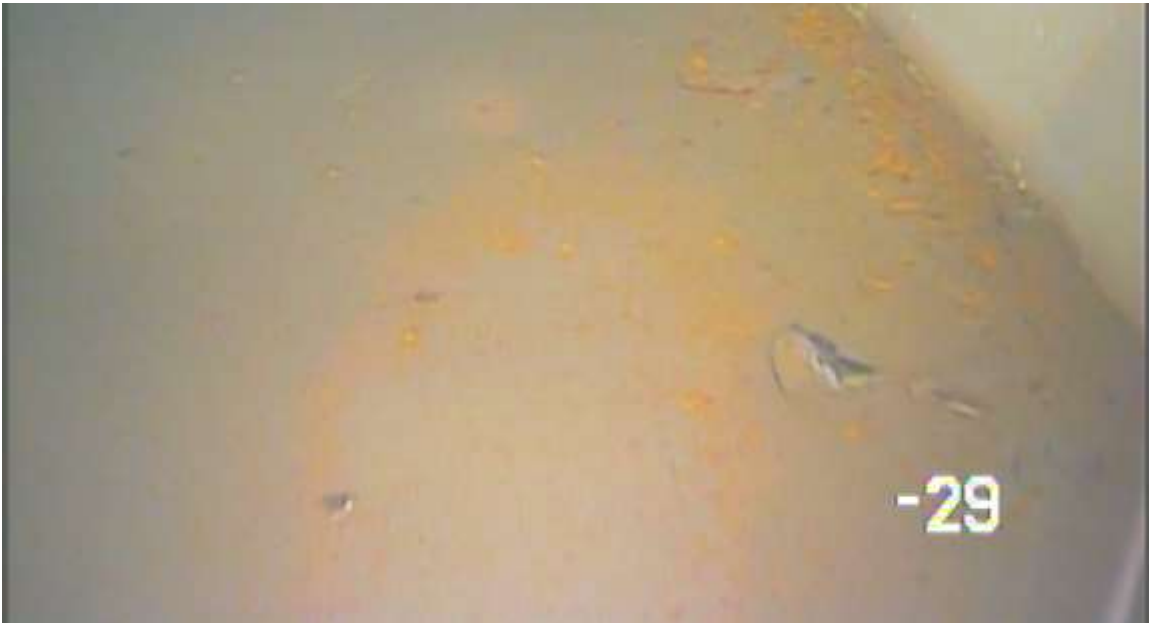
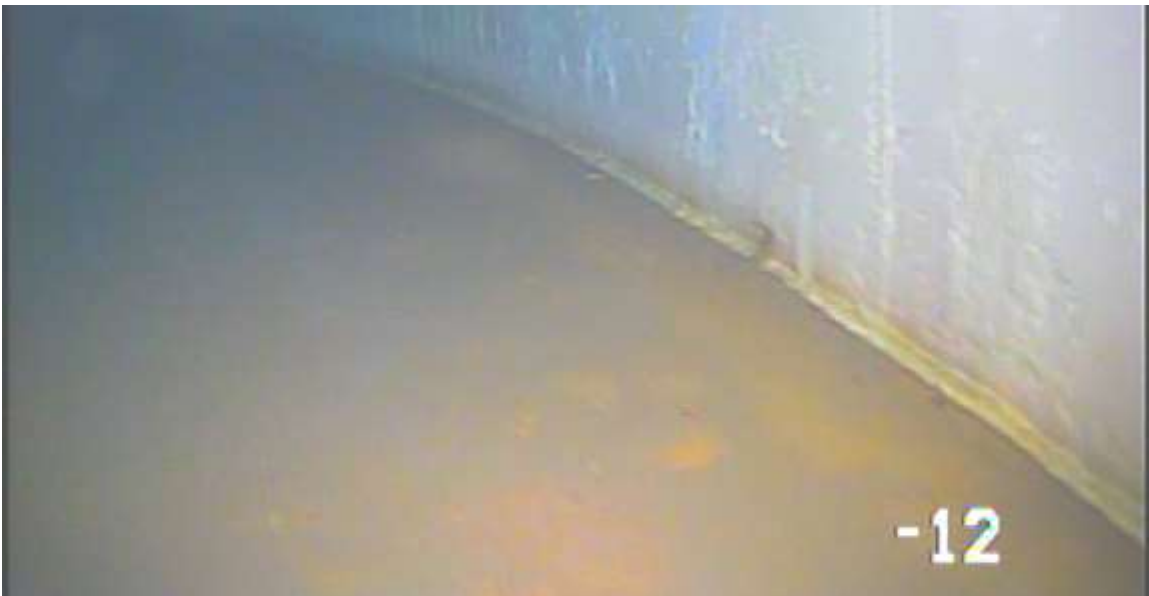
Photos show sediment in the tank. We recommend performing a robotic in-service interior cleanout in order to prevent contamination issues associated with excessive sediment buildup.

This work should be performed on an emergency basis.

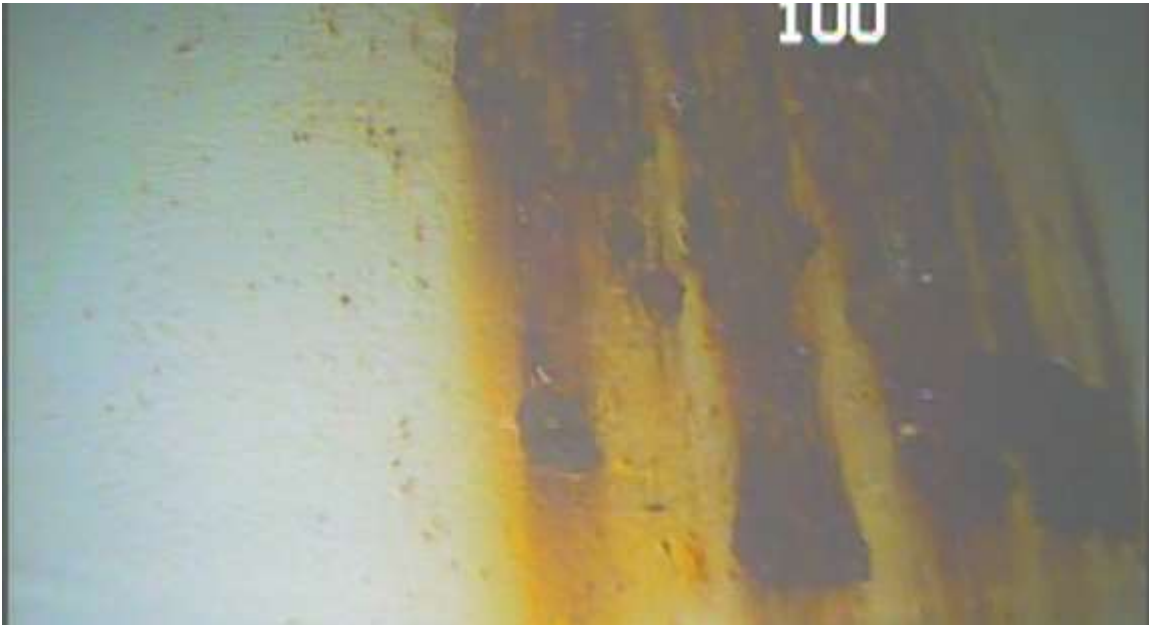
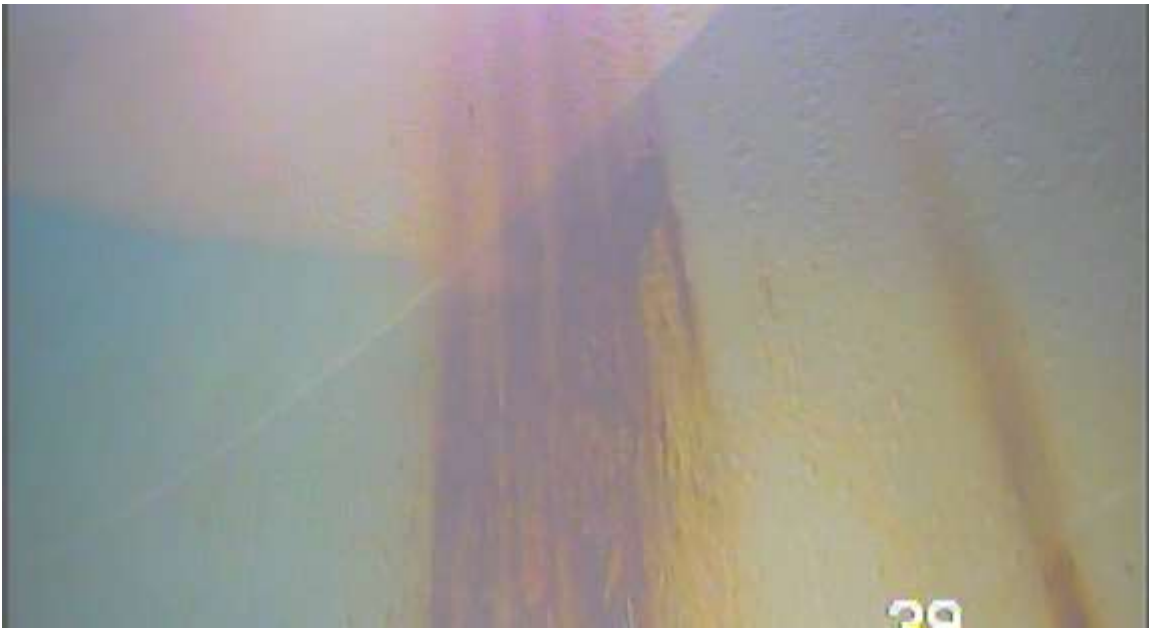
Photos show the condition of the interior coating system. We recommend sand-blasting all rusted and abraded interior areas to SSPC-SP10 (near white), and brush blasting all remaining interior areas to SSPC-SP7; then applying one (1) spot coat of epoxy primer to all areas sandblasted to #10, stripe coating all weld seams, and applying epoxy to the entire tank, to achieve 8 to 10 mils of total dry film thickness. Total mil thickness will include a combination of the existing and new coating.
