**Town of Carmel
60 McAlpin Avenue
Mahopac, NY 10541
RE: Clapboard Ridge; Mahopac, NY
500,000 Gallon GST
March 25, 2019
Mr. Rich Franzetti
Engineer
(845) 628-1500 x181
Job No. 319099-I**

GROUND STORAGE INSPECTION REPORT

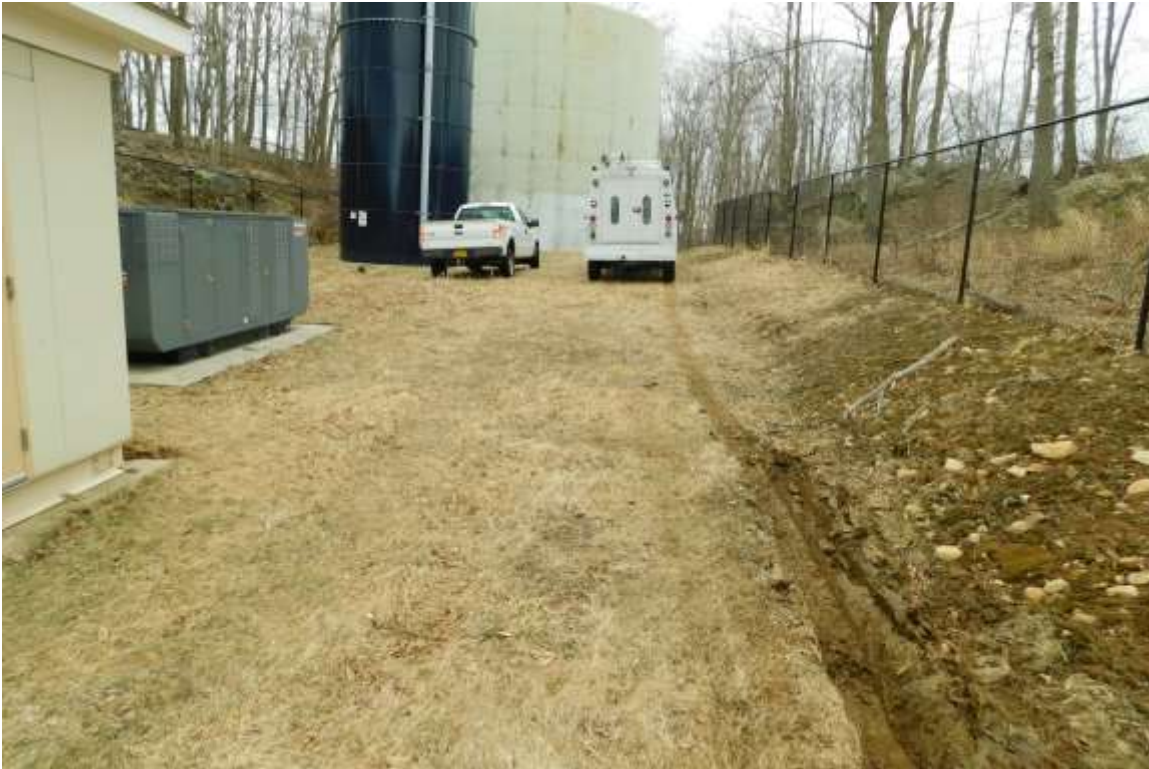
Photo shows the tank is secured with fencing. We recommend posting a **Warning, Tampering With This Facility is a Federal Offense** (US code title 42, section 300i-1) sign and **No Trespassing** sign.

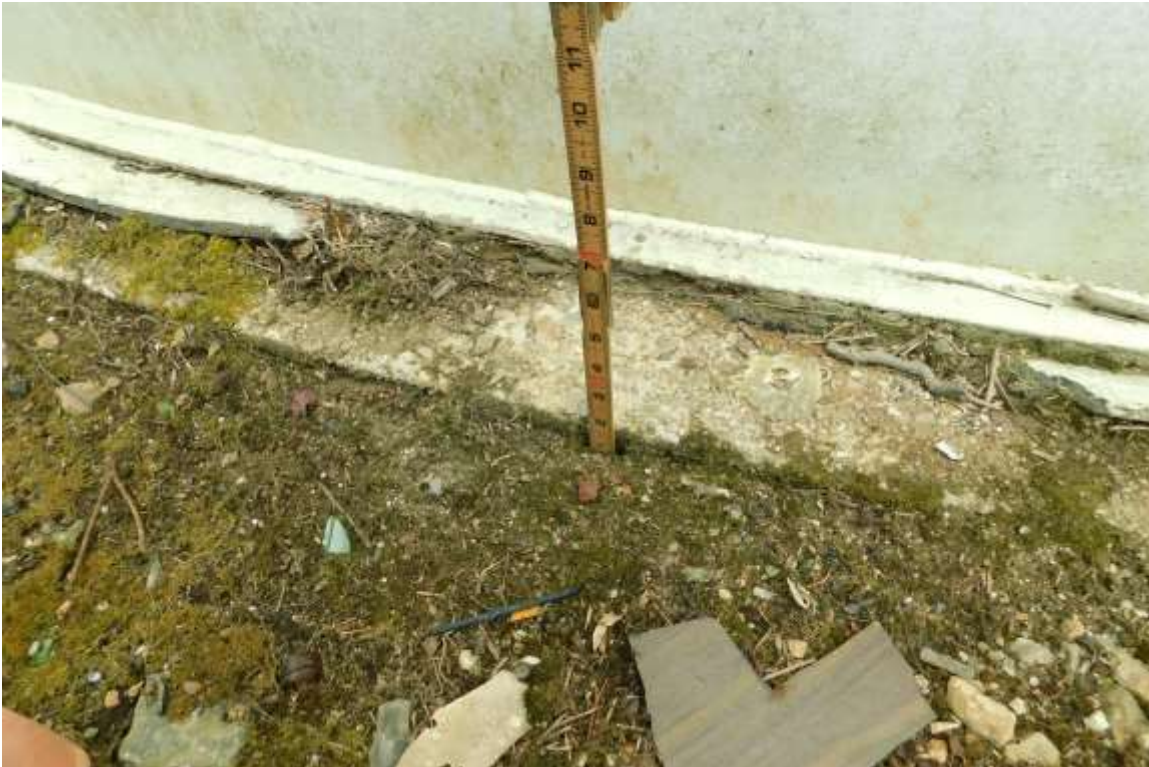
Photo shows the condition of the foundation. **AWWA D100-11; 12.7.1 Height aboveground** states, "The tops of the concrete foundations shall be a minimum of 6" above the finished grade, unless otherwise specified." We recommend clearing any dirt, debris and other loose gravel away from the tank foundation, down to a minimum 6" below top of foundation. This should be done by a local excavating company.

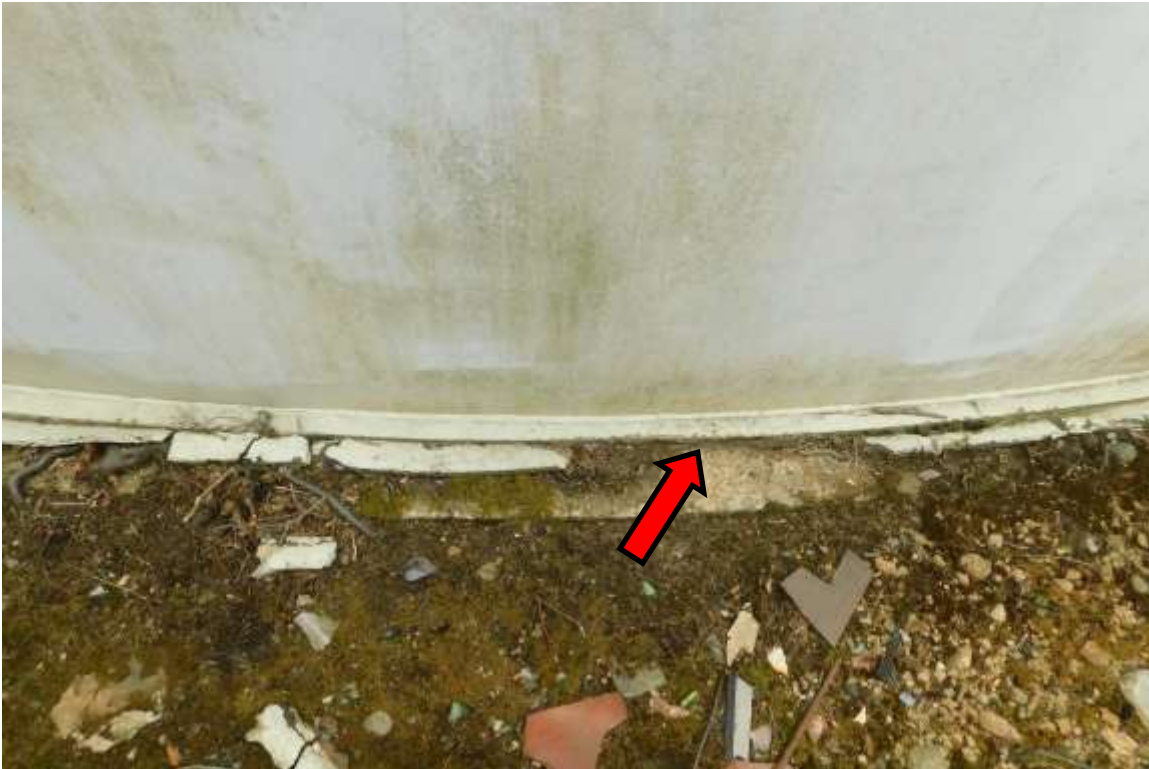
Photo shows the condition of the foundation. We recommend repairing any cracks and spalling in the concrete with a commercial non-shrinking grout, caulking/grouting around the base of the tank to foundation connection to prevent water from entering under the tank, then sealing the foundation with a sealant.

We further recommend inserting sacrificial cathodic protection rods radially every 15' beneath the floor of the tank.

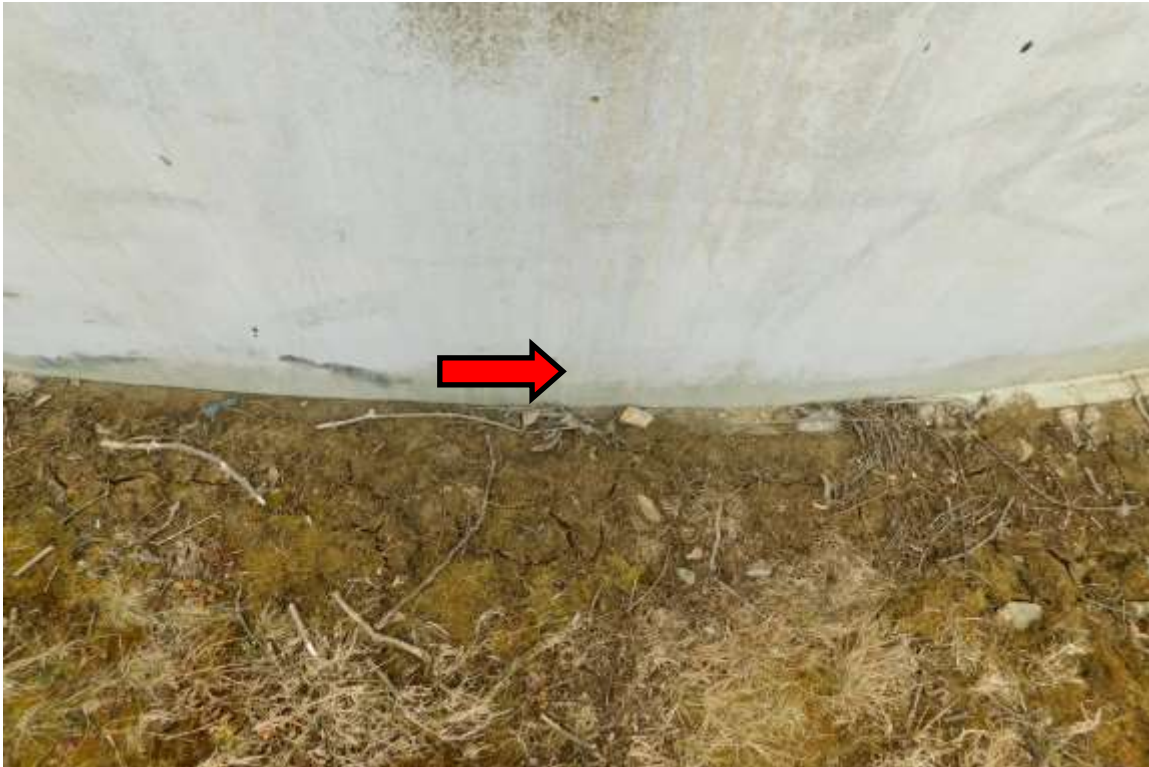
Photo shows the tank has no grounding system. We recommend electrically grounding the tank for lightning protection as required by **OSH Act of 1970 Section 5**.

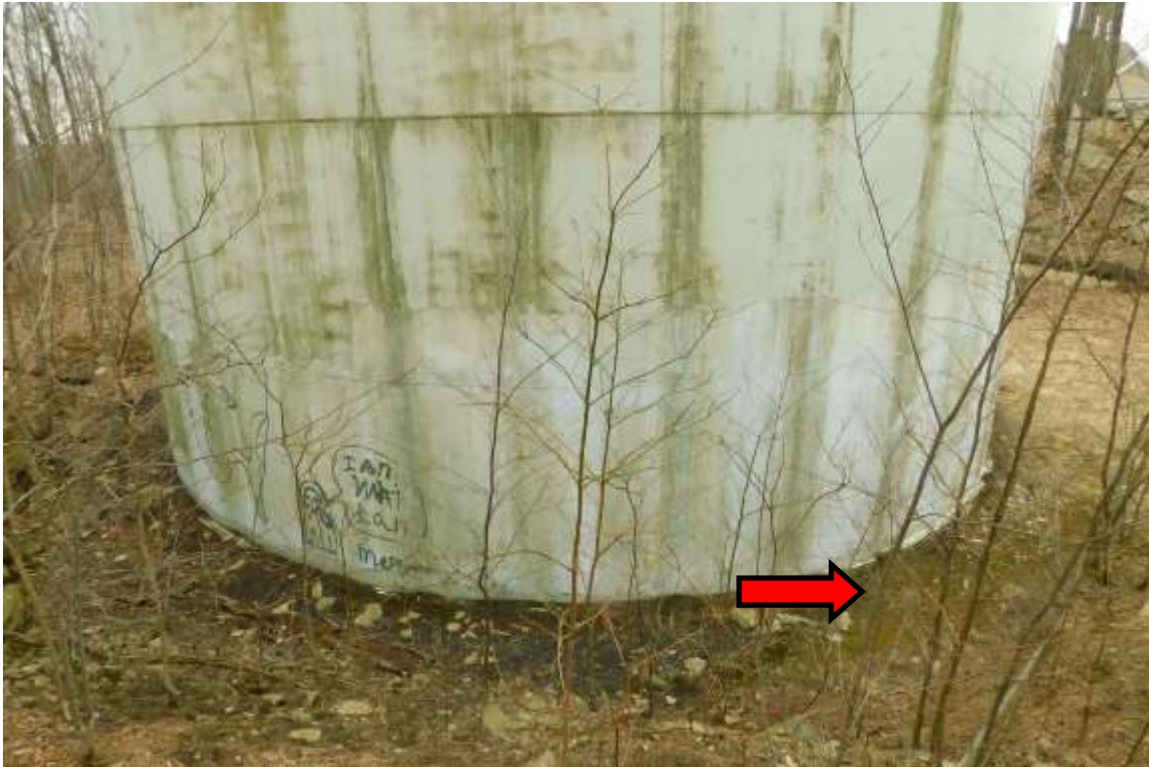
Photo shows the condition of the tank site. **Notice the vegetation growth around the tank foundation.** This could lead to deterioration of the structural components of the tank. **OSHA 1910.176(c)** states, "Storage areas shall be kept free from accumulation of materials that constitute hazards from tripping, fire, explosion, or pest harborage. Vegetation control will be exercised when necessary." We recommend removing the vegetation from around the tank foundation. This should be done by others.

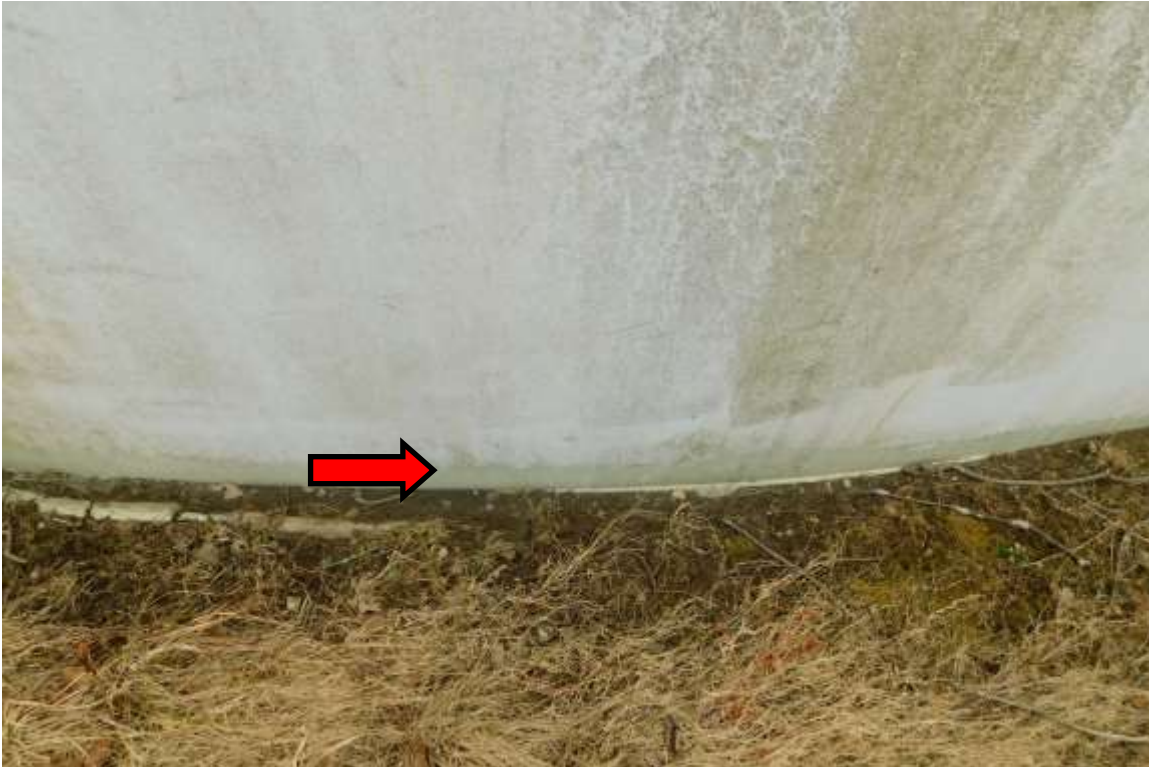
Photo shows the condition of the shell. Currently there is no drain valve. We recommend installing a frost proof drain valve near the shell-to-floor connection, complete with a locking device to prevent unauthorized draining of the tank and a splash pad to direct water away from the foundation.

**Splash pad to be installed by owner.*

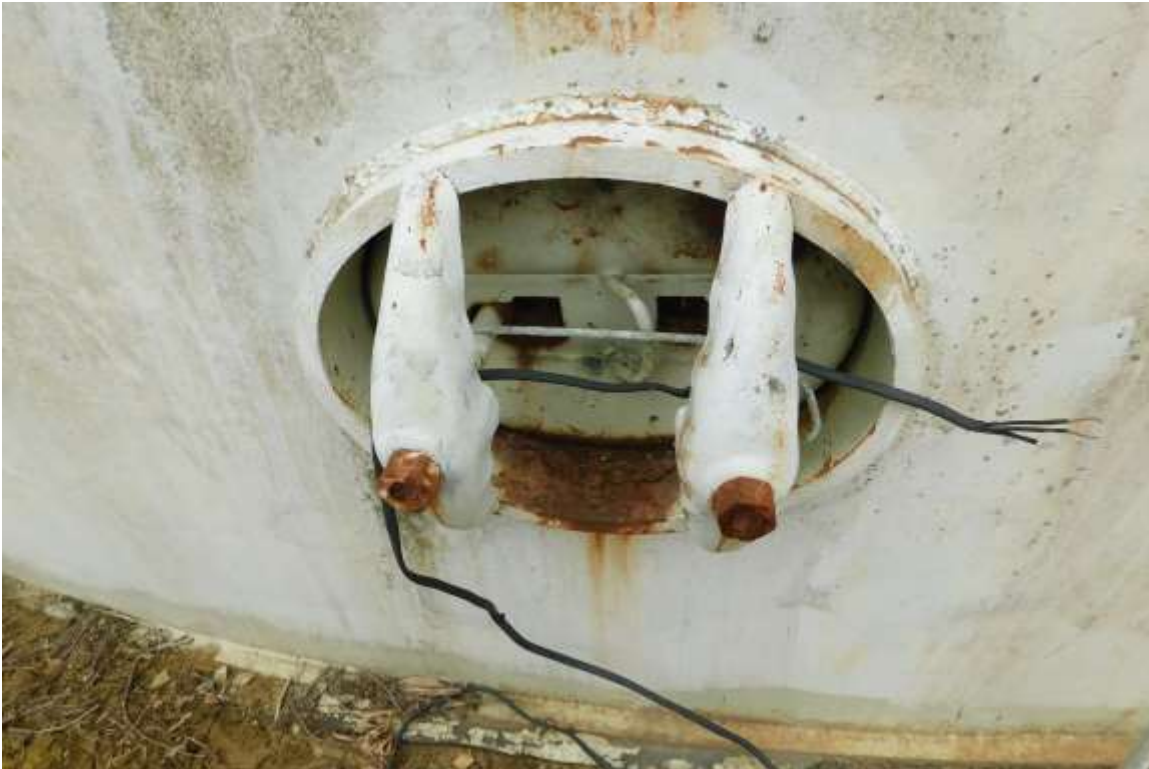
Photo shows the condition of the 18" x 24" primary shell manway. The following is required for the tank to be in compliance with **AWWA D100-11; 7.4.4 Shell manholes** and **OSHA 1910.146(c)(2) Confined spaces**.

Install 30" secondary shell manway 180° from primary manway
Post **Confined Space Entry** signs

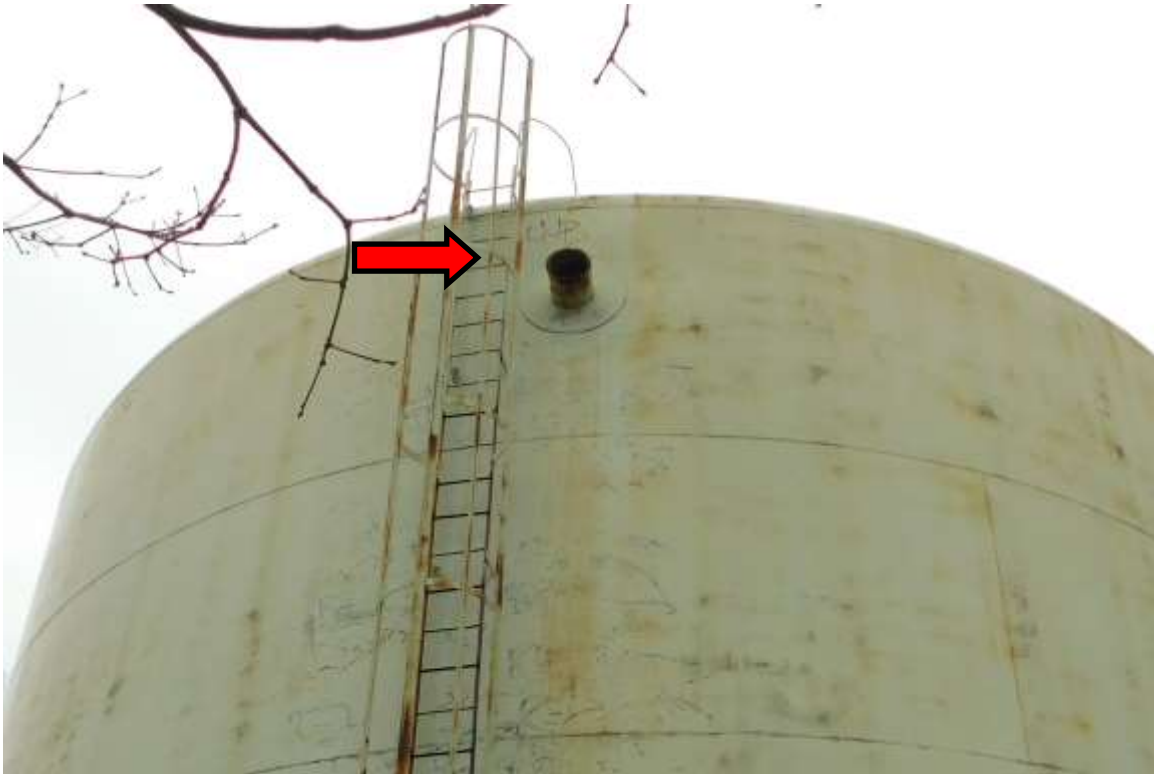
Photo shows the condition of the 12" stub overflow pipe. **NFPA 22-2018; 14.6.3** states, "Where dripping water or a small accumulation of ice is not objectionable...The pipe shall be extended with a slight downward pitch to discharge beyond the tank or balcony and away from the ladders and shall be adequately supported." We recommend extending the overflow down the exterior to grade with same size pipe, complete with standoffs every 10' on center, an elbow at the base fitted with a flapper valve and screen to prevent the ingress of contaminants into the water supply, and a splash pad to direct the water away from the tank foundation.

**Splash pad to be installed by owner.*

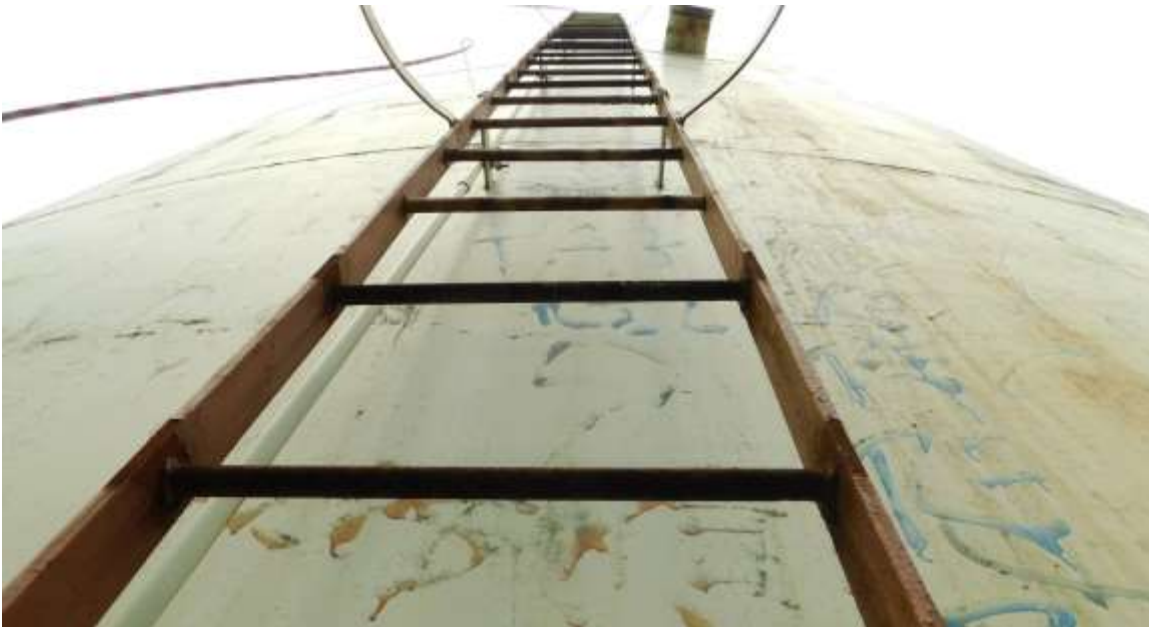
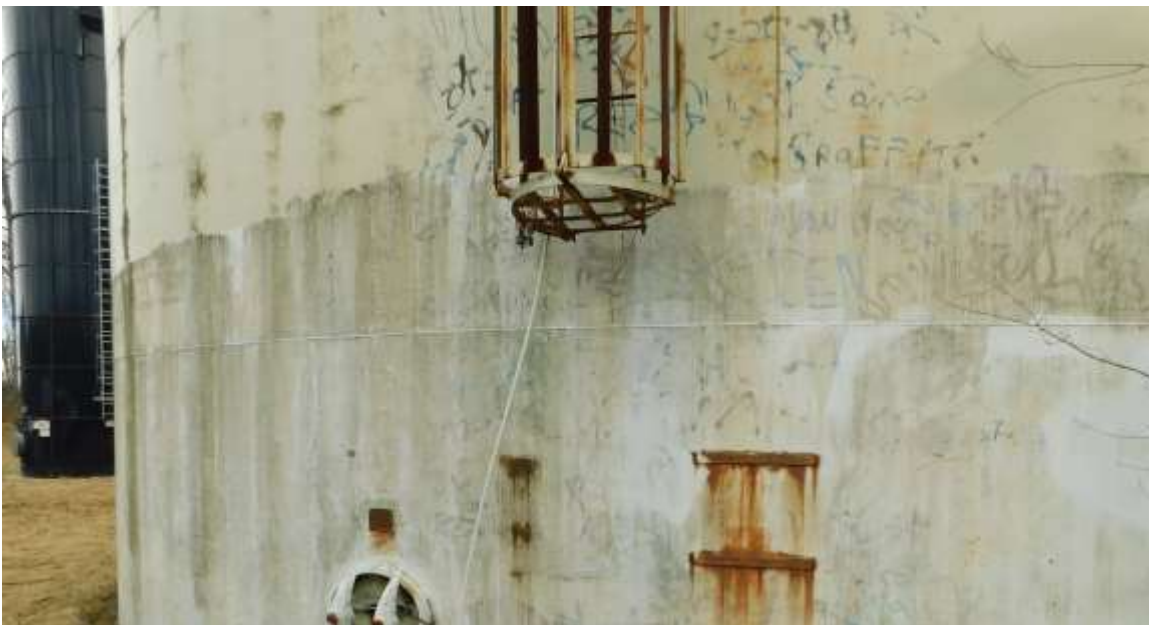
Shell access ladder in above photos is not equipped with anti-skid rungs, and is only 15" wide. **OSHA 1910.23(b)(4)** states, "Ladder rungs, steps, and cleats have a minimum clear width of... 16 inches (41 cm) (measured before installation of ladder safety systems) for fixed ladders,..." We recommend installing an **OSHA** compliant shell access ladder complete with standoffs every 10' on center, a cable type ladder safety device, a lockable ladder guard to prevent unauthorized access and posting a **Fall Protection Required** sign at the base of the ladder.

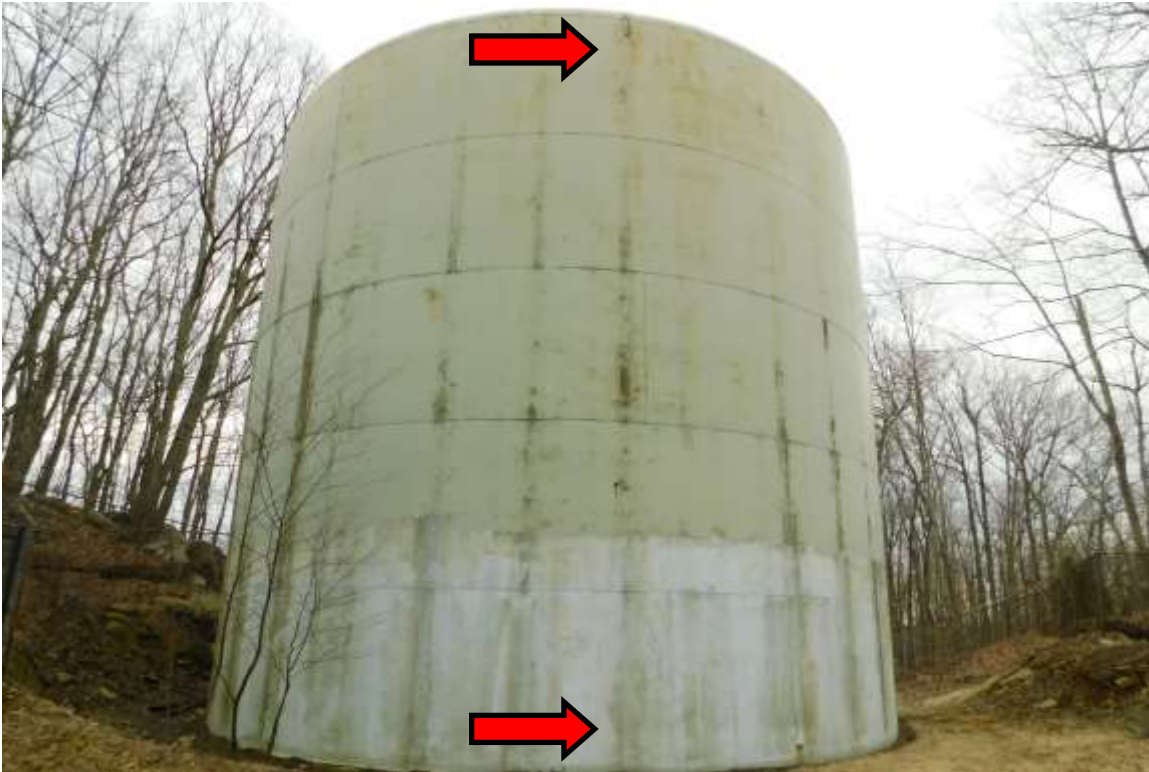
Photo shows the tank is not equipped with a liquid level indicator. We recommend installing a float-type liquid level indicator.

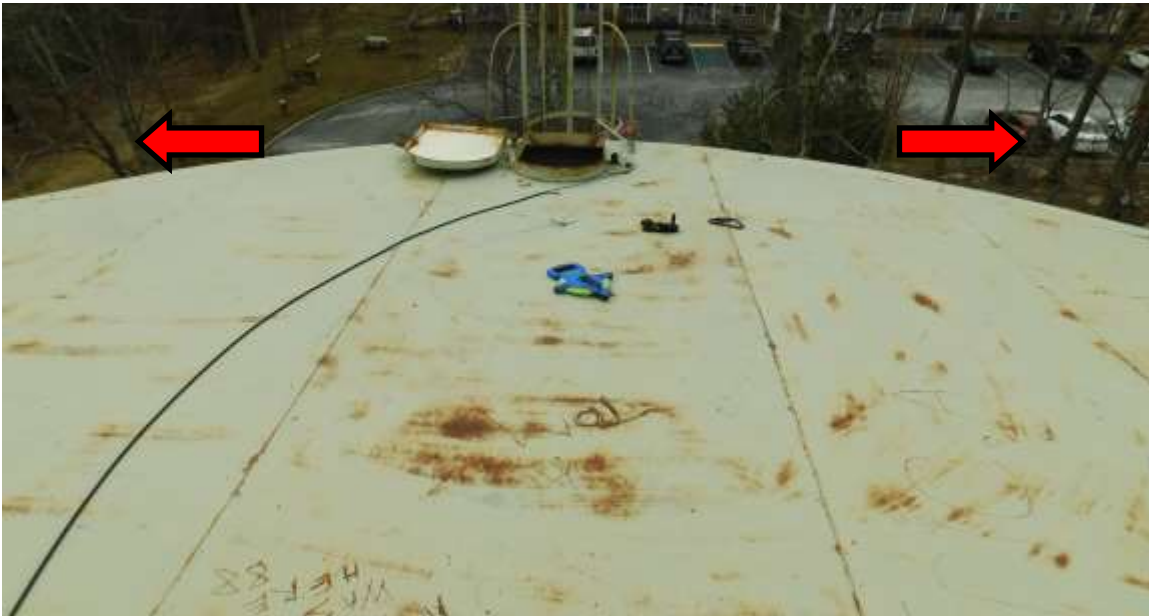
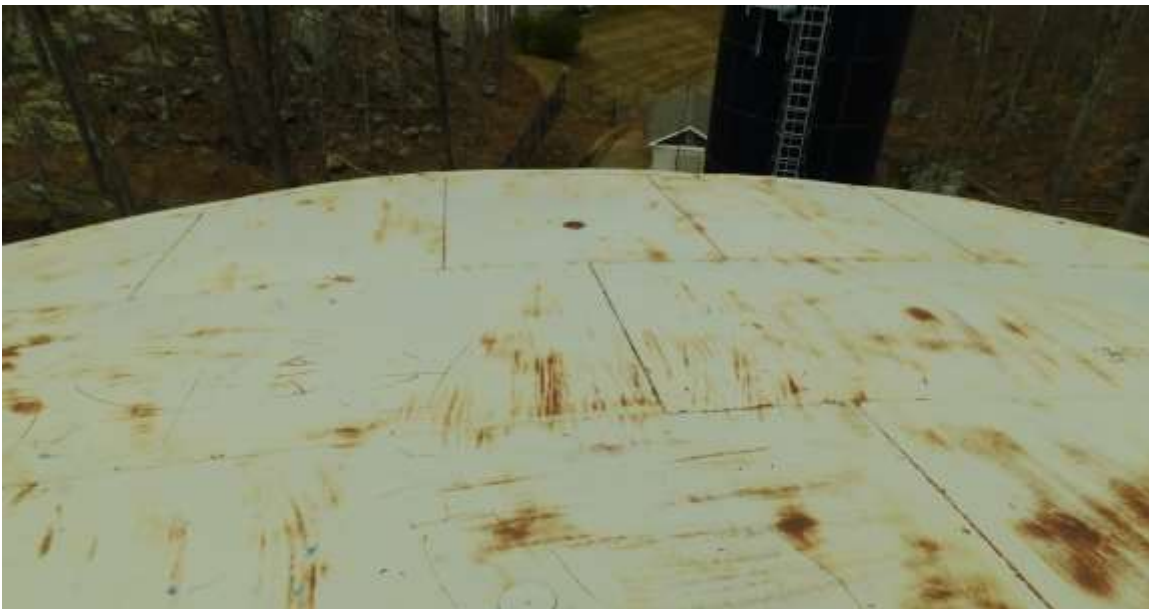
Photos show the tank roof edge is not equipped with a required handrail system for fall protection. **OSHA 1910.28(b)(1)(i)** states, "...the employer must ensure that each employee on a walking-working surface with an unprotected side or edge that is 4 feet (1.2 m) or more above a lower level is protected from falling by one or more of the following: **1910.28(b)(1)(i)(A) Guardrail systems.**" We recommend installing an **OSHA** compliant 42" high handrail system around the circumference of the tank roof, complete with intermediate rail, toeboard and a swing gate at the junction of the shell-to-roof access ladder and tank roof.

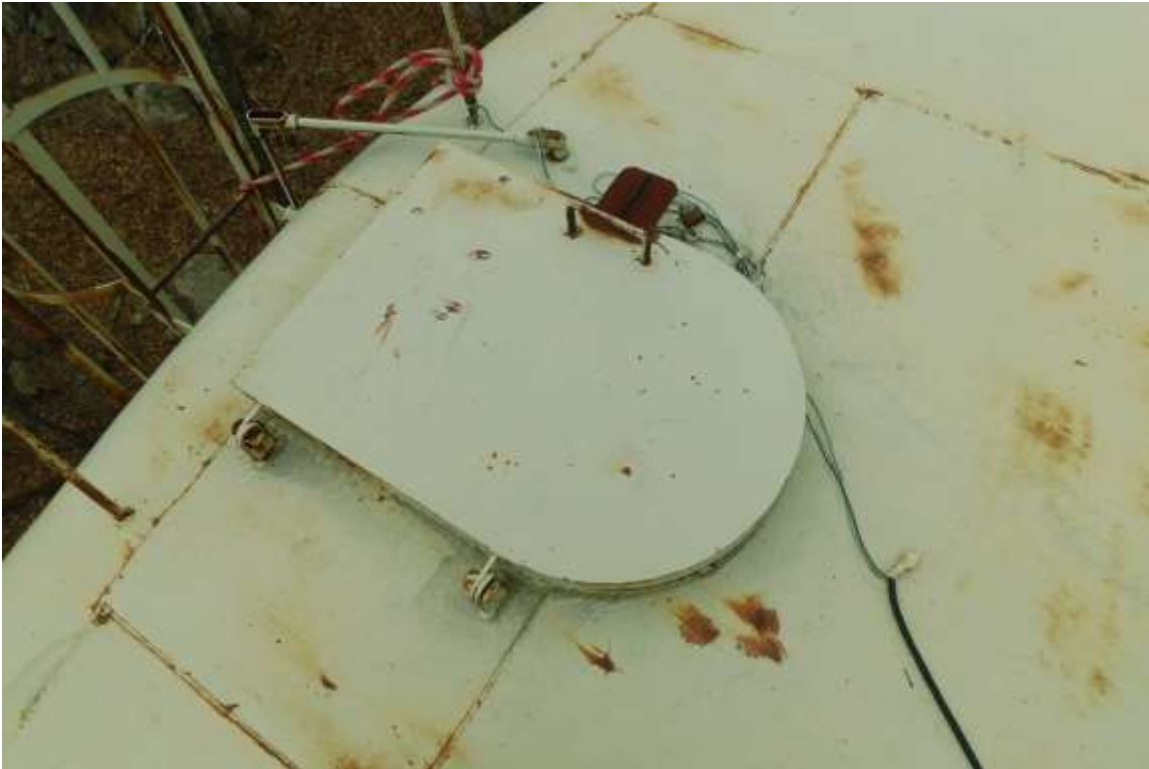
Photo shows the condition of the 25" x 35" primary roof hatch. Roof openings on this tank require the following to be in compliance with **AWWA D100-11; 7.4.3 Roof openings** and **OSHA 1910.146(c)(2) Confined spaces**.

Install 30" secondary hatch 180° from primary roof hatch
Post **Confined Space Entry** signs

We further recommend installing an **OSHA** compliant interior access ladder complete with standoffs every 10' on center, and a cable type ladder safety device at the suggested secondary roof hatch.

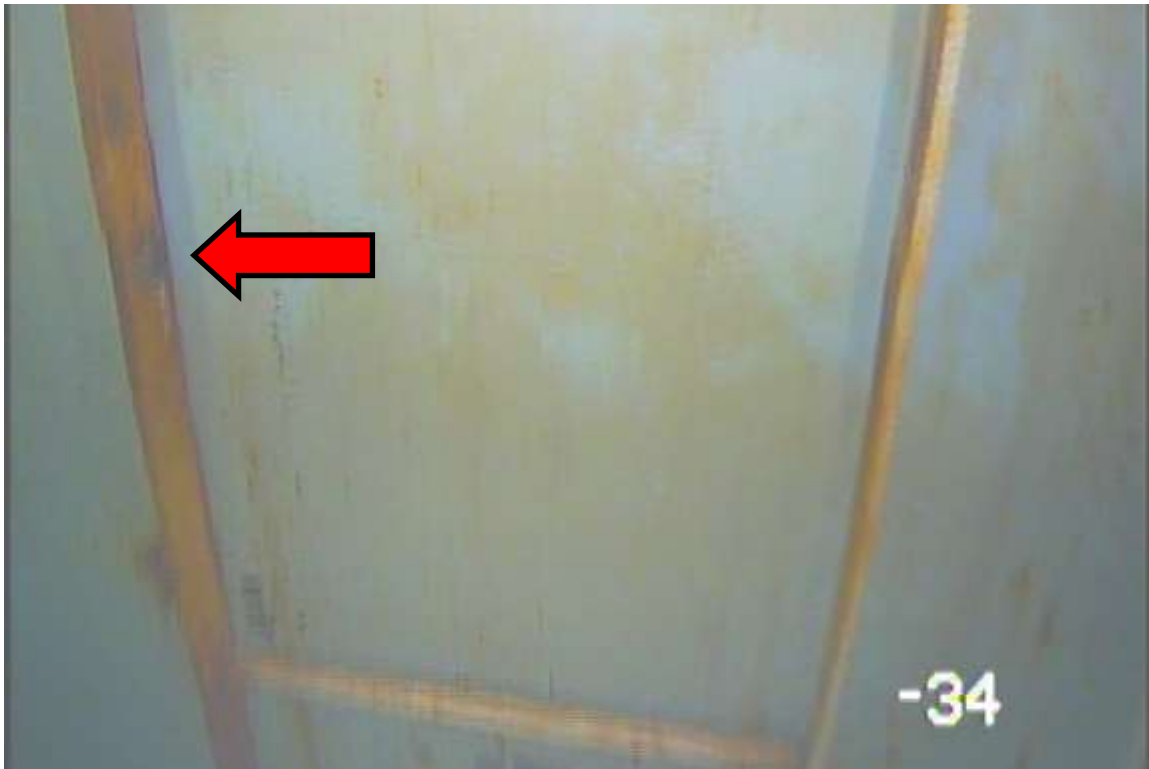
Primary interior access ladder in above photo is not equipped with anti-skid rungs and is seriously deteriorated. **Notice the missing rungs.** OSHA 1910.23 (b)(10) states, "Any ladder with structural or other defects is immediately tagged "Dangerous: Do Not Use" or with similar language in accordance with § 1910.145 and removed from service until repaired in accordance with § 1910.22 (d), or replaced;..." We recommend installing an OSHA compliant interior access ladder complete with standoffs every 10' on center, and a cable type ladder safety device at the primary roof hatch.

This ladder should be replaced on an emergency basis.

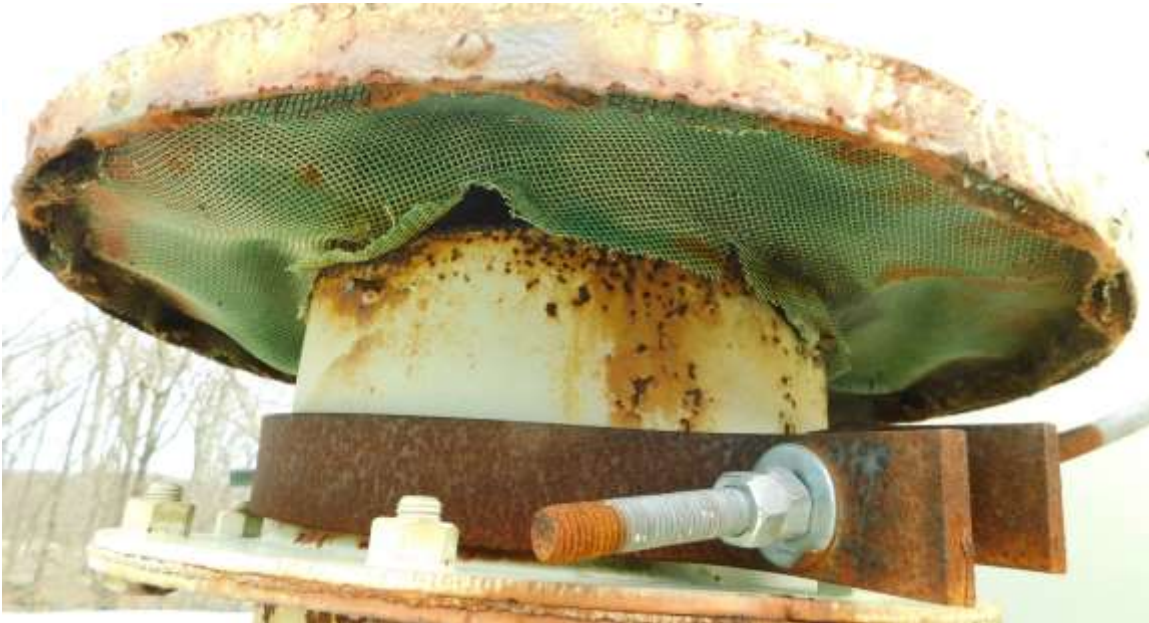
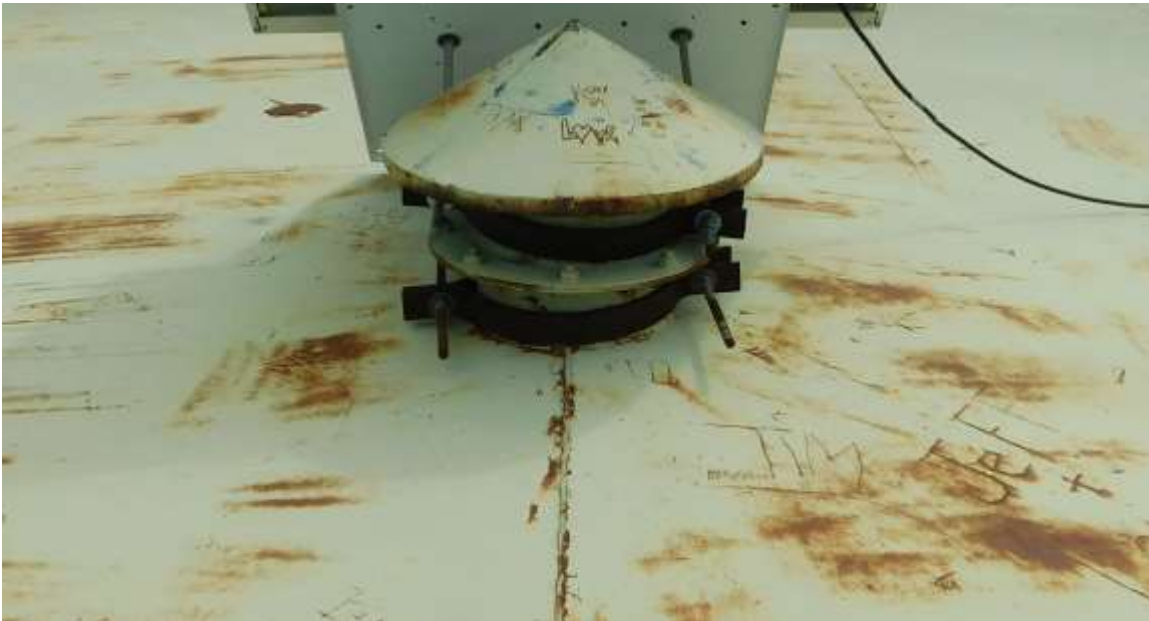
Photos show the condition of the existing 14" roof vent. **This vent is allowing the ingress of rain and wind-borne contaminants into the water system. An improperly vented tank may cause external pressure to act on the tank which can cause buckling even at low pressure differential.** We recommend replacing the existing roof vent with a vacuum-pressure, frost proof vent and screen.

This work should be performed on an emergency basis.

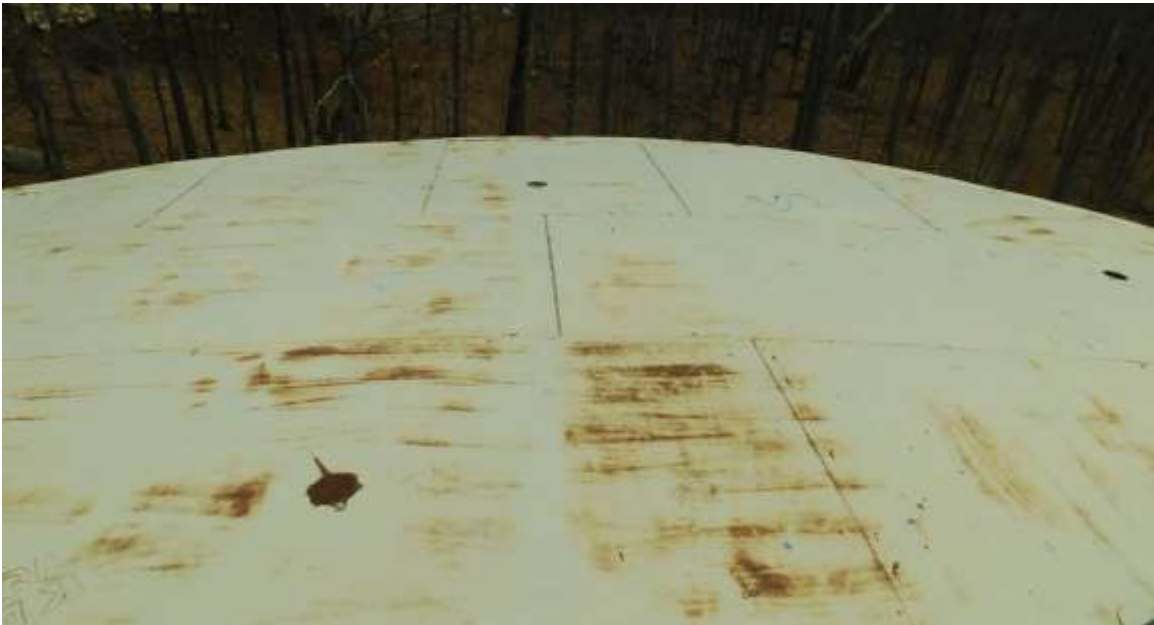
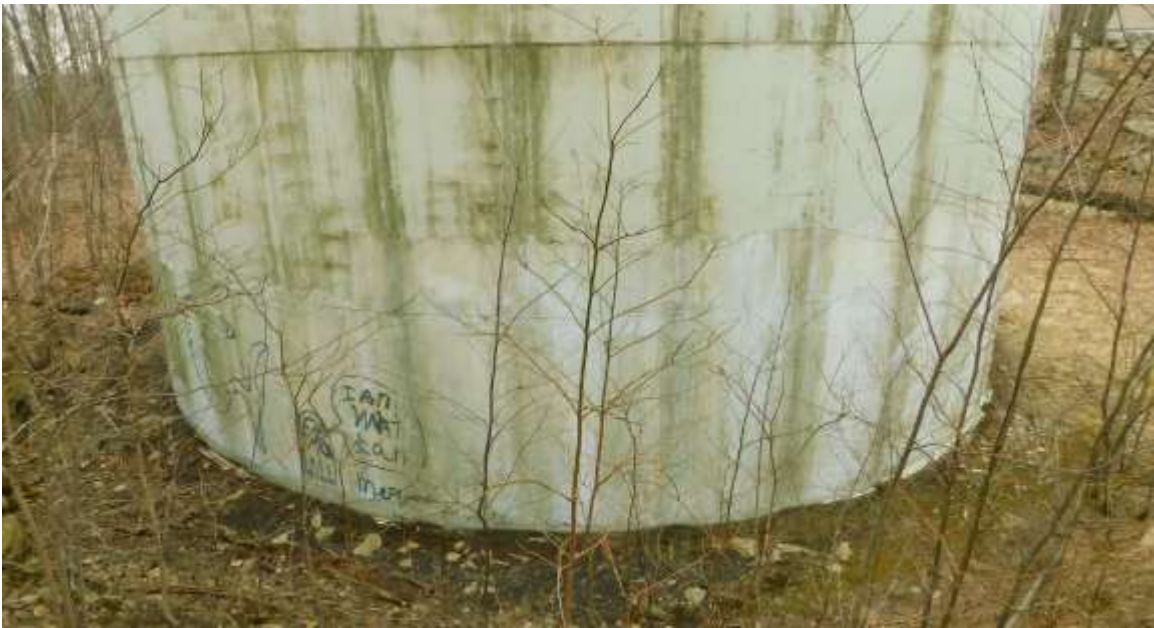
Photos show the tank exterior coating system. We recommend pressure washing the tank exterior with biodegradable detergent injection (minimum 3,500 psi at 3.0 gpm) then removing all loose rust and scale with wire brushes and hand scrapers in accordance with SSPC#2 (hand tool cleaning), spot priming and applying one (1) finish coat of acrylic paint.

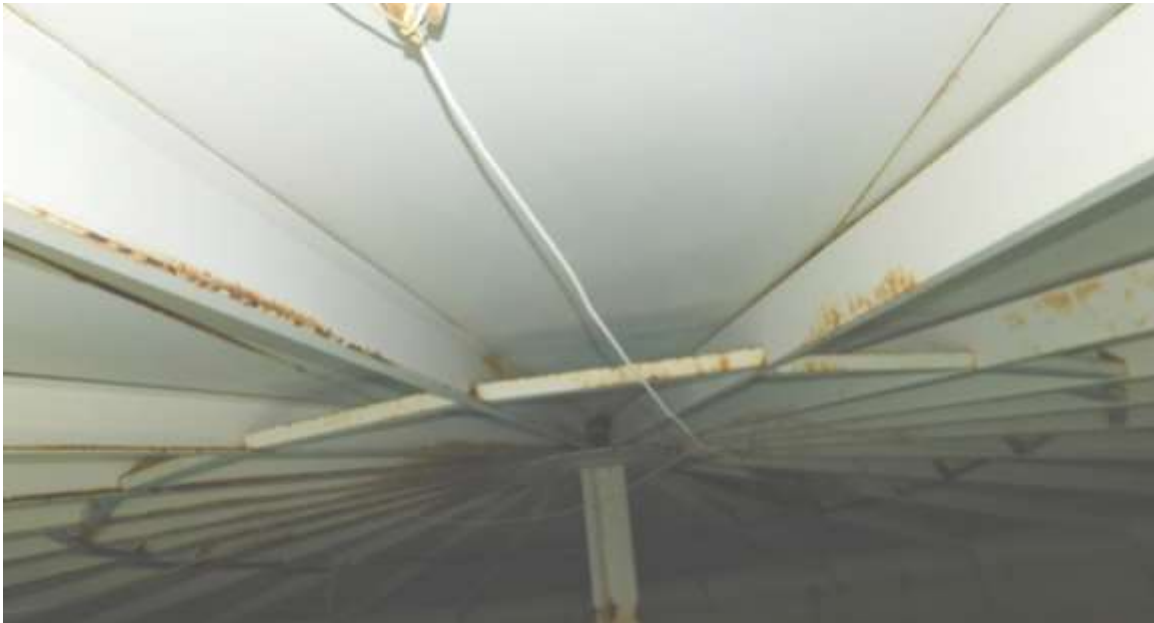
Top photo shows the interior roof lap seams, which appear to be in good condition.

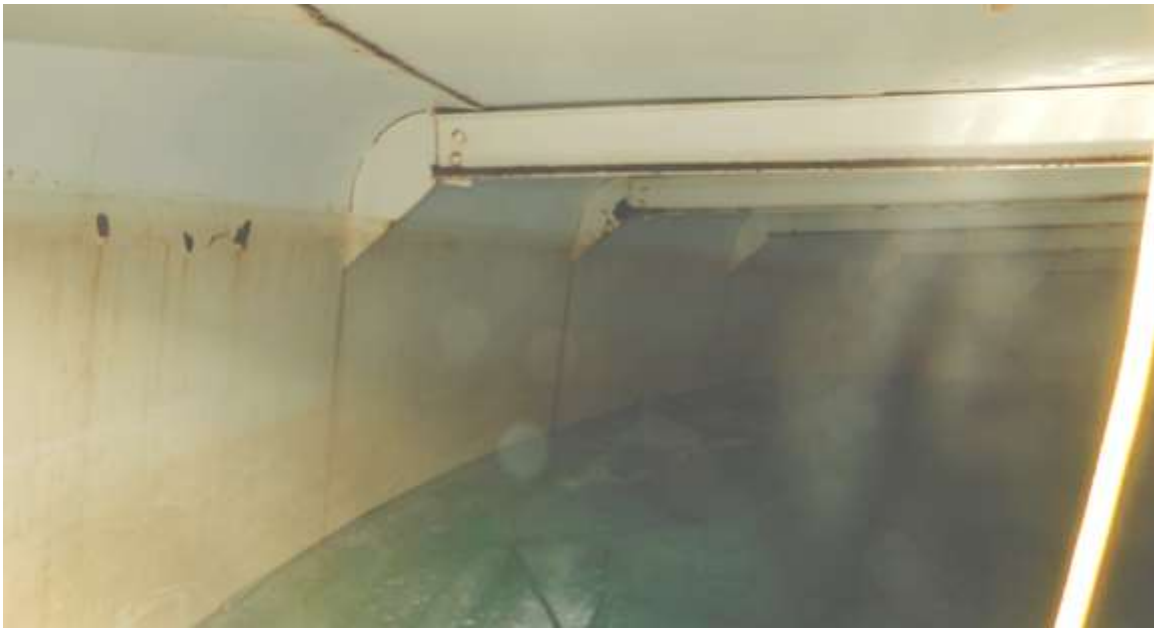
Bottom photo shows the interior roof-to-rim angle connection, which appears to be in good condition.

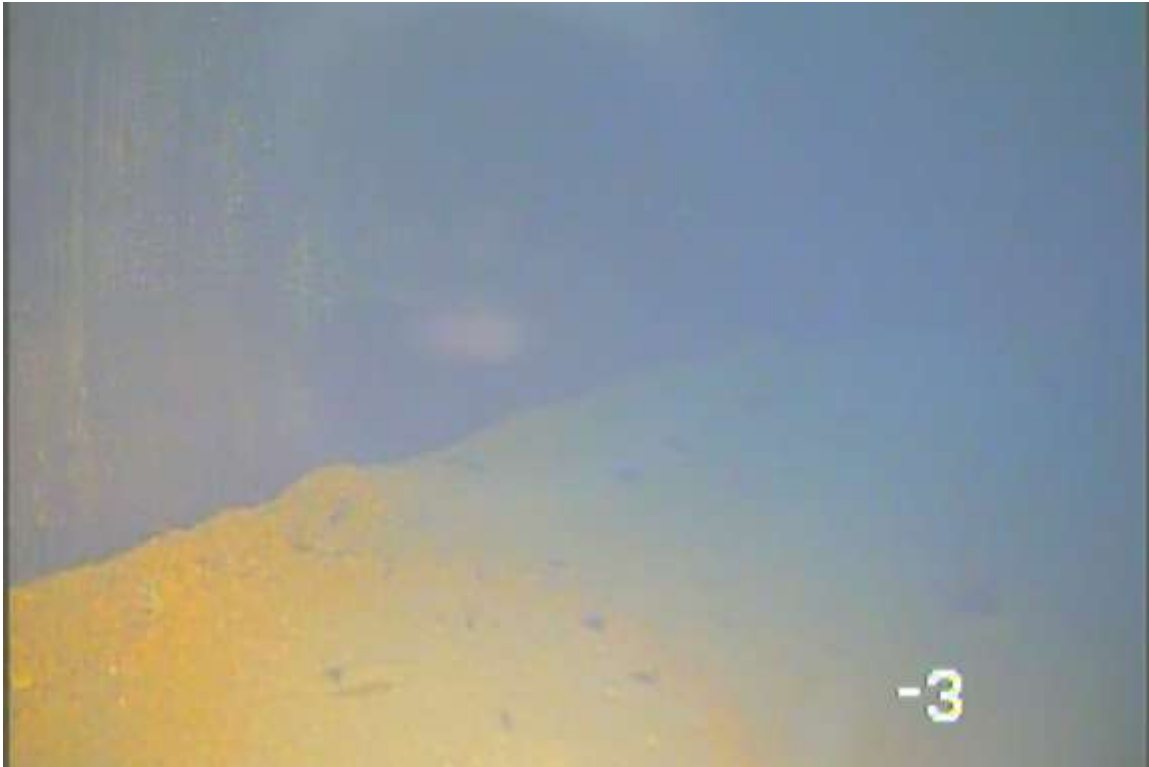
Photo shows the tank interior. A temperature difference between the water in the top and bottom of a tank, even as little as 1-2 degrees Fahrenheit, is an indication of thermal stratification and the tank water not being completely mixed. Incomplete mixing would result in short-circuiting, and localized increase in water age would develop inside the tank. This typically leads to water quality problems, such as loss of residual, DBP spikes, HPC spikes, bacteria regrowth, formation of bio-film, changes in pH and dissolved oxygen. We recommend installing a mixing system. Electrical work to be done by others if required.

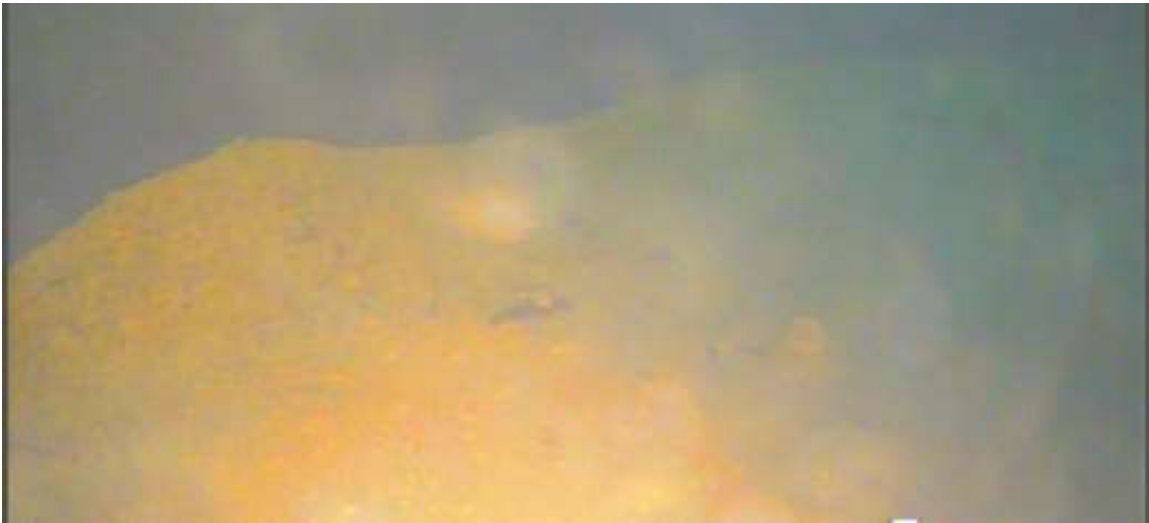
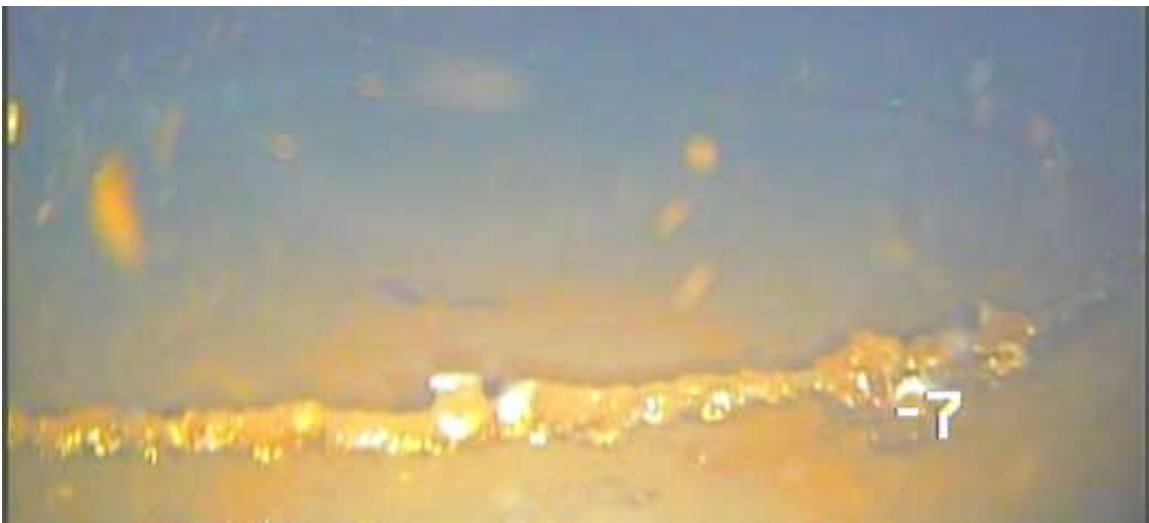
Photos show sediment in the tank. We recommend performing a dry interior cleanout in order to prevent contamination issues associated with excessive sediment buildup.

Due to amount of sediment and debris, a robotic in-service cleanout can not be performed.

This work should be performed on an emergency basis.

We further recommend installing a passive cathodic protection system.

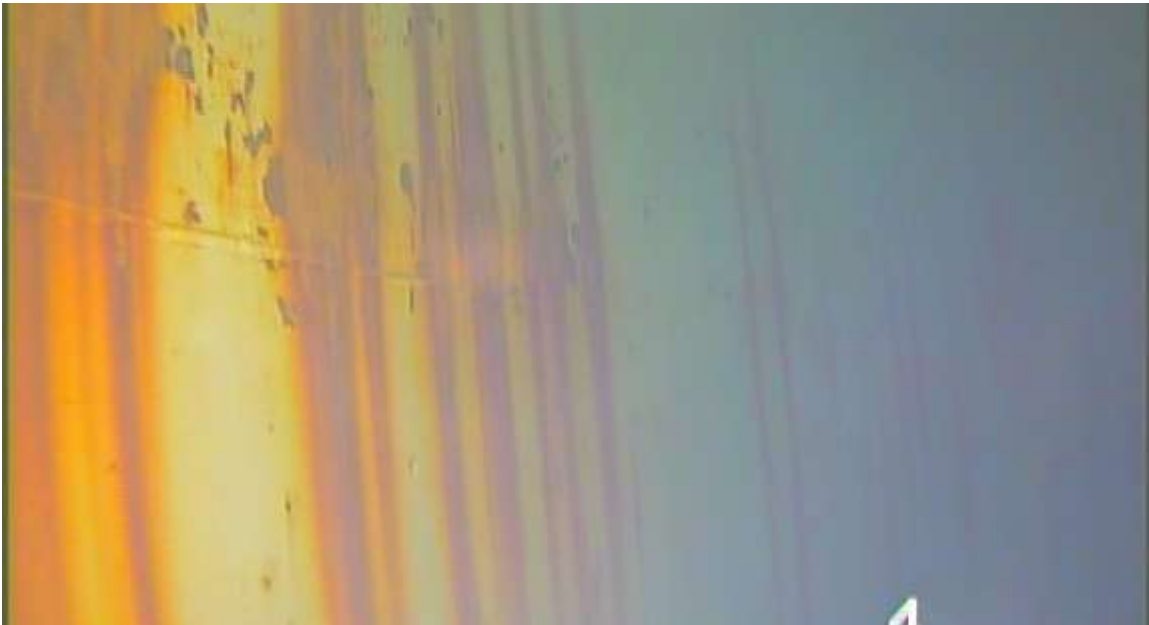
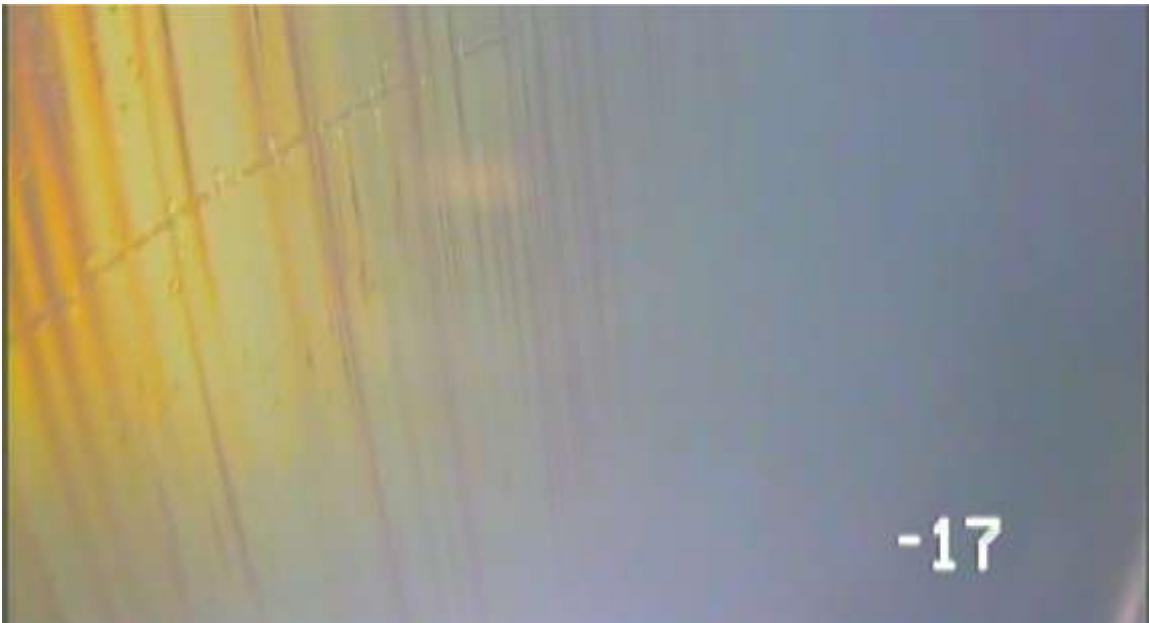
Photos show the condition of the interior coating system. We recommend sand-blasting all rusted and abraded interior areas to SSPC-SP10 (near white), and brush blasting all remaining interior areas to SSPC-SP7; then applying one (1) spot coat of epoxy primer to all areas sandblasted to #10, stripe coating all weld seams, and applying epoxy to the entire tank, to achieve 8 to 10 mils of total dry film thickness. Total mil thickness will include a combination of the existing and new coating.
