TOWN OF CARMEL
ENVIRONMENTAL CONSERVATION BOARD

ENVIRONMENTAL CONSERVATION BOARD AGENDA

**Re: Lake Plaza Shopping Center
983-1005 Route 6,
Mahopac, NY 10541
Tax Map #65.10-1-45 & 46
Wetland Permit Application**

Wetland Permit Application

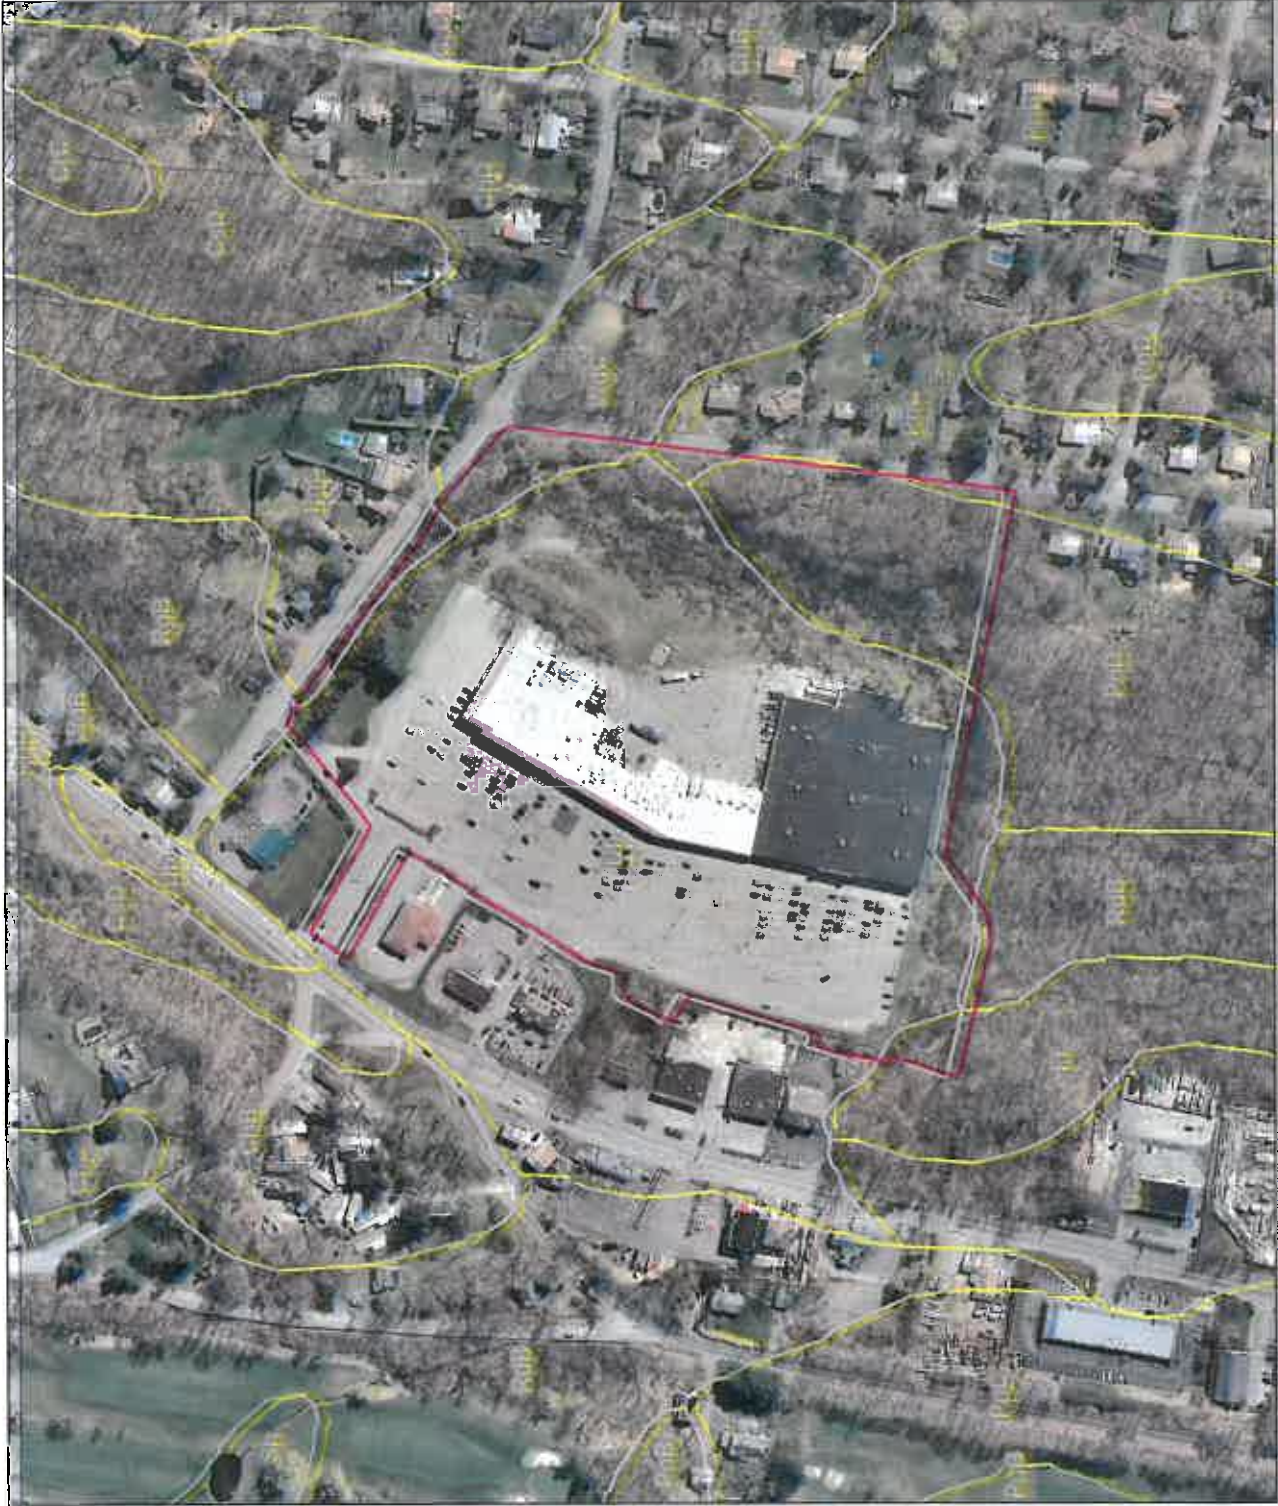
A map depicting the soil units present within the study area has been provided (**Appendix E: Figure 2**).

Source: Aerial Imagery from Google Earth Pro, 2015. Soils from NRES, 2013. VHB is not responsible for the accuracy of the data provided by the sources listed above.

VHB conducted a desktop review of soils via Web Soil Survey prior to performing environmental surveys (NRCS, 2015). The VHB study area is comprised of seven soil types, including: Fluvaquents-Udifuvents complex (Ff), Paxton fine sandy loam, 8 to 15 percent slopes (PnC), Paxton fine sandy loam, 15 to 25 percent slopes (PnD), Ridgebury loam, 3 to 8 percent slopes (RdB), Ridgebury loam, 2 to 8 percent slopes, very stony (RgB), Urban Land (Uf), and Woodbridge loam (WdC).

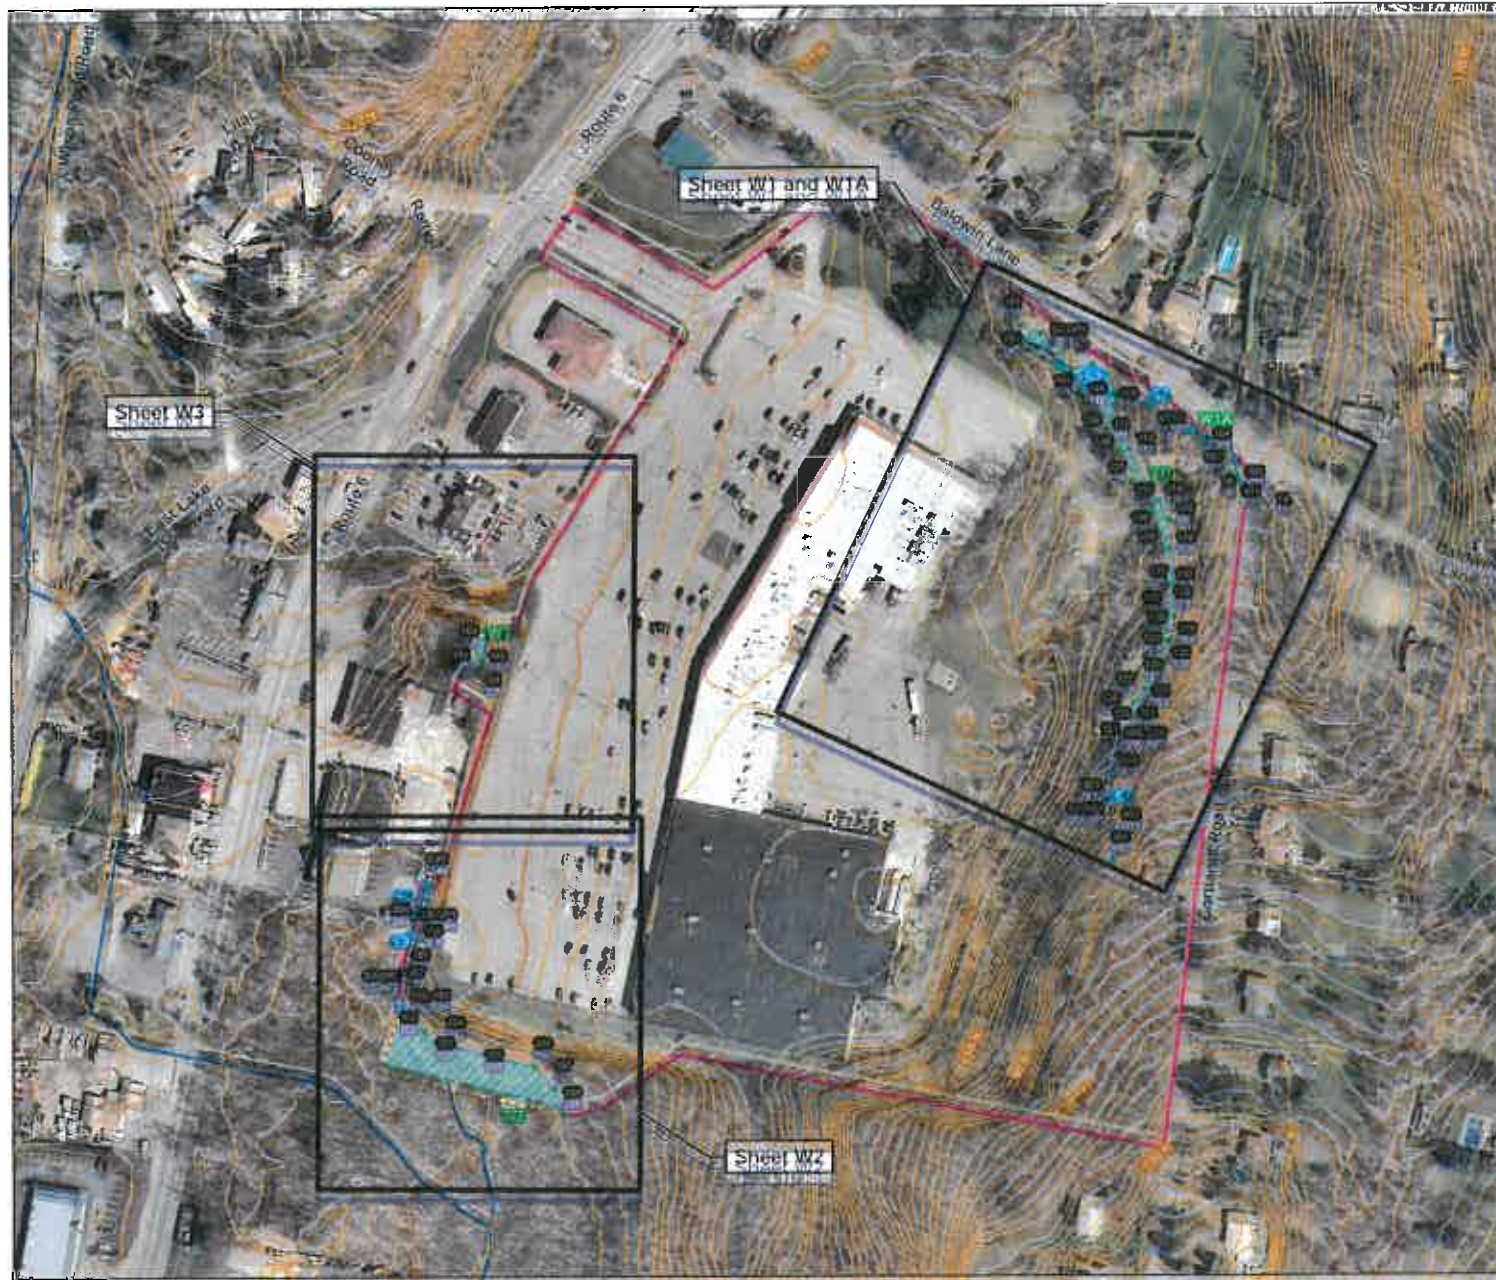
**Figure 5
Natural Resources Series - Index Map**

VHB has delineated four wetland features within the study area, including palustrine emergent and palustrine forested wetlands: Wetland 1 (W1), Wetland 1A (W1A), Wetland 2 (W2), and Wetland 3 (W3). Of these, W1 and W1A are generally in the northeast, W2 is in the southwest, and W3 at the west edge of the study area, as illustrated by the Natural Resource Series mapping (**Appendix E: Figure 5**).

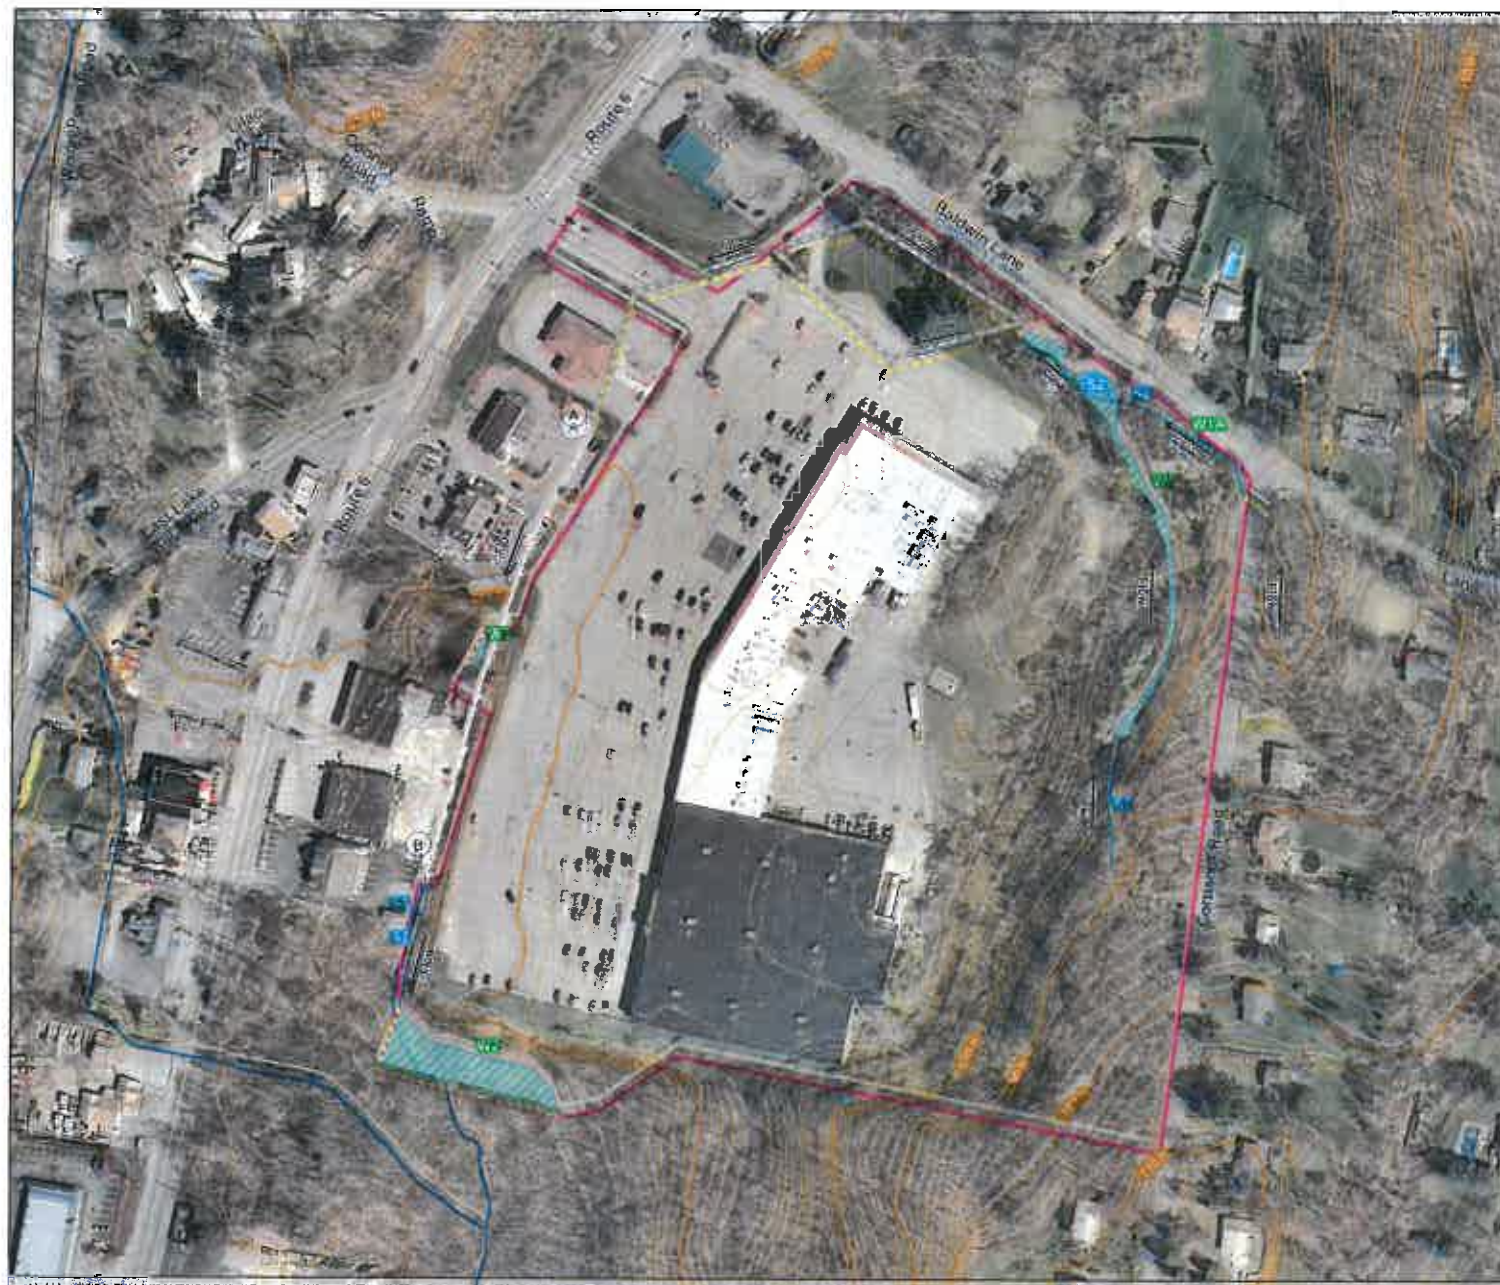
Figure 6 - Flow Map
January 28, 2016

Stream 2 (S2) originates from an offsite wetland and stream drainage area to the east of Cortlandt Road. S2 then flows through an HDPE culvert under Cortlandt Road, generally flowing northwest until it continues underground via a culvert (Flag S2-618). Based on the culvert information available, VHB believes the outlet of S2 is approximately 1000 feet south west of where a 4-foot corrugated metal pipe (CMP) culvert outlet was found (**Appendix E: Figure 6**). The stream at this outlet was collected as feature Stream 3 (S3).

Sources: Background - NYS Ortho
(2013): Exact location of flow connection
between points A & B unknown. Streams
(NHD) from USGS (2014): Putnam County
contours from NYS GIS Clearinghouse.
Stormwater drainage features from site
Engineering, Survey & Landscape Architecture
PC's Preliminary Lake Plaza Survey (6/24/15).
PC's Preliminary Lake Plaza Survey (6/24/15).

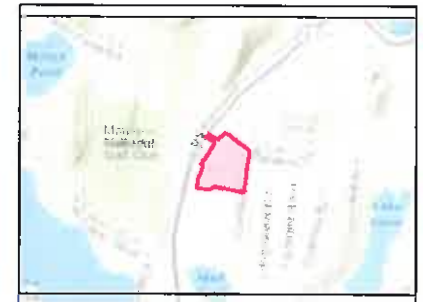
-
- Study Area (VHB)
 Wetlands (VHB)
 Wetland Continues
 Stream Type (VHB)
 Center
 Top-of-Bank
 Streams (NHD)
 Culvert (VHB)
 Existing Stormwater Drainage
 Assumed Flow Connection Between A & B
 10' Contour
 2' Contour

A total of three water features were delineated within the study area. S1 was determined to be ephemeral; flowing through an existing trench northwest until dispersing into W1. S2 originates from outside of the study area; east of Cortlandt Road and flows through W1A and W1 into a HDPE culvert. VHB assumed that the outlet of S2 flows through a culvert into S3 (**Appendix E: Figure 6**). S3 begins at the culvert outlet, and flows south into W2, the flagged boundary of NYSDEC regulated wetland LC-32 (Class II).

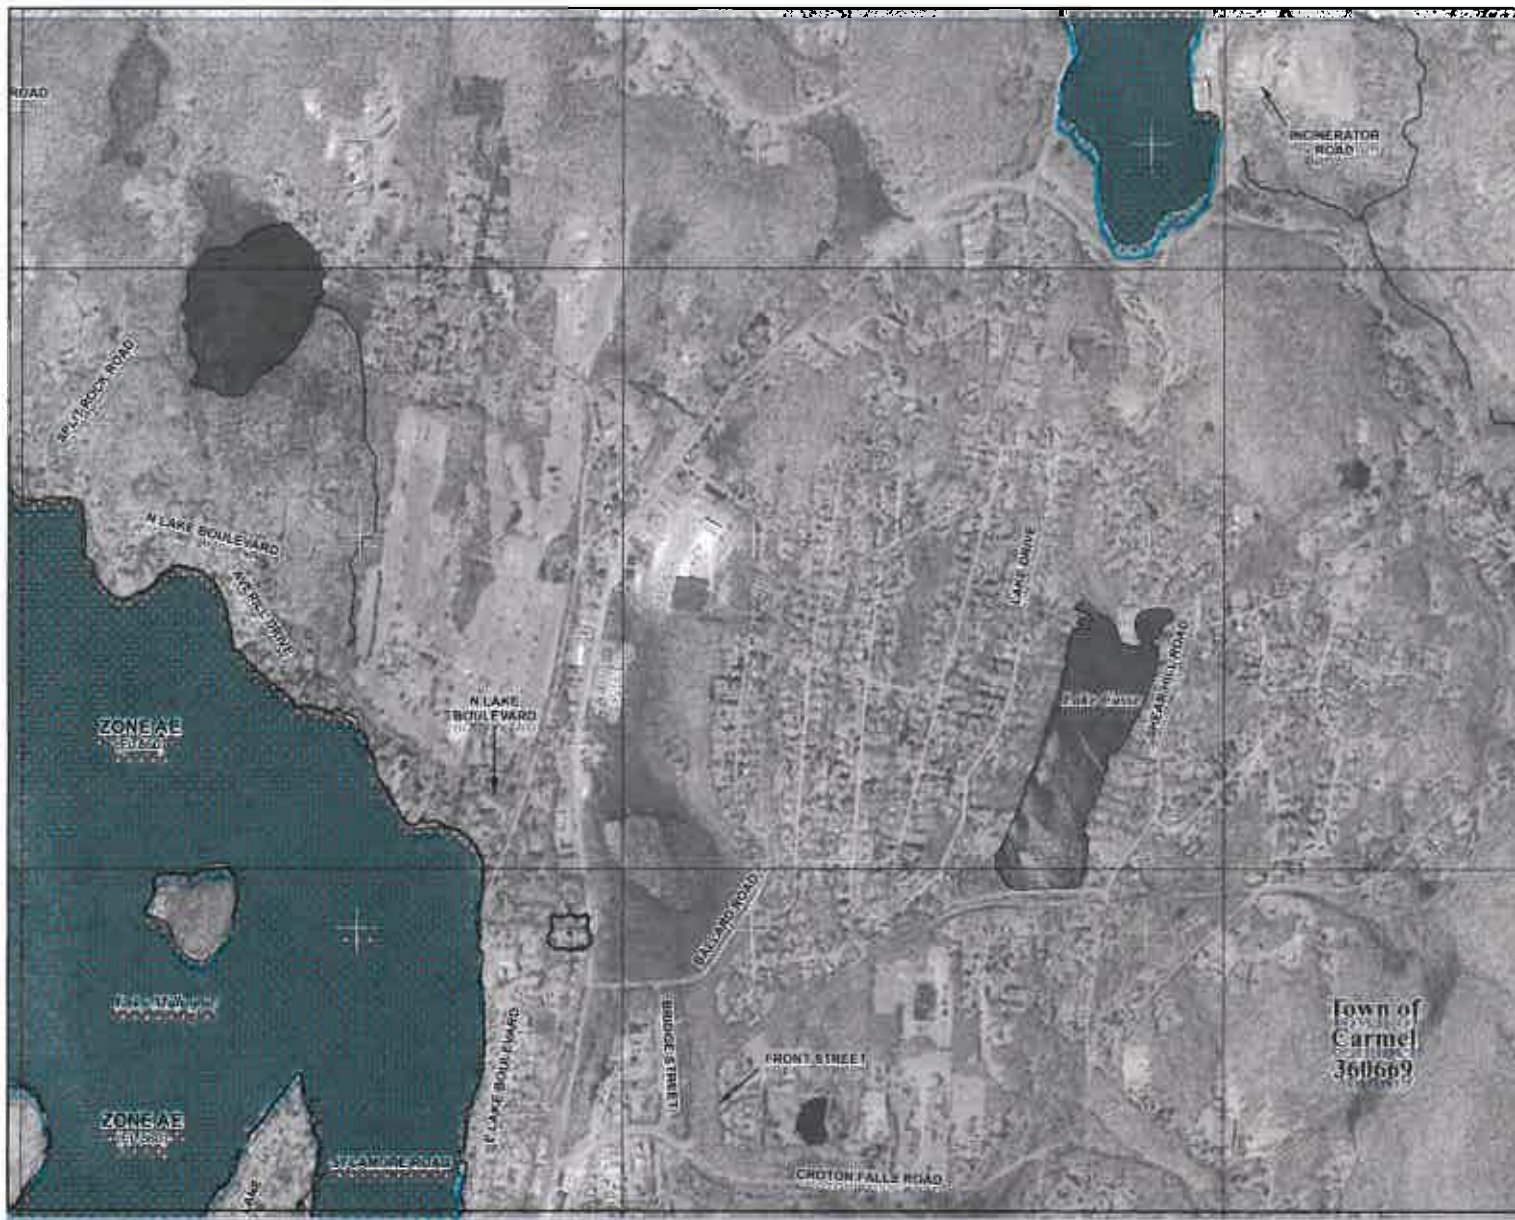
Figure 7. FEMA/FIRM

PANEL 0140E
PANEL 0140E

FIRM
FLOOD INSURANCE RATE MAP
FLOOD INSURANCE RATE MAP
