TOWN OF CARMEL
PLANNING BOARD

PLANNING BOARD AGENDA
SEPTEMBER 14, 2023– 7:00 P.M.

RE: Site Plan P&R Estate Corp.
44.13-2-68

PROJECT: **DDP - SELF STORAGE**
4 BALDWIN PLACE ROAD, TOWN OF CAMEL, PUTNAM COUNTY, NY.
DRAWING: **EXISTING CONDITIONS PLAN**

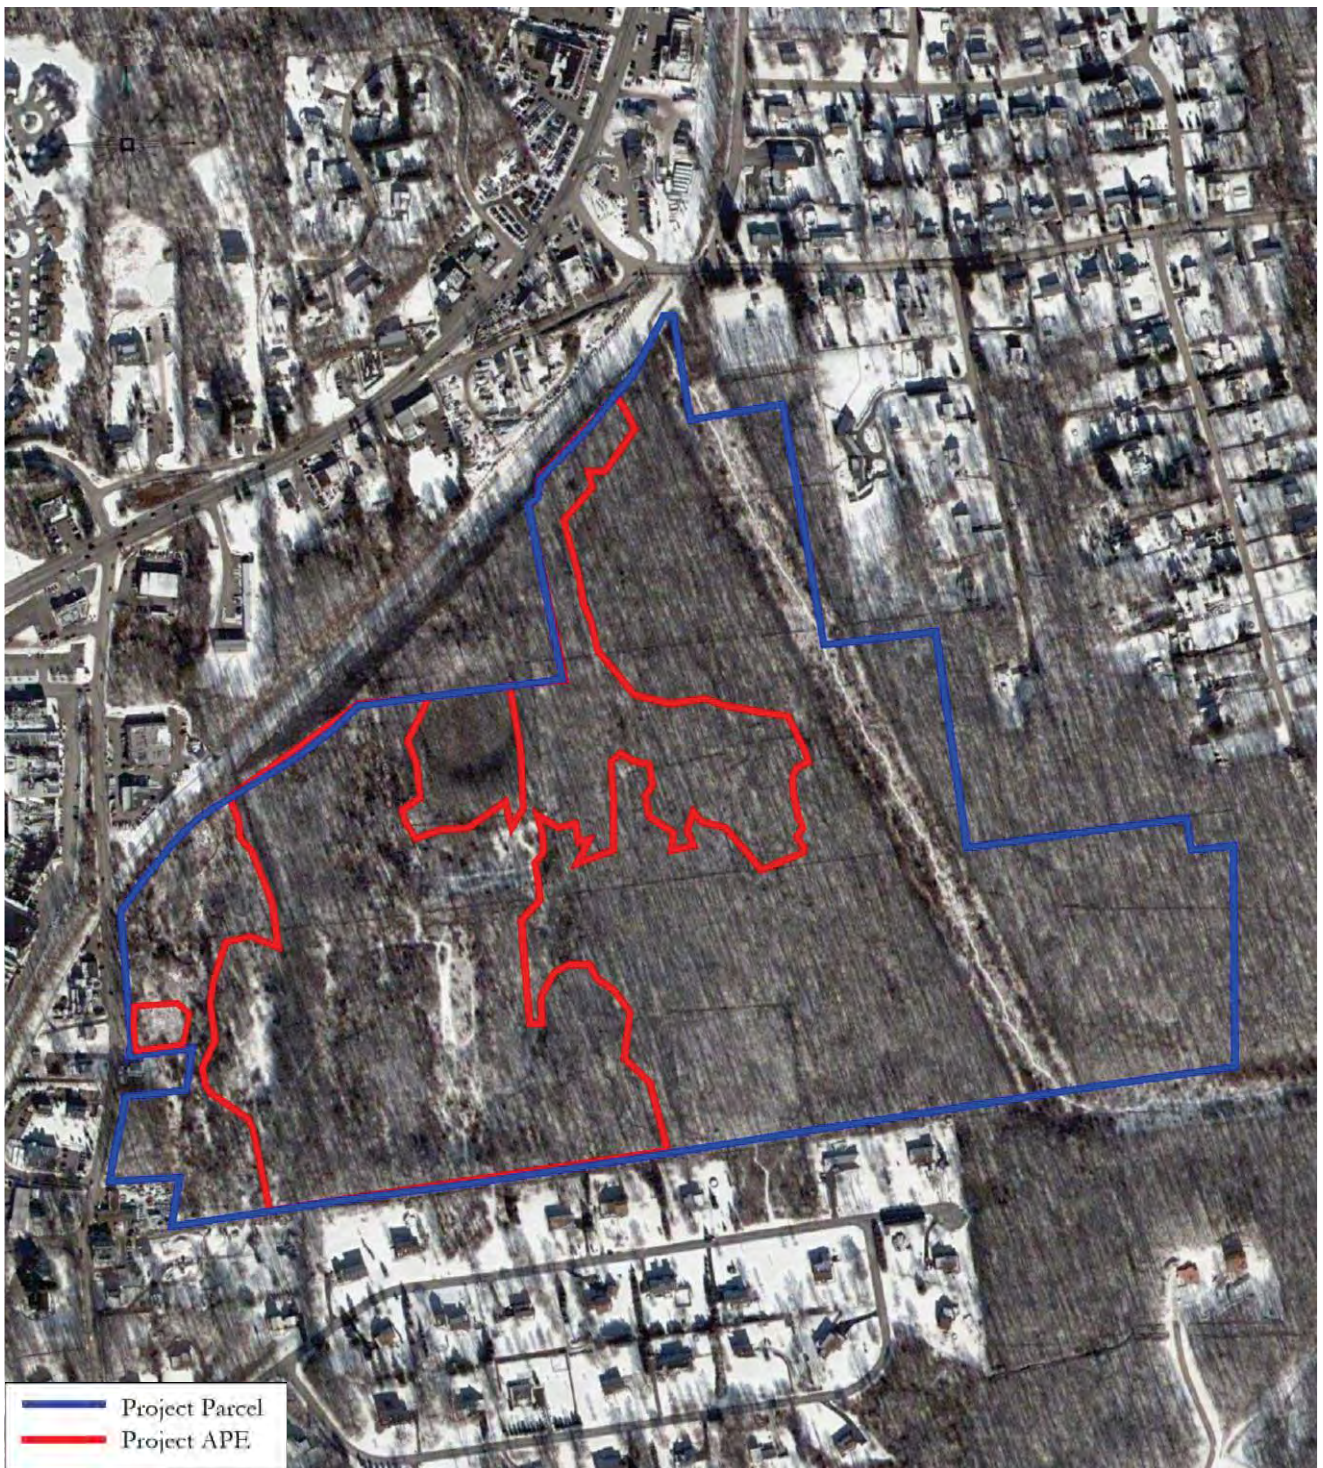
Figure 4: 2005 Aerial Image showing the Project APE. (Source: New York GIS Clearinghouse.) Scale: 1" =550'.

The 2005 Aerial image shows an additional area of disturbance to the north of the small dirt track. The dirt track is still visible, although the overall shape of the track has changed. To the west, along Miller Road, the landscape is visibly disturbed. The field investigations noted extensive piles of soils and debris in this location.

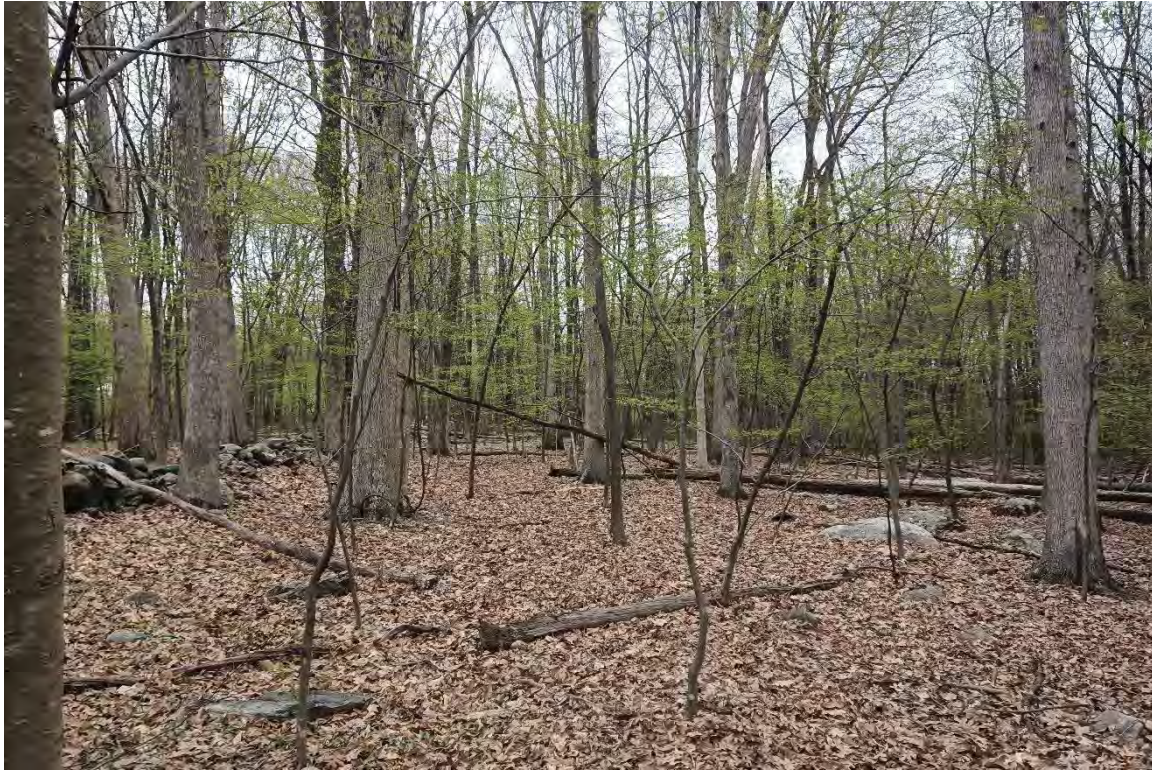
Photo 5: The landscape is very stony, with rock walls separating large areas of the Project APE. View to the north from the end of TR 1.

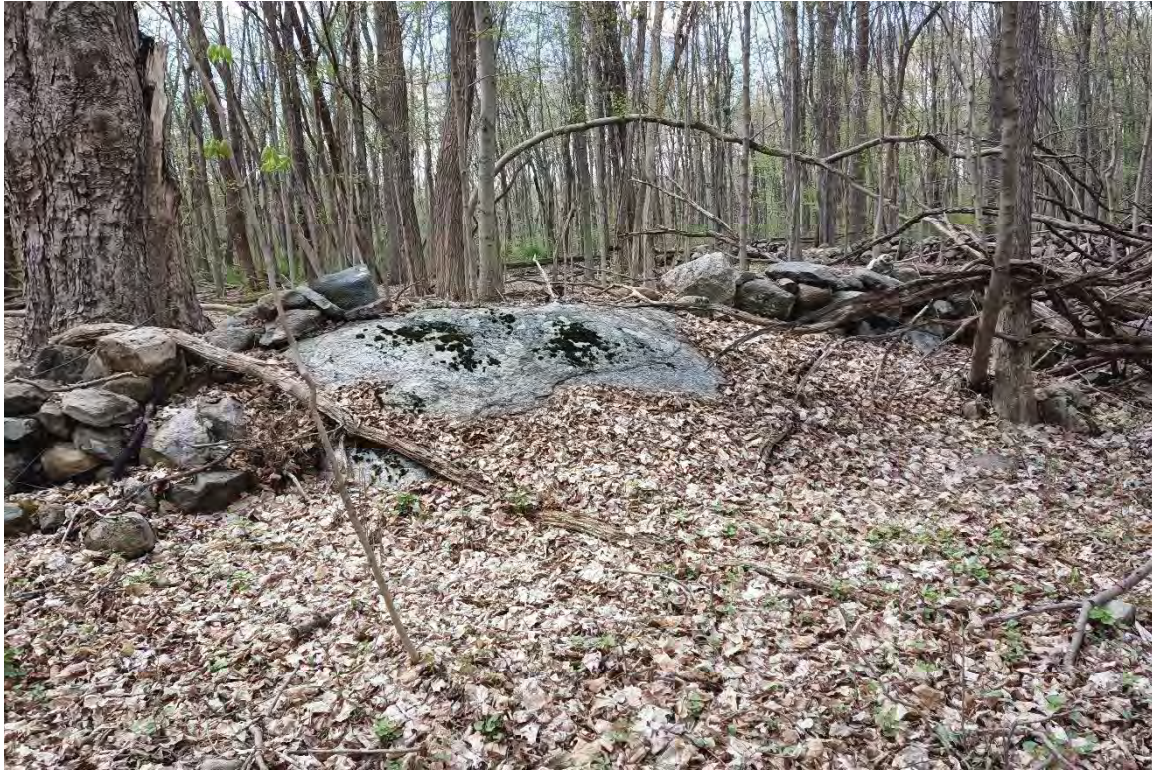
Photo 9: Large pieces of bedrock form wall foundations in much of the Project APE. View to the northeast.

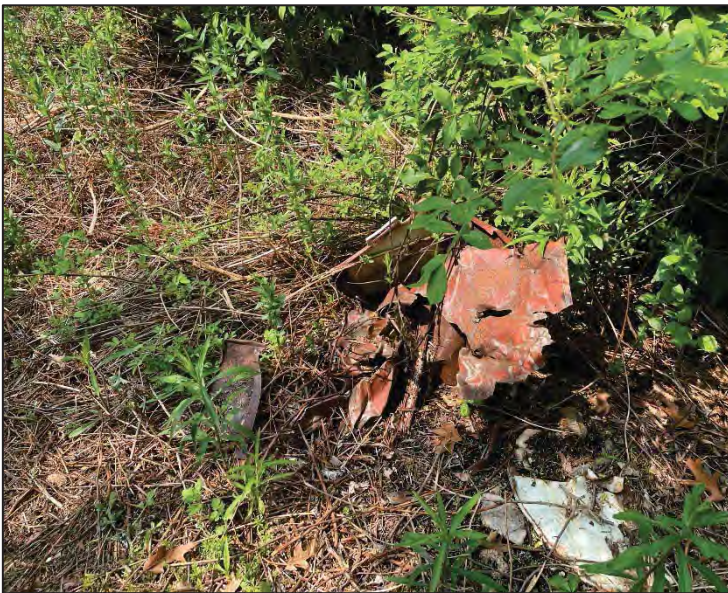
Photo 3 – Scrap metal observed on the northeastern portion of the Subject Property

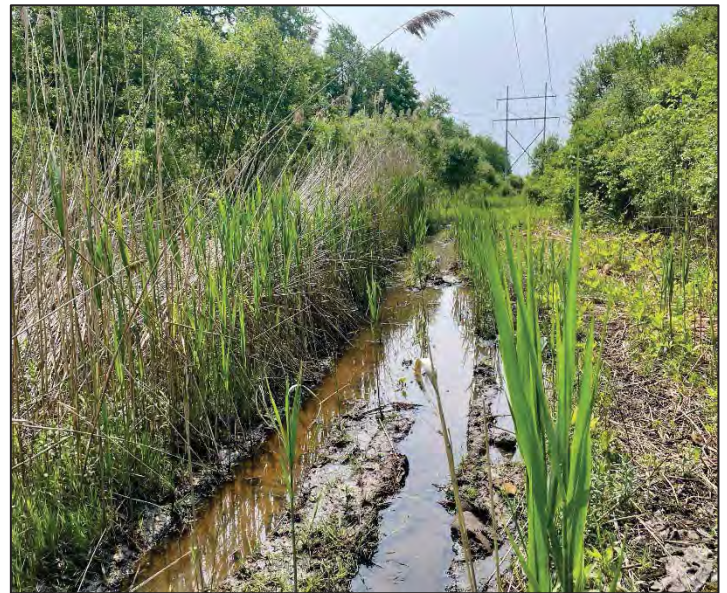
Photo 4 – View of standing water along the utility easement located on the northeastern portion of the Subject Property

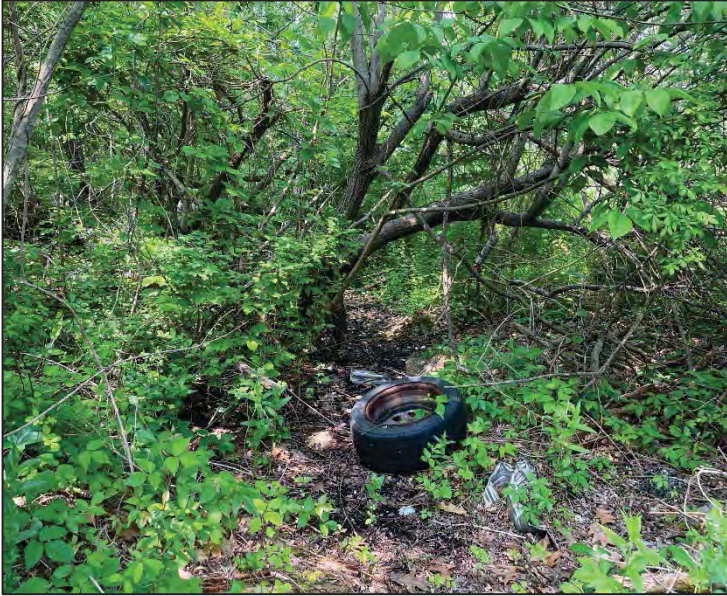
Photo 5 – Old tires observed within the north-northeastern portion of the Subject Property

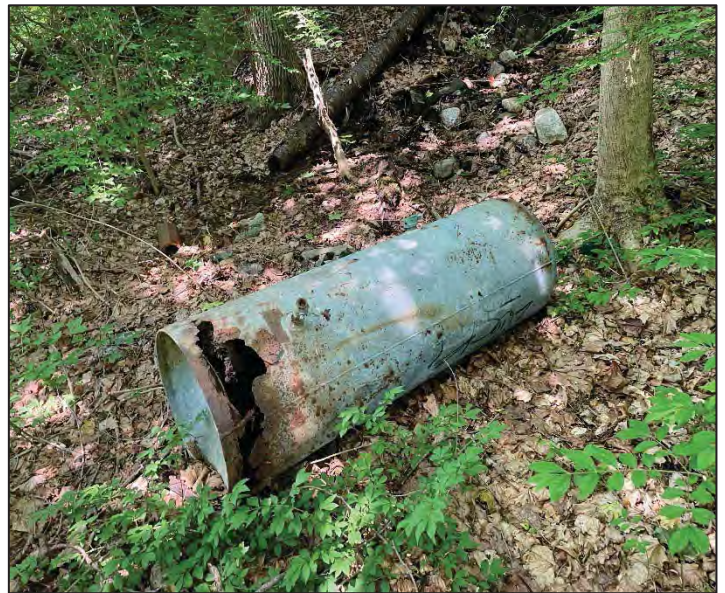
Photo 8 – Rusted hot water heater tank located adjacent to the north of the Subject Property

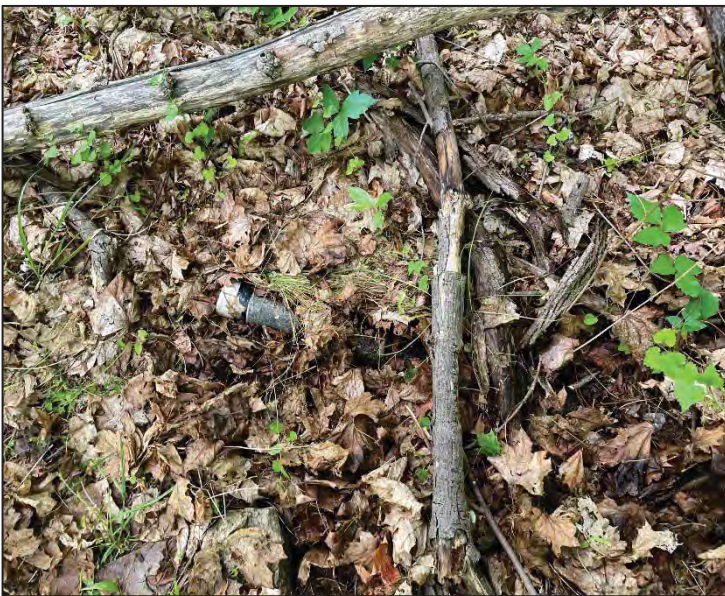
Photo 19 – Partially buried PVC pipe observed within the southwestern portion of the Subject Property

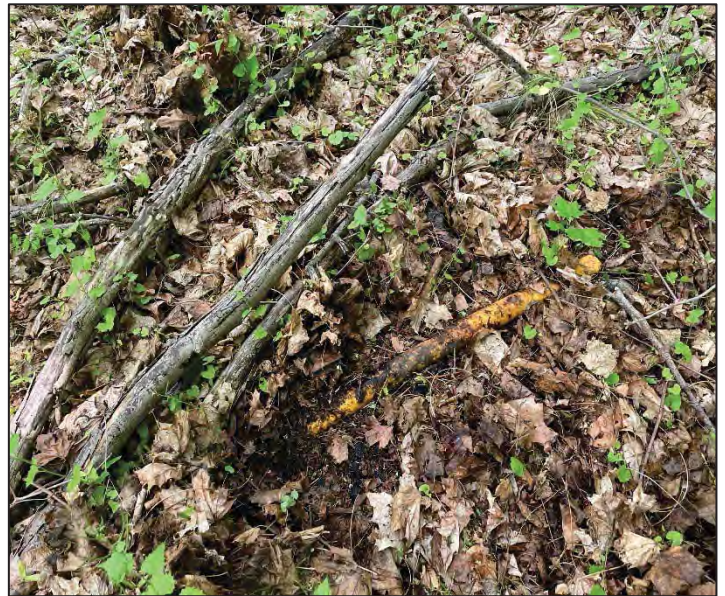
Photo 20 – Partially buried metal pipe observed within the southwestern portion of the Subject Property

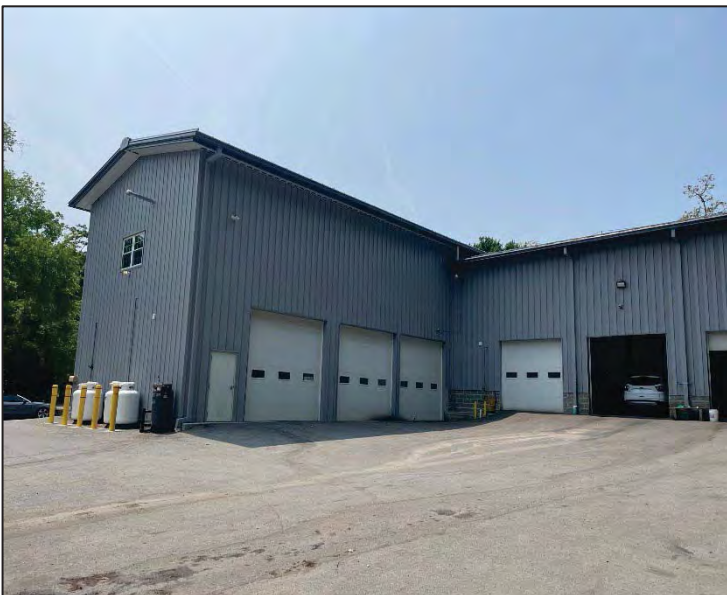
Photo 23 – View of the auto repair shop located adjacent to the southwestern portion of the Subject Property
